Charlotte County Utilities Department

2023 Annual Report

March 2024

Jones Edmunds Project No.: 03405-029-07

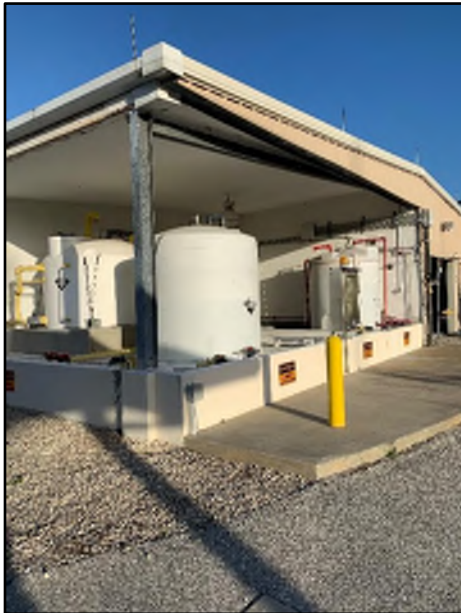
The sodium hypochlorite system consists of two bulk storage tanks, one 200-gallon day tank, two chemical metering pumps, and two injection points. The two bulk storage tanks are outside the process room and hold 1,400 and 1,100 gallons. The chemical containment area for the bulk storage tanks requires periodic painting. The day tank and chemical feed skid are in a segment of the RO process room. Sodium hypochlorite is primarily injected before water enters the storage tanks (pre-disinfection), although operators also have the capability of injecting after the GSTs (post-disinfection) if needed to boost the chlorine residual. The sodium hypochlorite system appears to be in good operating condition.

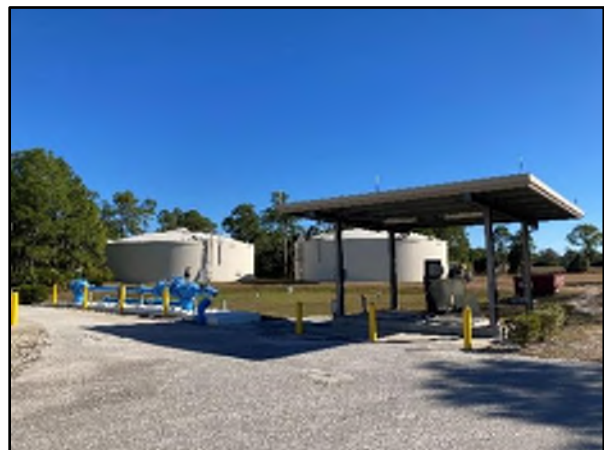
The VFDs on the pumps provide a constant pressure of 65 psi at the beginning of the distribution system at the WTP regardless of the water use. At the time of the site visit, the HSPs were operational and appeared to be in good condition.

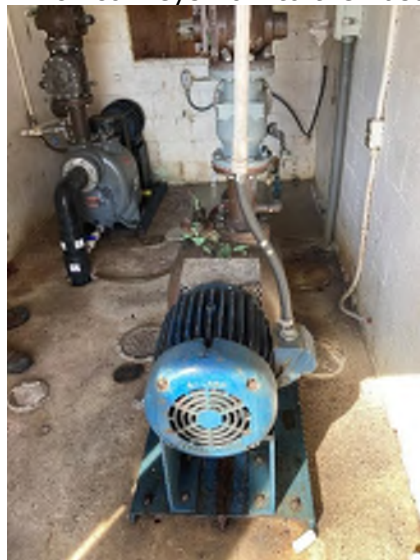
Originally built in 1959, LS-1 is housed in a concrete building on an open easement with no fencing. A large amount of insects, feces, and eggs were observed in and around the station. The wall of the structure contains visible cracks. This LS contains two above ground, self-priming, belt-driven pumps, one being a 15-HP Gorman-Rupp model T4A3-B and the other being an All Prime model XS-4. The original Gorman Rupp was installed, in 1980 and the All Prime was installed in 2022. The Gorman Rupp has an estimated capacity of 220 gpm at approximately 65 feet of head and

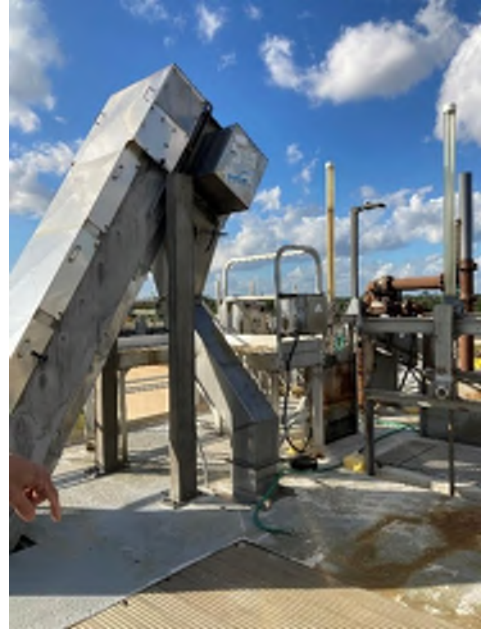
The two SRSs require constant maintenance due to the high number of septage haulers that use the facilities and the nature of the waste. The SRSs are reaching the end of their useful life and are included in the 9.0-MGD WRF upgrade that is under construction.

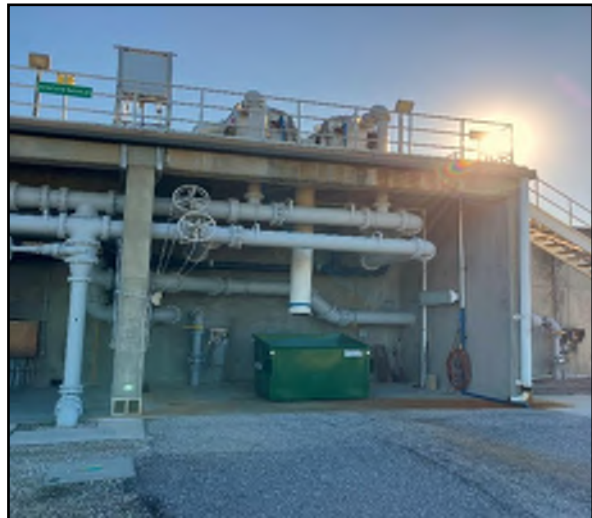
A fiberglass grating over the influent flow splitter area had been supported by two carbon-steel beams. These beams were replaced with aluminum beams in FY 2015. The fiberglass grating is showing minor signs of fraying.

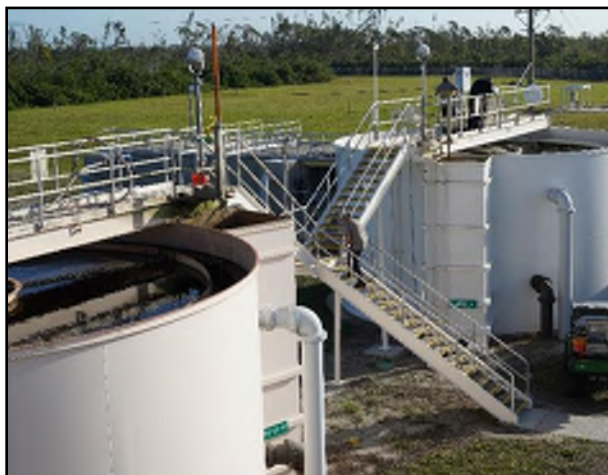
Although most of the unit process tanks are made of concrete or Type 304 stainless steel, the four secondary clarifiers consist of carbon steel and require constant paint maintenance every 2 years. The overall condition of the clarification process is fair. High sudden increases in influent flows can cause further issues with the clarifier performance when one of the four clarifiers is out of service. Installing submerged stamford baffling in the clarifiers could aid with sludge settlement and prevent solids from billowing up the walls and potentially entering the effluent launder.

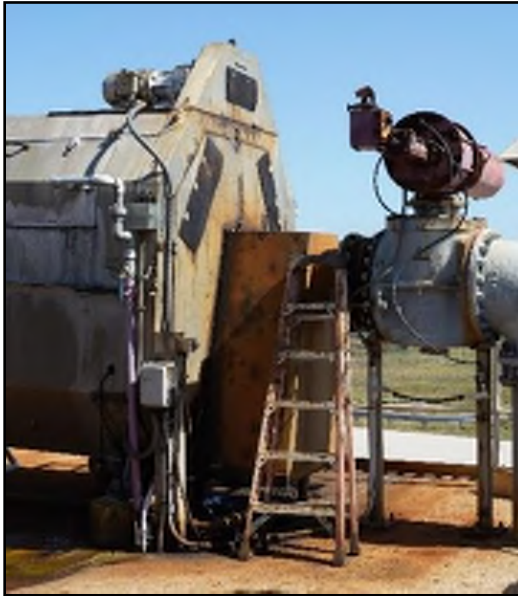
The overall condition of the headworks is fair to poor. The headworks is undergoing an improvement and rehabilitation/replacement project that will include new piping and fine screens as well other improvements to the headworks.

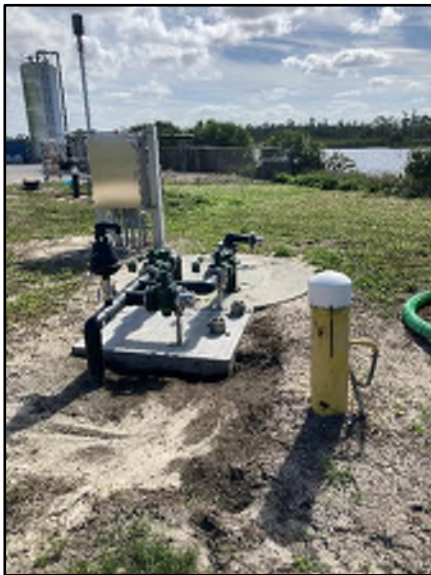
The influent pump station (PS-1) was rehabilitated in 2023 and is in excellent condition, however the operator reports pumping capacity is not as expected. CCU is working with the design engineer to resolve the issue. Although the influent is primarily fed by the gravity-driven network, a significant amount of storage is within the landfill collection system, which provides some operational flexibility for the LTF and can be used if PS-1 is temporarily out of service.

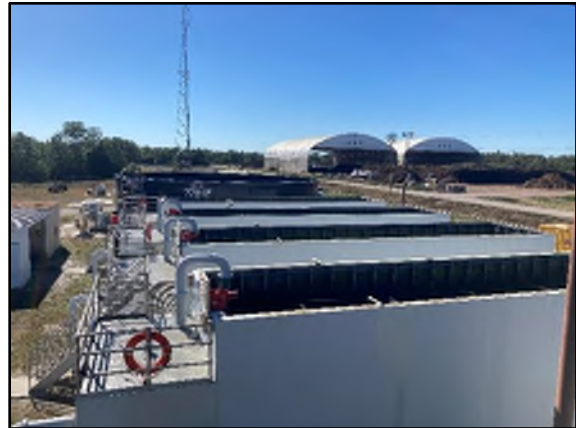
The three PACT units are in good-to-poor condition. The tanks' exteriors and interiors are in good condition since they were partially painted in FY 2017 and completed in FY 2018. Surfaces were pressure washed and rust and lost paint were removed and primed before painting was completed. The polymer feed systems and blower air intakes for the treatment trains should be replaced.
