CHARLOTTE COUNTY RAILROAD TRESTLES / FISHING PIERS: HISTORICAL BACKGROUND AND CONDITION UPDATE

OBSERVATIONS

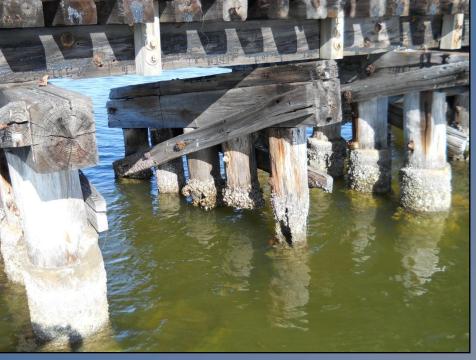
- From this cursory inspection, it was apparent the structure was in disrepair.
- Public safety being the primary concern, not because of the structure's inability to carry the pedestrian loads on the fishing piers, but because of the severely deteriorated timber components found missing or about to break free from the structure.

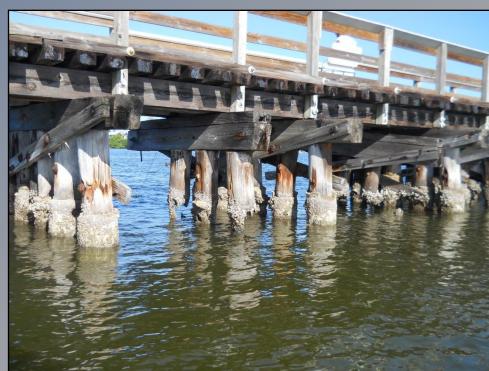
- Below water, marine borers have severely infested any accessible exposed timber.
- The timber piles were, at some point, repaired with concrete jackets.
- Piles with concrete jackets intact may have service life remaining.

The concrete jackets prevented the borers from causing further damage; however, over 50 percent of the jackets have failed and exposed the timber, resulting in severe loss of section and/or failure.

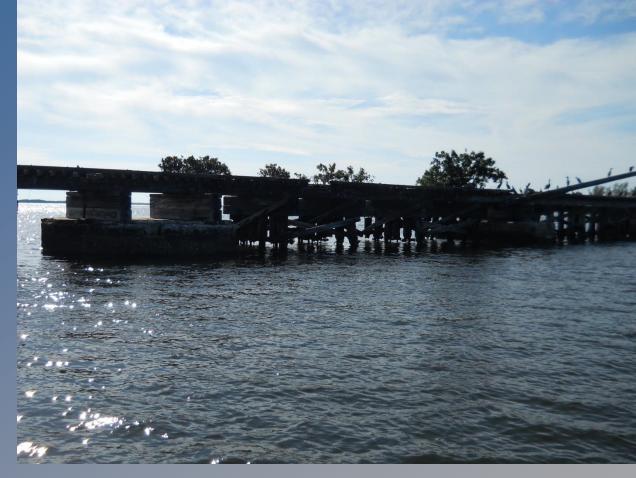
A significant number of piles were observed to be missing.

Other piles were observed consumed by borers, severed in the tidal zone and precariously suspended from the pile cap beams.

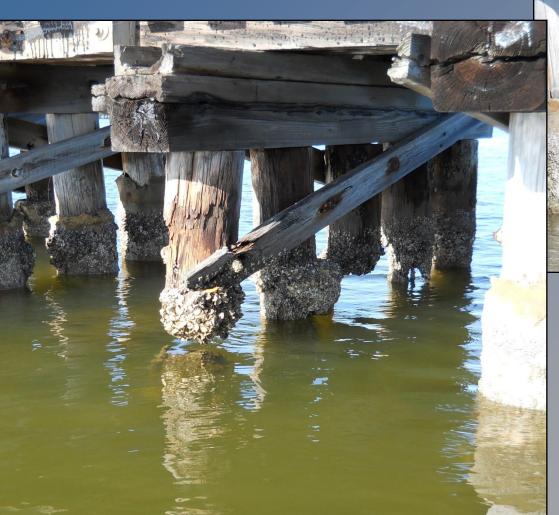
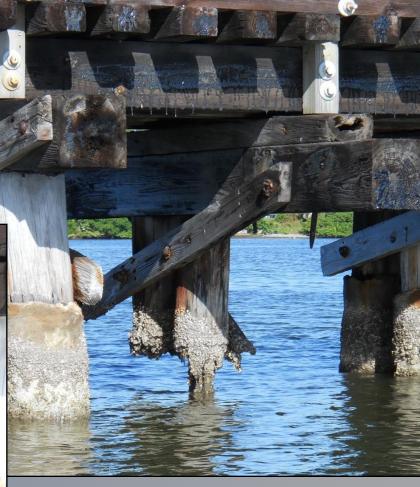
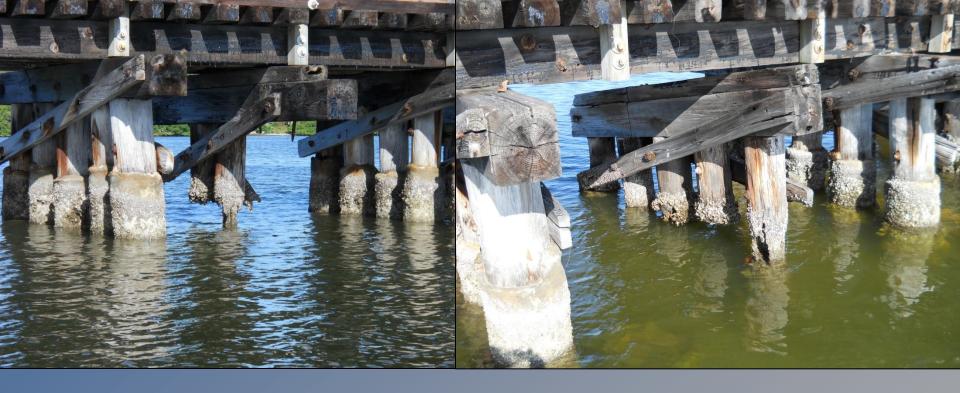
The next storm event may cause the deteriorated piles to break free and be set adrift.

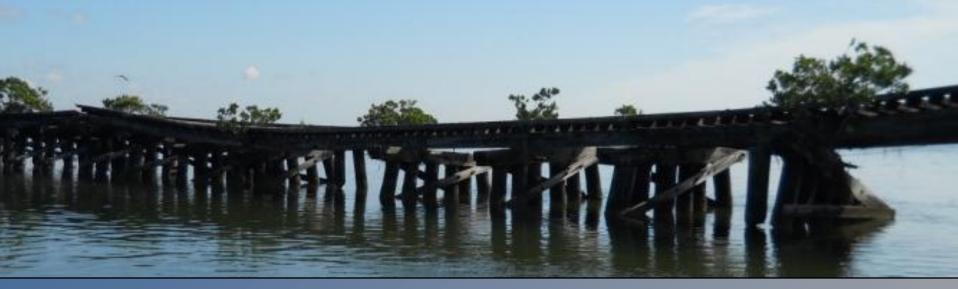
- Above water the timbers were in fair condition for the structure's age.
- Weathering and fungal decay were common deficiencies found throughout the superstructure.
- Steel fasteners connecting the members were heavily corroded.

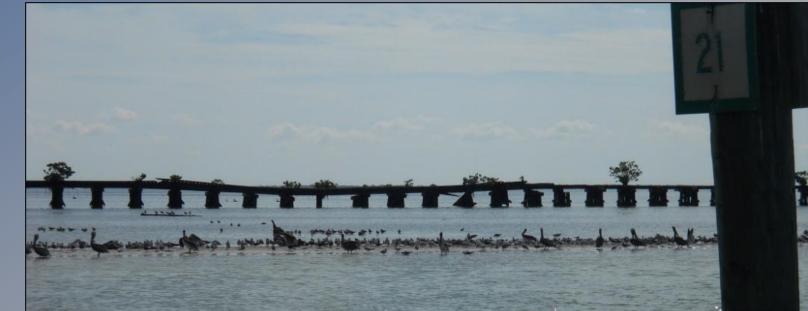
Collapse of a 100-foot long section of the trestle is imminent.

This section is located between the Gasparilla Channel and the south spoil island.

- The 100-foot long collapsing section of trestle should be condemned as soon as practical. All materials including pile stubs should be removed from the sound.
- Remove all significantly deteriorated piles and timber members no longer contributing to the stability of the trestle structure.
- Inspect the remaining piles and concrete jackets supporting the fishing piers. Ensure that there are adequate piles (minimum of two) properly spaced to support each pile bent.
- Repair all pile/jacket deficiencies found during inspection to prevent future marine borer infestation. To reduce costs, repairs could concentrate on the minimum number of piles at each bent. For example, each pile bent consists of six piles, but only the two outboard piles are needed for support. The other four piles would not necessarily need to be repaired.

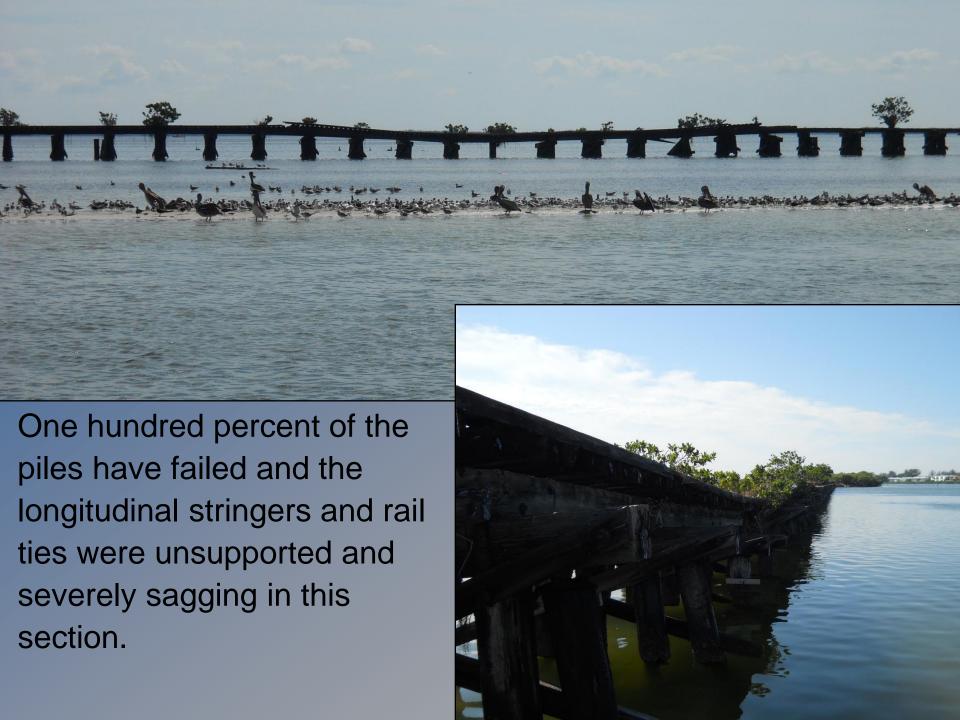
Unprotected piles have been completely consumed by marine borers in the tidal zone

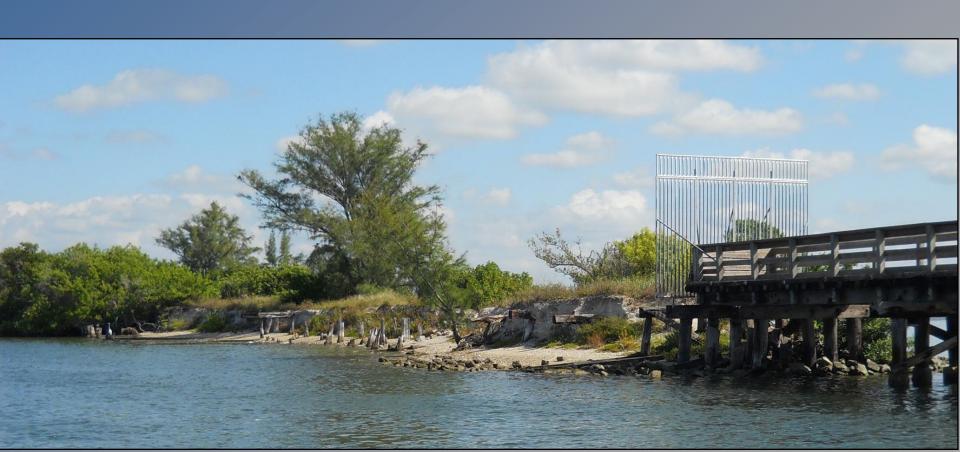
- Timber bulkheads constructed to contain the spoil and prevent erosion were in poor condition and/or missing.
- Deterioration of the bulkhead was more advanced than the trestle and much of the timber elements have been washed away.

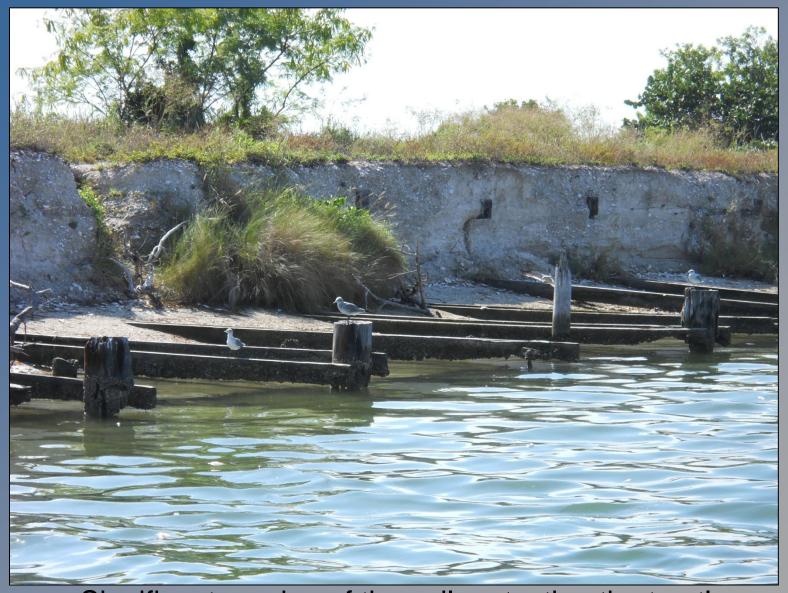
Significant erosion of the soil protecting the trestle along the causeway's spoil island was observed.

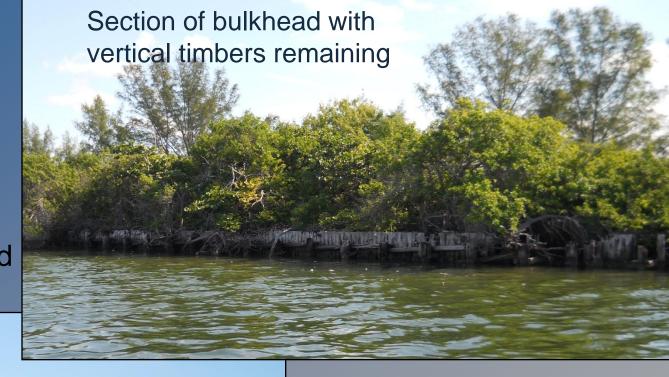
Deterioration of the bulkhead was more advanced than the trestle and much of the timber elements have been washed away.
