# Charlotte County Utilities Department

## 2024 Annual Report

### May 2025

Jones Edmunds Project No.: 03405-029-08

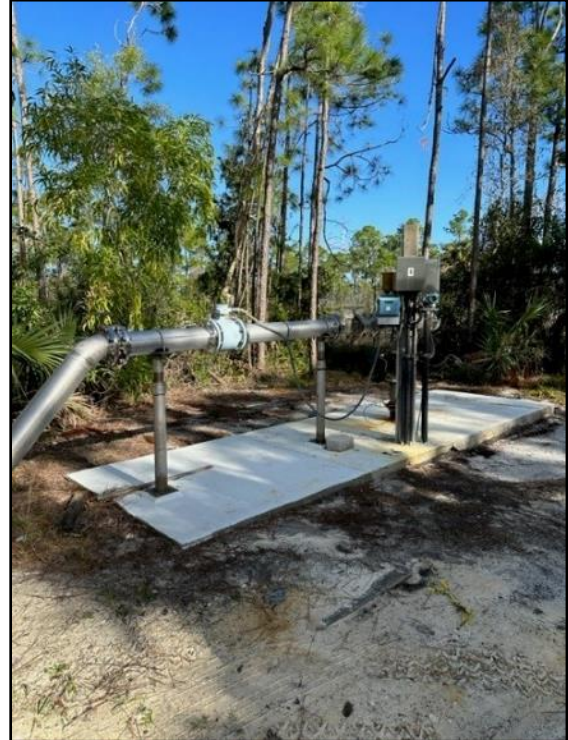
- Well No. 16 is a 12-inch-diameter well on the east side of the site. The well pump is in excellent condition.

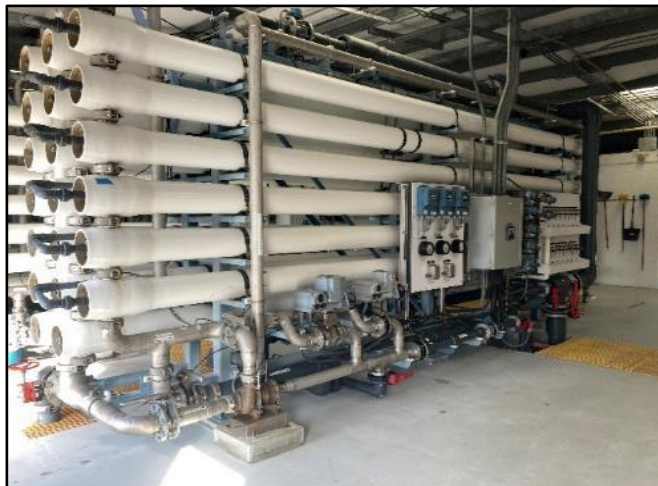
- At the time of the visit, Train B was out of service due to a pressure break. CCU is working on repairing or replacing the train. CCU also indicated that Trains A and B will eventually be replaced by larger membranes to match Trains C, D, and E.
- The older train, A, is still producing good-quality permeate but operates at a higher pressure, indicating that fouling is occurring.
- Trains C, D, and E are in good working condition except for some leaks on the concentrate port seals on Trains C and D.

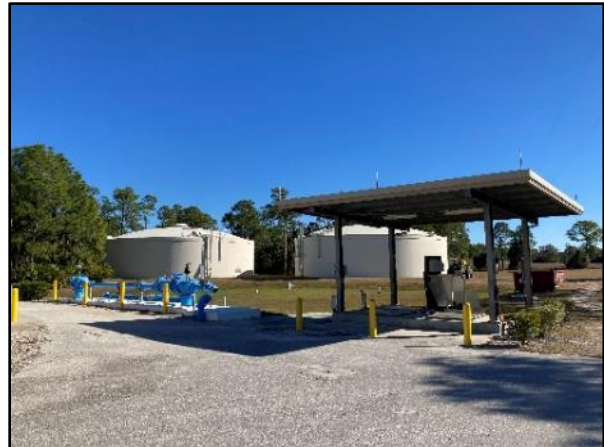
- GSTs A and B were inspected by USG Water Solutions in FY 2023.
- GST C was inspected and repainted in FY 2023.
- No sedimentation or defects were found in the GSTs.

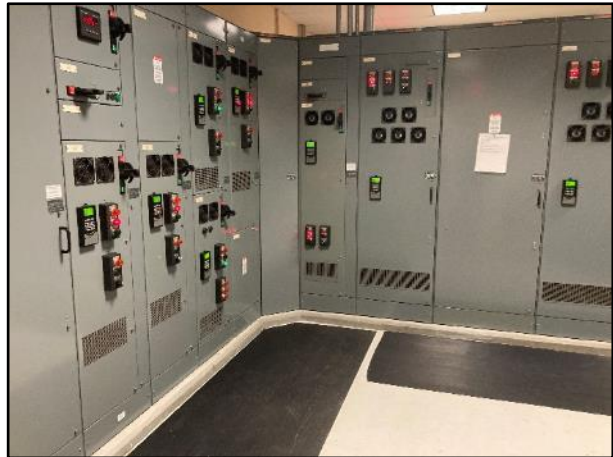
- The distribution transformer, which provides power to the site, appears to be in good condition with no obvious signs of significant concern.
- The incoming switchgear appears to be in good condition with minor issues.

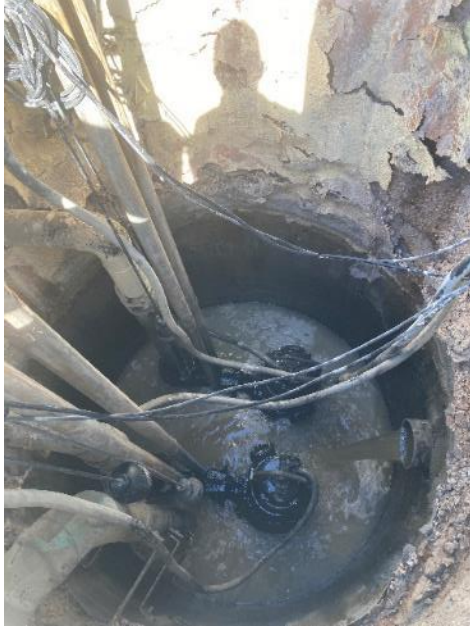
The power service to the station is 230-volt, three-phase, with a pole-mounted transformer. The control panel has seal-offs although becoming corroded likely due to the high exposure to hydrogen sulfide and is equipped with a portable generator receptacle. The station did not appear to have a mechanical interlock. The station has a DFS Tac II SCADA system with a telemetry transmitter/receiver.

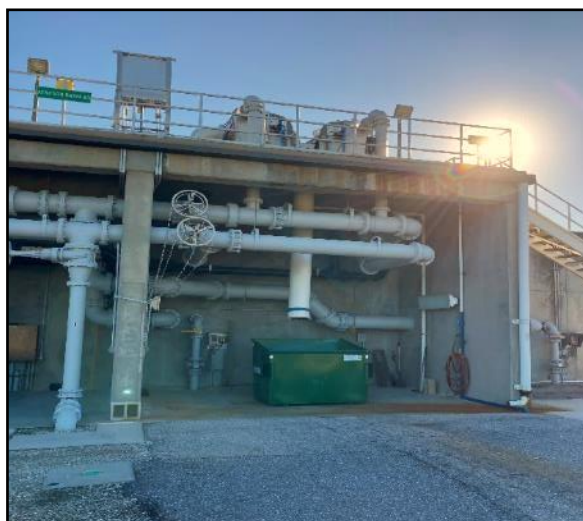
A fiberglass grating over the influent flow splitter area had been supported by two carbon-steel beams. These beams were replaced with aluminum beams in FY 2015. The fiberglass grating shows minor signs of fraying.

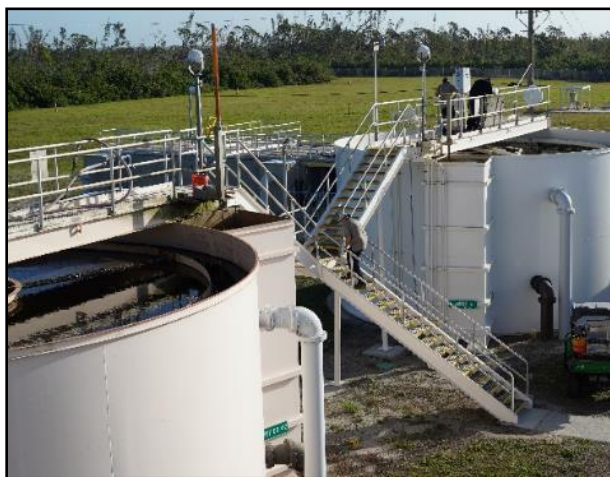
Although most of the unit process tanks are made of concrete or Type 304 stainless steel, the four secondary clarifiers consist of carbon steel and require constant paint maintenance every 2 years. The overall condition of the clarification process is fair. High sudden increases in influent flows can cause further issues with the clarifier performance when one of the four clarifiers is out of service.

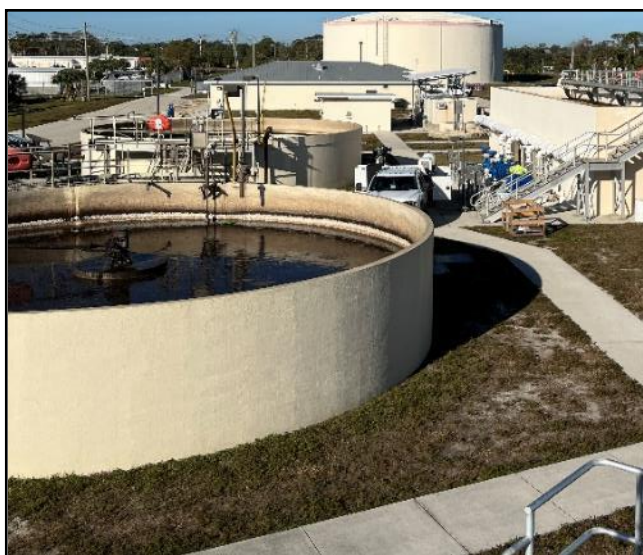
- The Flygt dry-installation submersible pumps are used to return to the treatment stream are in good working condition.
  - The EQ tank has an overflow that sends flow to the reject pond and is pumped back to the front of the plant. The Chief Operator noted that this happens on occasion.
  - The positive displacement blowers are run intermittently to save power. Oil sight glasses and fill ports improve maintenance.
  - The EQ tank was painted in FY 2019.
- The Chief Operator indicated that an additional EQ tank is necessary to respond to additional surges and continue to maintain a steady flow to the MBRs.

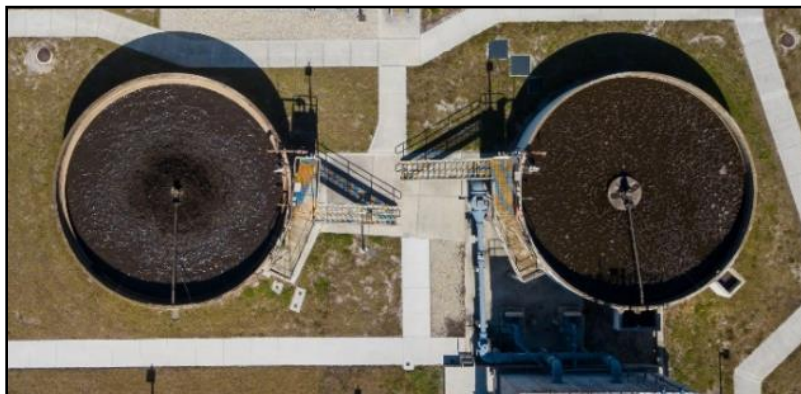
The overall condition of the solids-handling facilities is good. The decant mechanism for the sludge-holding tanks use telescoping valves, but the telescoping valves are limited to being lowered to one-half the depth of the tank. The operators have replaced the designed method of decanting by using bottom-

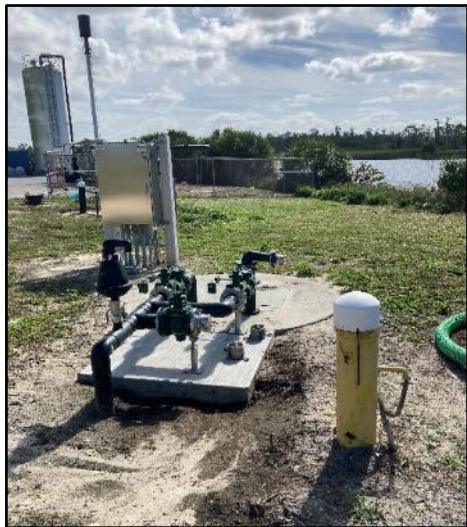
The influent pump station (PS-1) was rehabilitated in FY 2023 and is in excellent condition; however, the operator reports pumping capacity is not as expected. CCU is working with the design engineer to resolve the issue. Although the influent is primarily fed by the gravity-driven network, a significant amount of storage is within the landfill collection system, which provides some operational flexibility for the LTF and can be used if PS-1 is temporarily out of service.
