**HISTORICAL ASSESSMENT & FEASIBILITY STUDY OF  
THE OLD CHARLOTTE COUNTY STOCKADE  
FOR  
CHARLOTTE COUNTY**

**BY  
FERRELL SANFORD STUDIO INC  
ANCHOR ENGINEERING CONSULTANTS INC  
HISTORICAL & ARCHITECTURAL RESEARCH SERVICES  
NOVEMBER 2008**

**THE  
OLD CHARLOTTE COUNTY STOCKADE  
CULTURAL & HISTORIC ASSESSMENT SURVEY AND EVALUATION  
May, 2006  
Amended April, 2008**

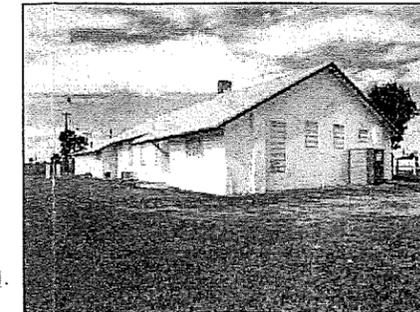
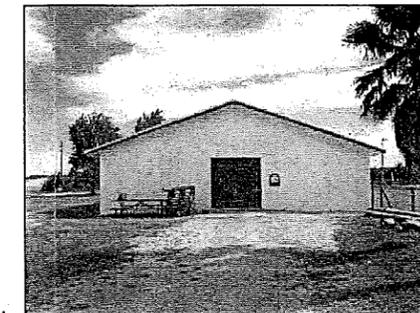
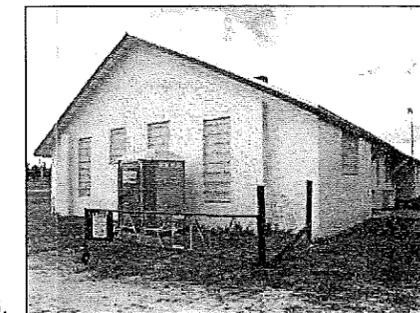
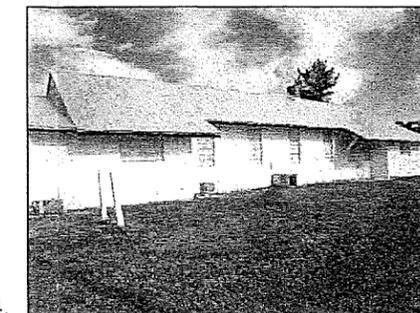
1. Southwest Elevation - image # 8302
2. North Elevation - image # 8295
3. Southeast Elevation - image # 8197
4. West Elevation - image # 8300

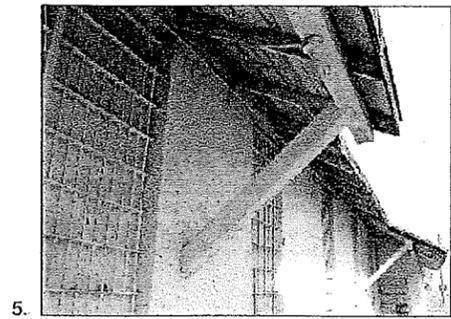
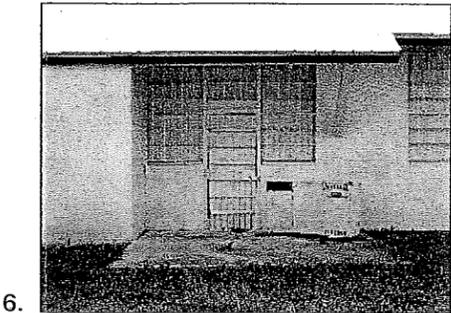
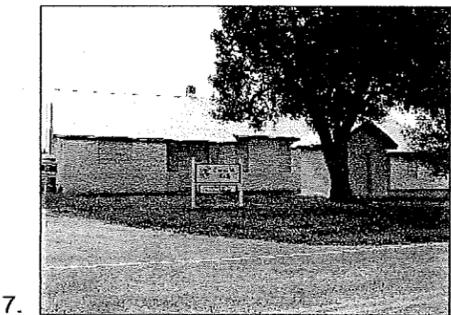
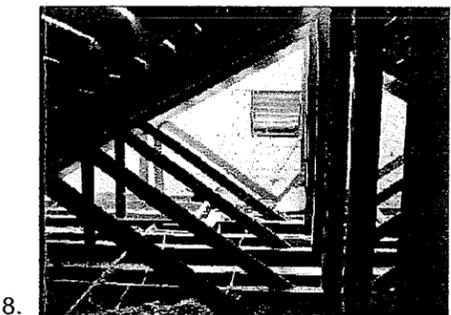
- 5. Bracket support at entrance - image # 8251
- 6. Bracket support at entrance - image # 8262
- 7. Pump House with metal roof - image # 8291
- 8. Attic with loose insulation - image # 8219

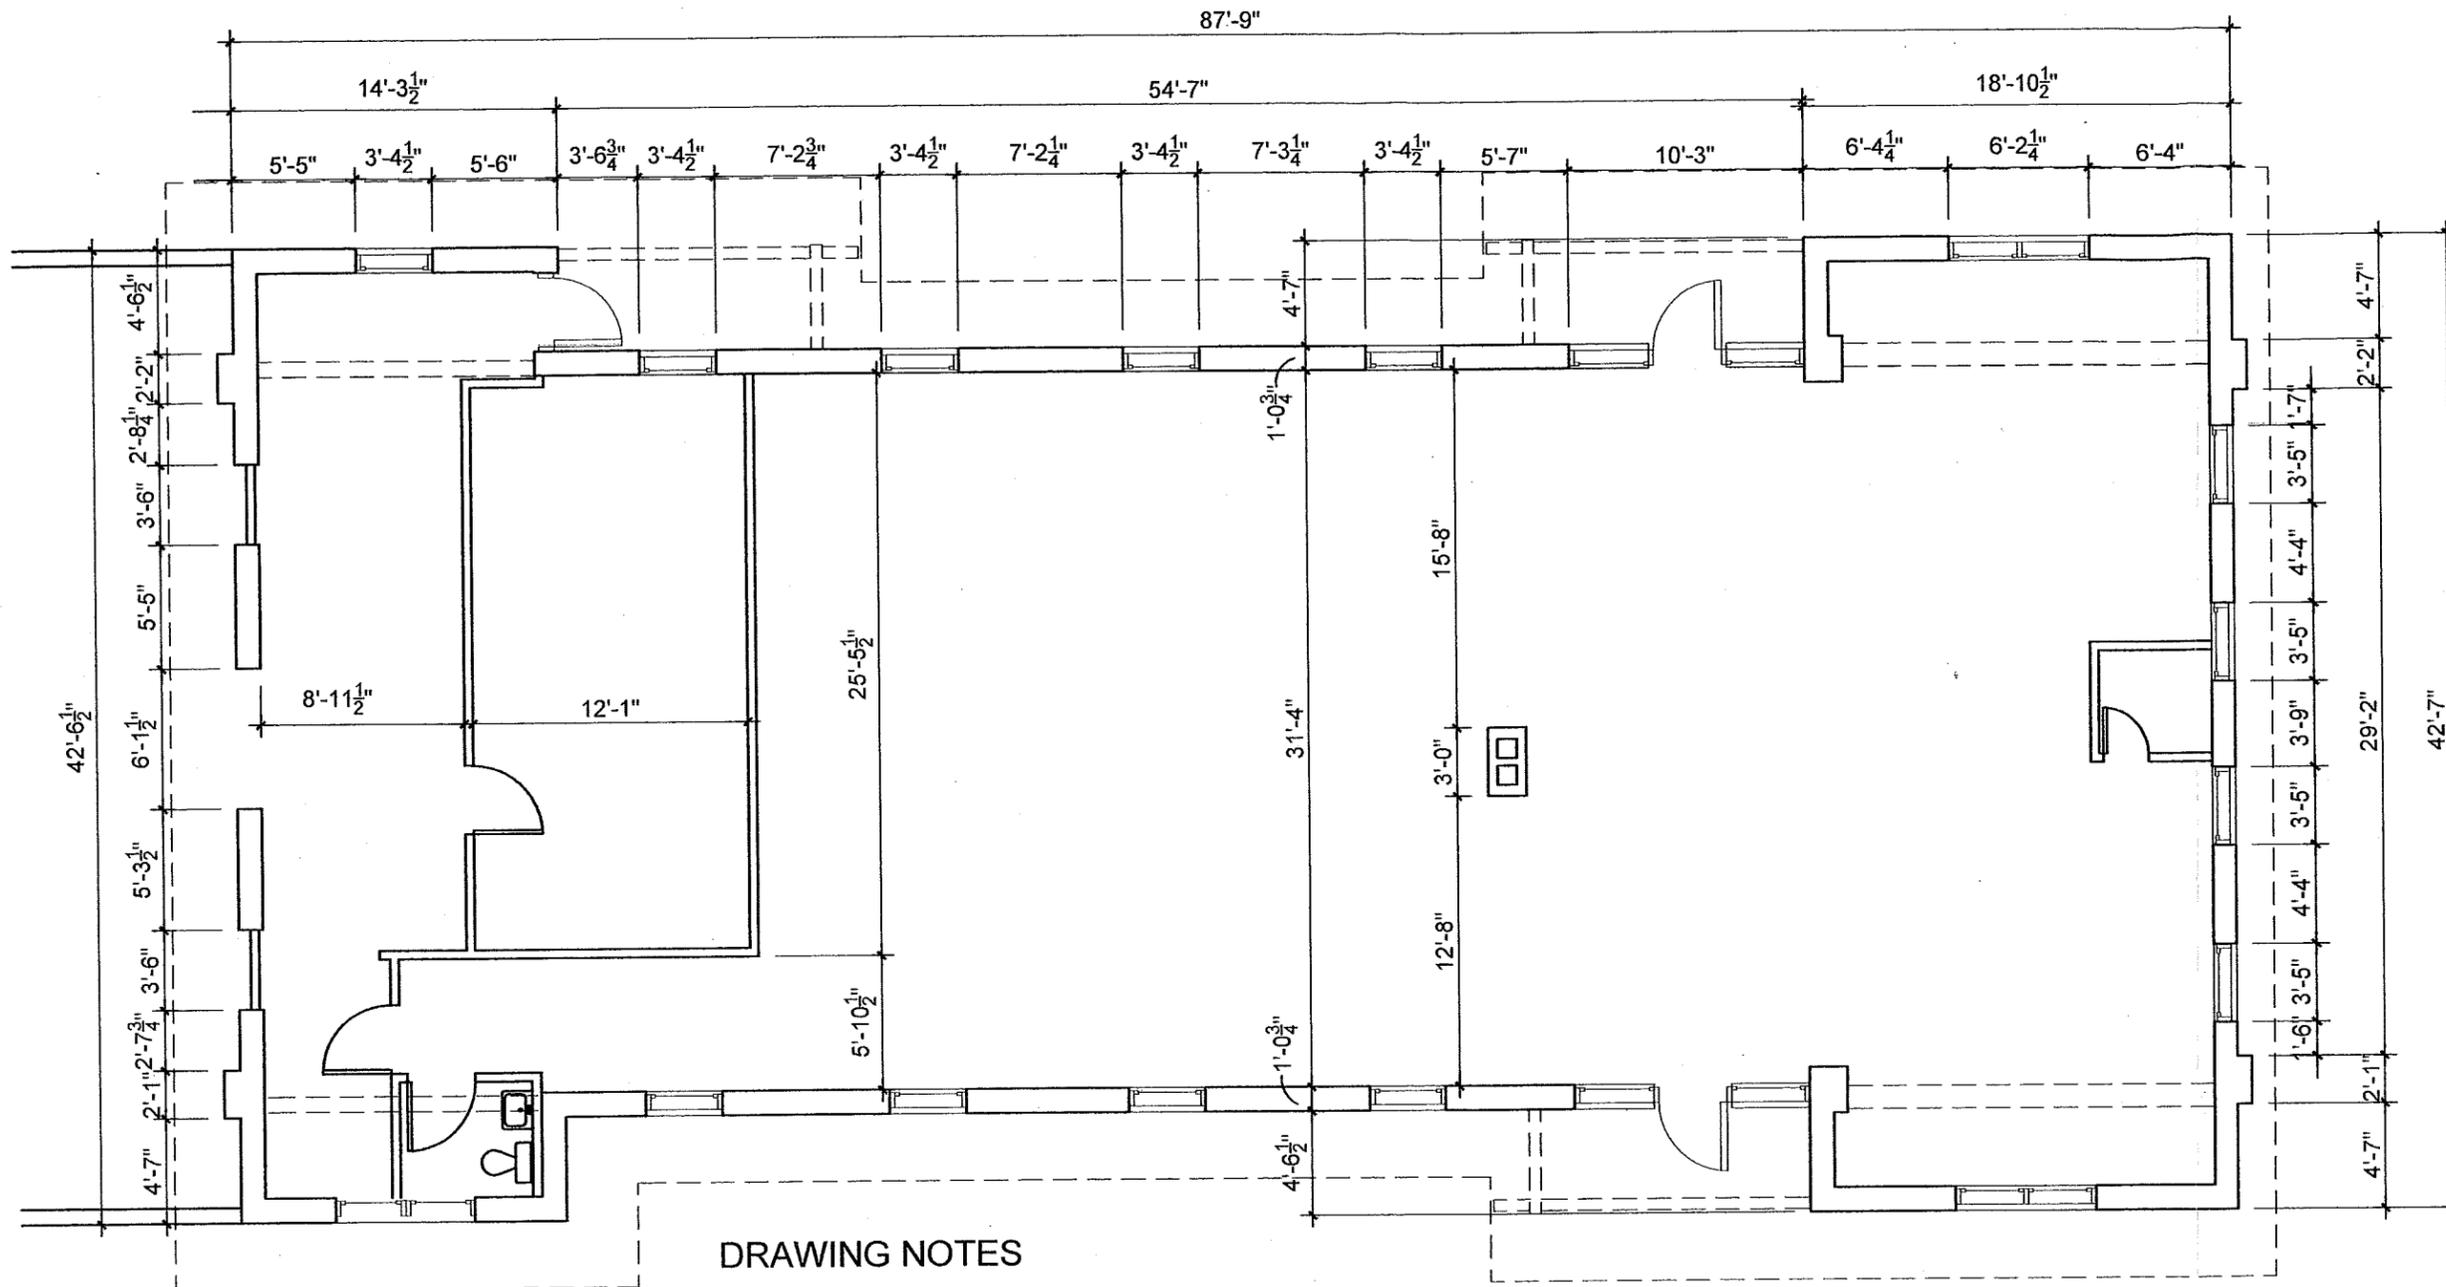
The roof of the Old Stockade was badly damaged by a hurricane, shortly before the field work was completed for this survey. The structure was temporarily covered by a plastic tarp. Water infiltration and wet conditions in the building persisted for a number of months until a new, Galvalume 5 V Crimp roof was installed, replicating the original historic roof material.

Throughout the historic building, 1x 4, beaded T&G painted wood is installed on the bottom of the trusses and is the original material. Due to the water intrusion previously noted, this material is not likely to be salvaged.

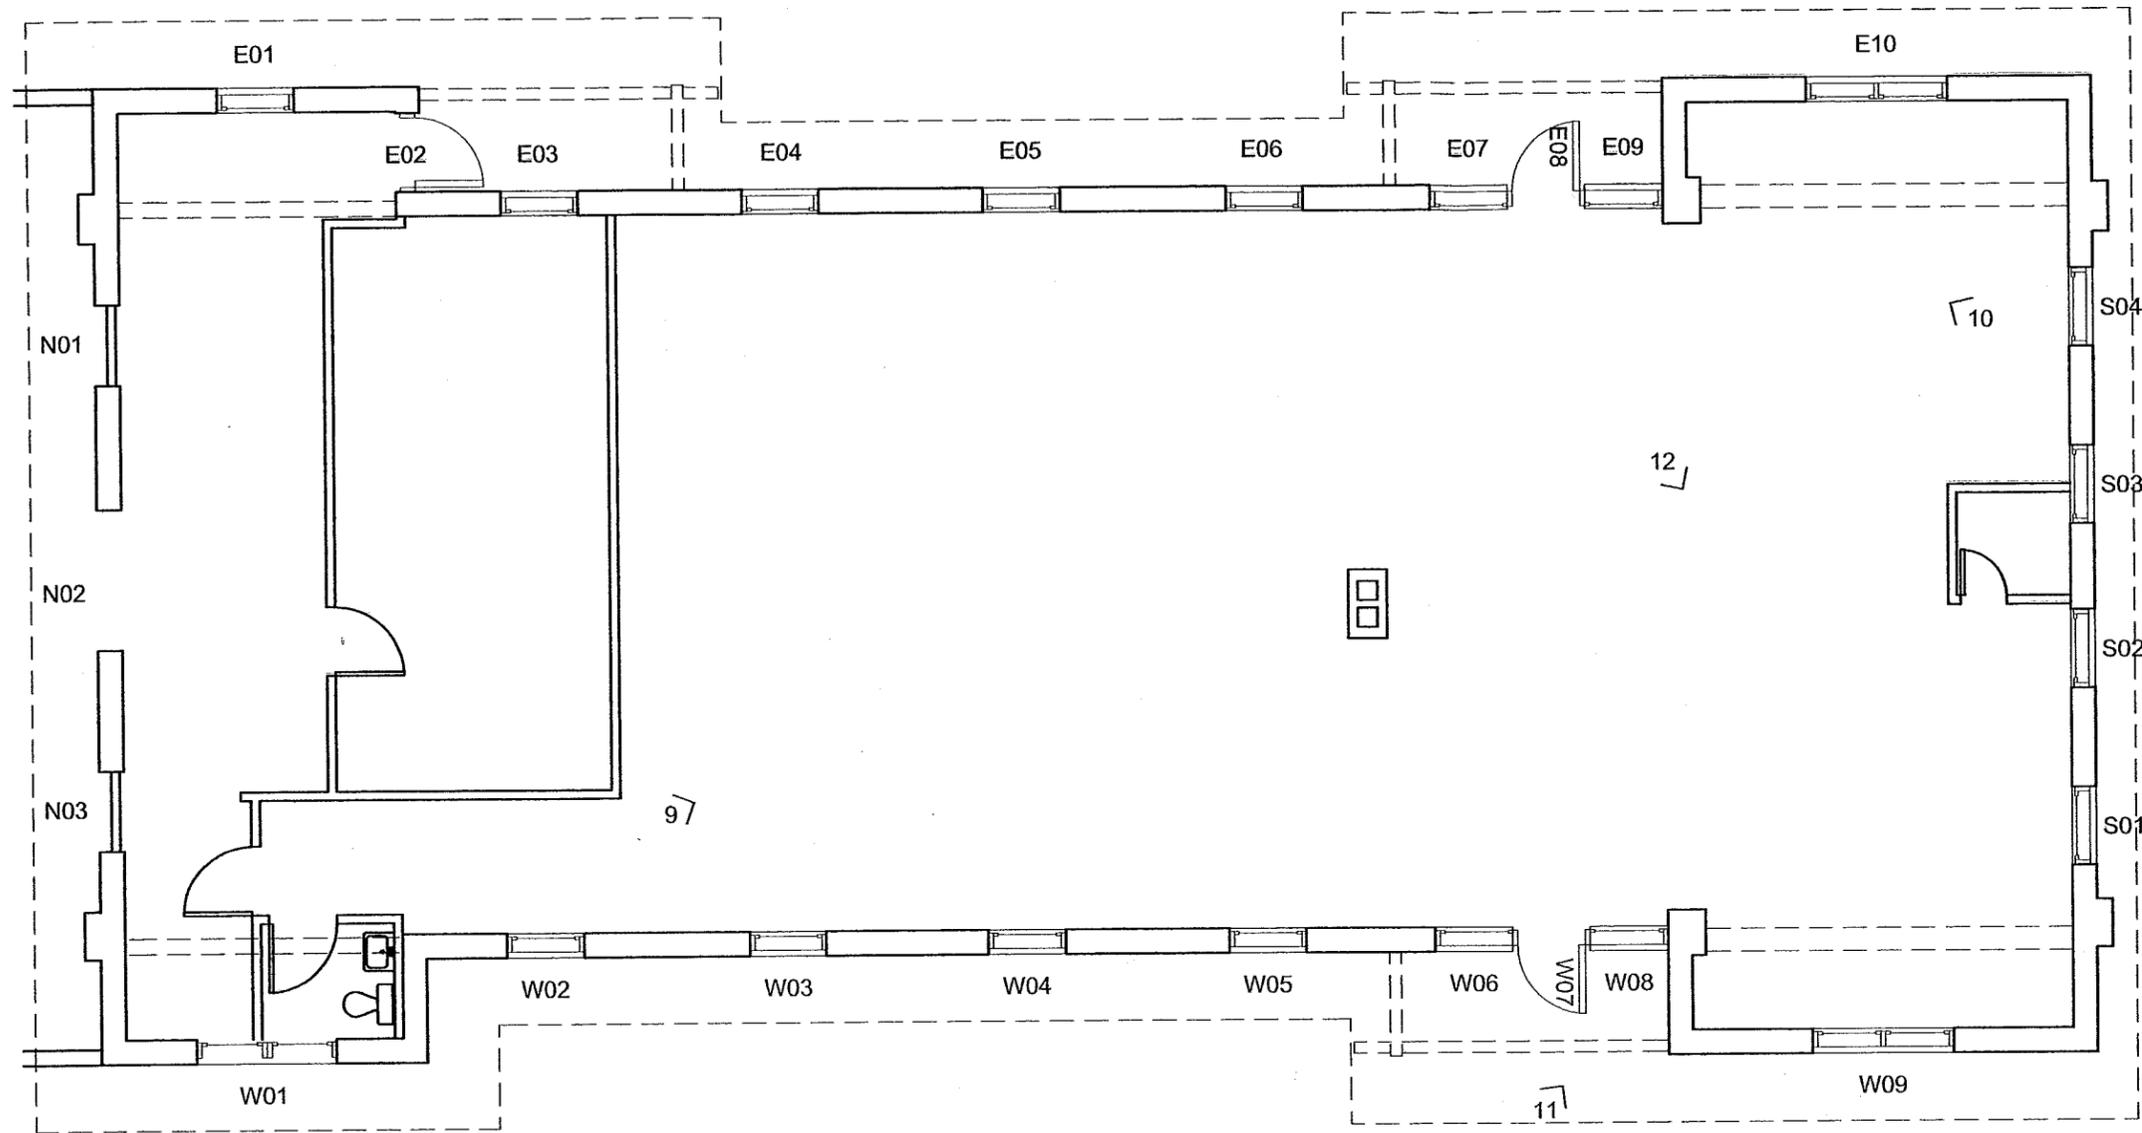
As a jailhouse, one of the primary contributing details of the Old Stockade is the jail bars. While all of the interior bars have been removed, it should be noted that nearly all of the original exterior bars remain in place and in good condition. Some of the original interior bar locations can be noted by observing holes in the masonry walls.
