**BUNK HOUSE FIELD REVIEW &
CONDITION NOTES 09/19/08 SAI**

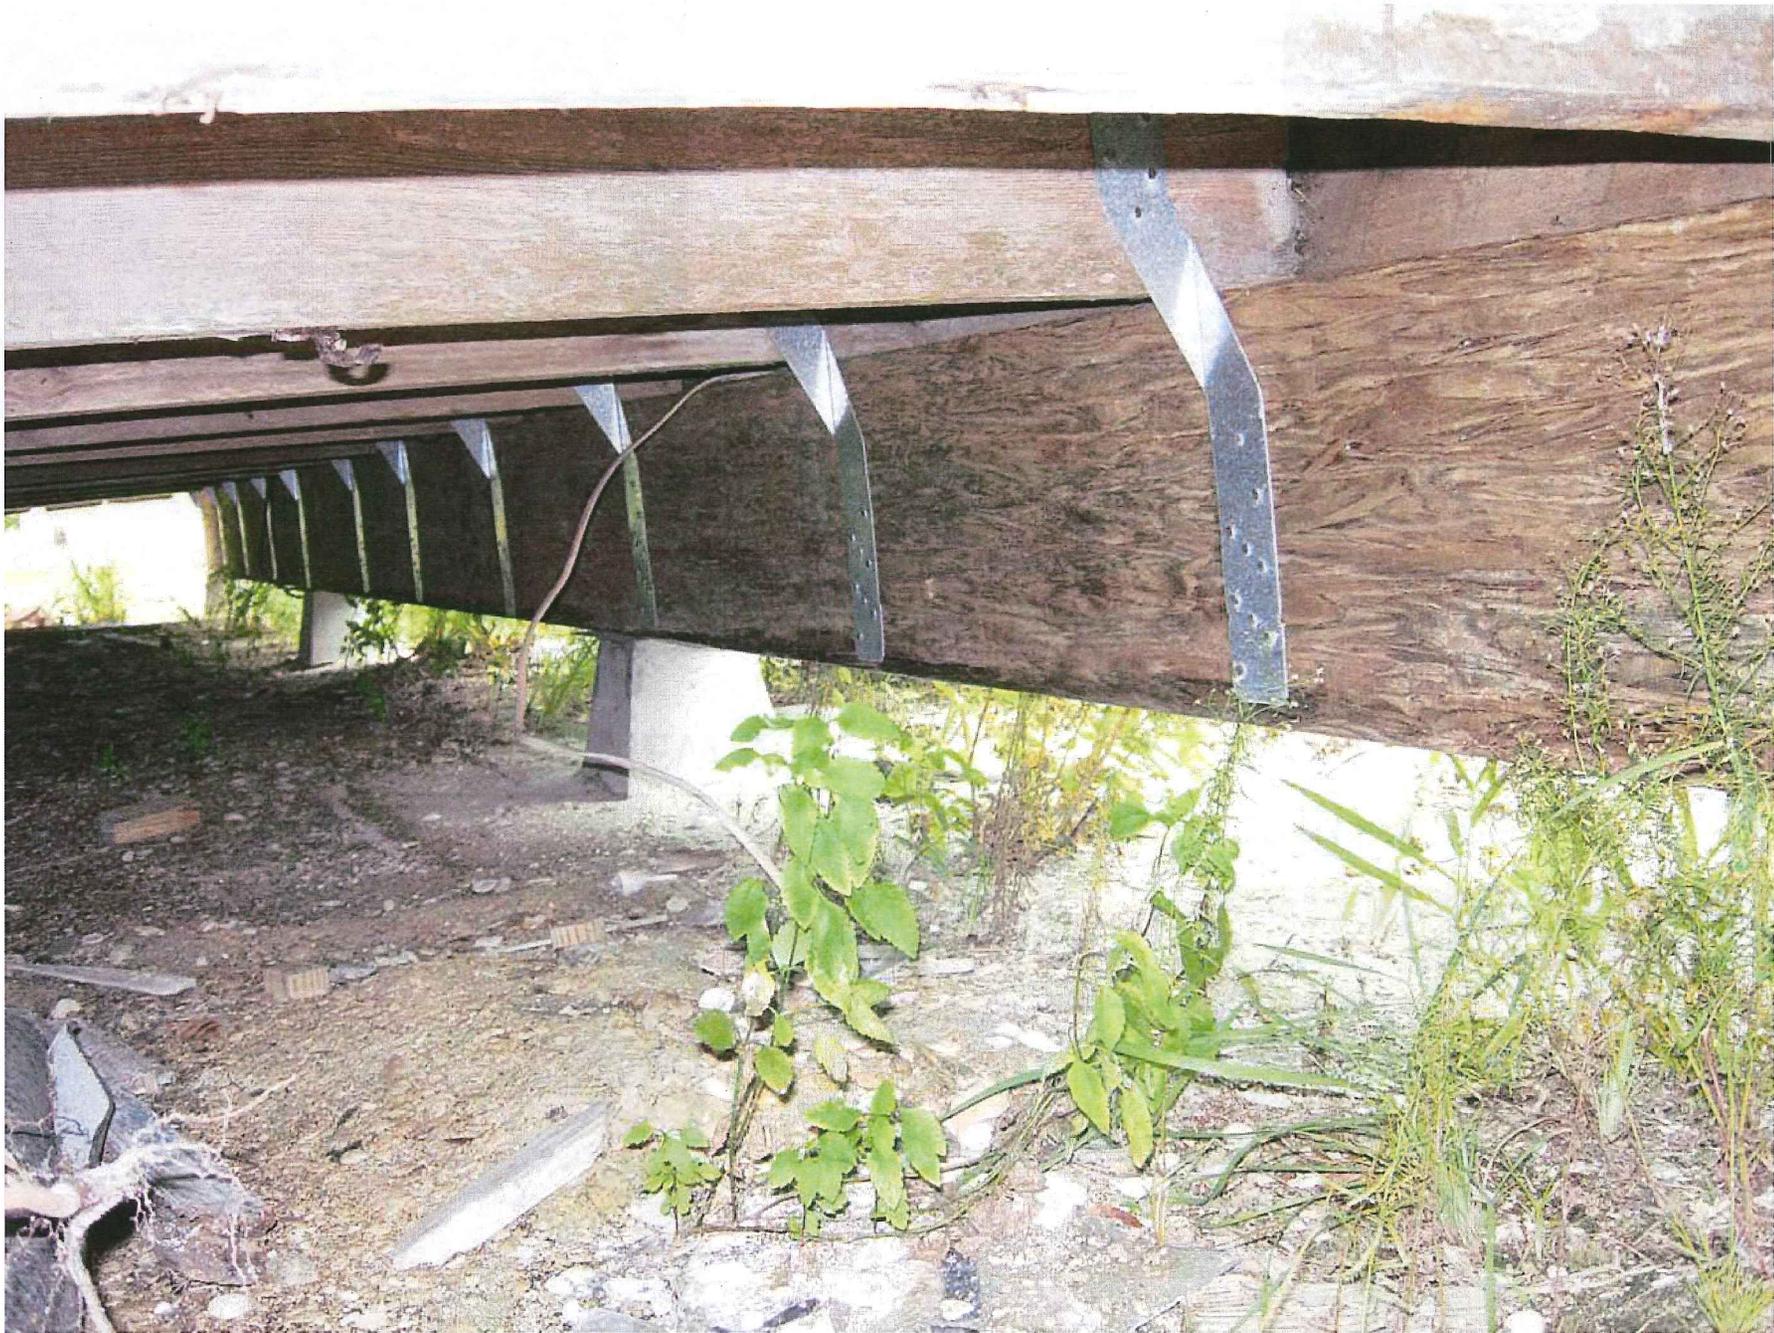
North wall – floor joists and new foundation with galvanized connectors – about 4 to 5 joists have some damage – can be sistered with new p.t. joists from span to span - overall condition is good

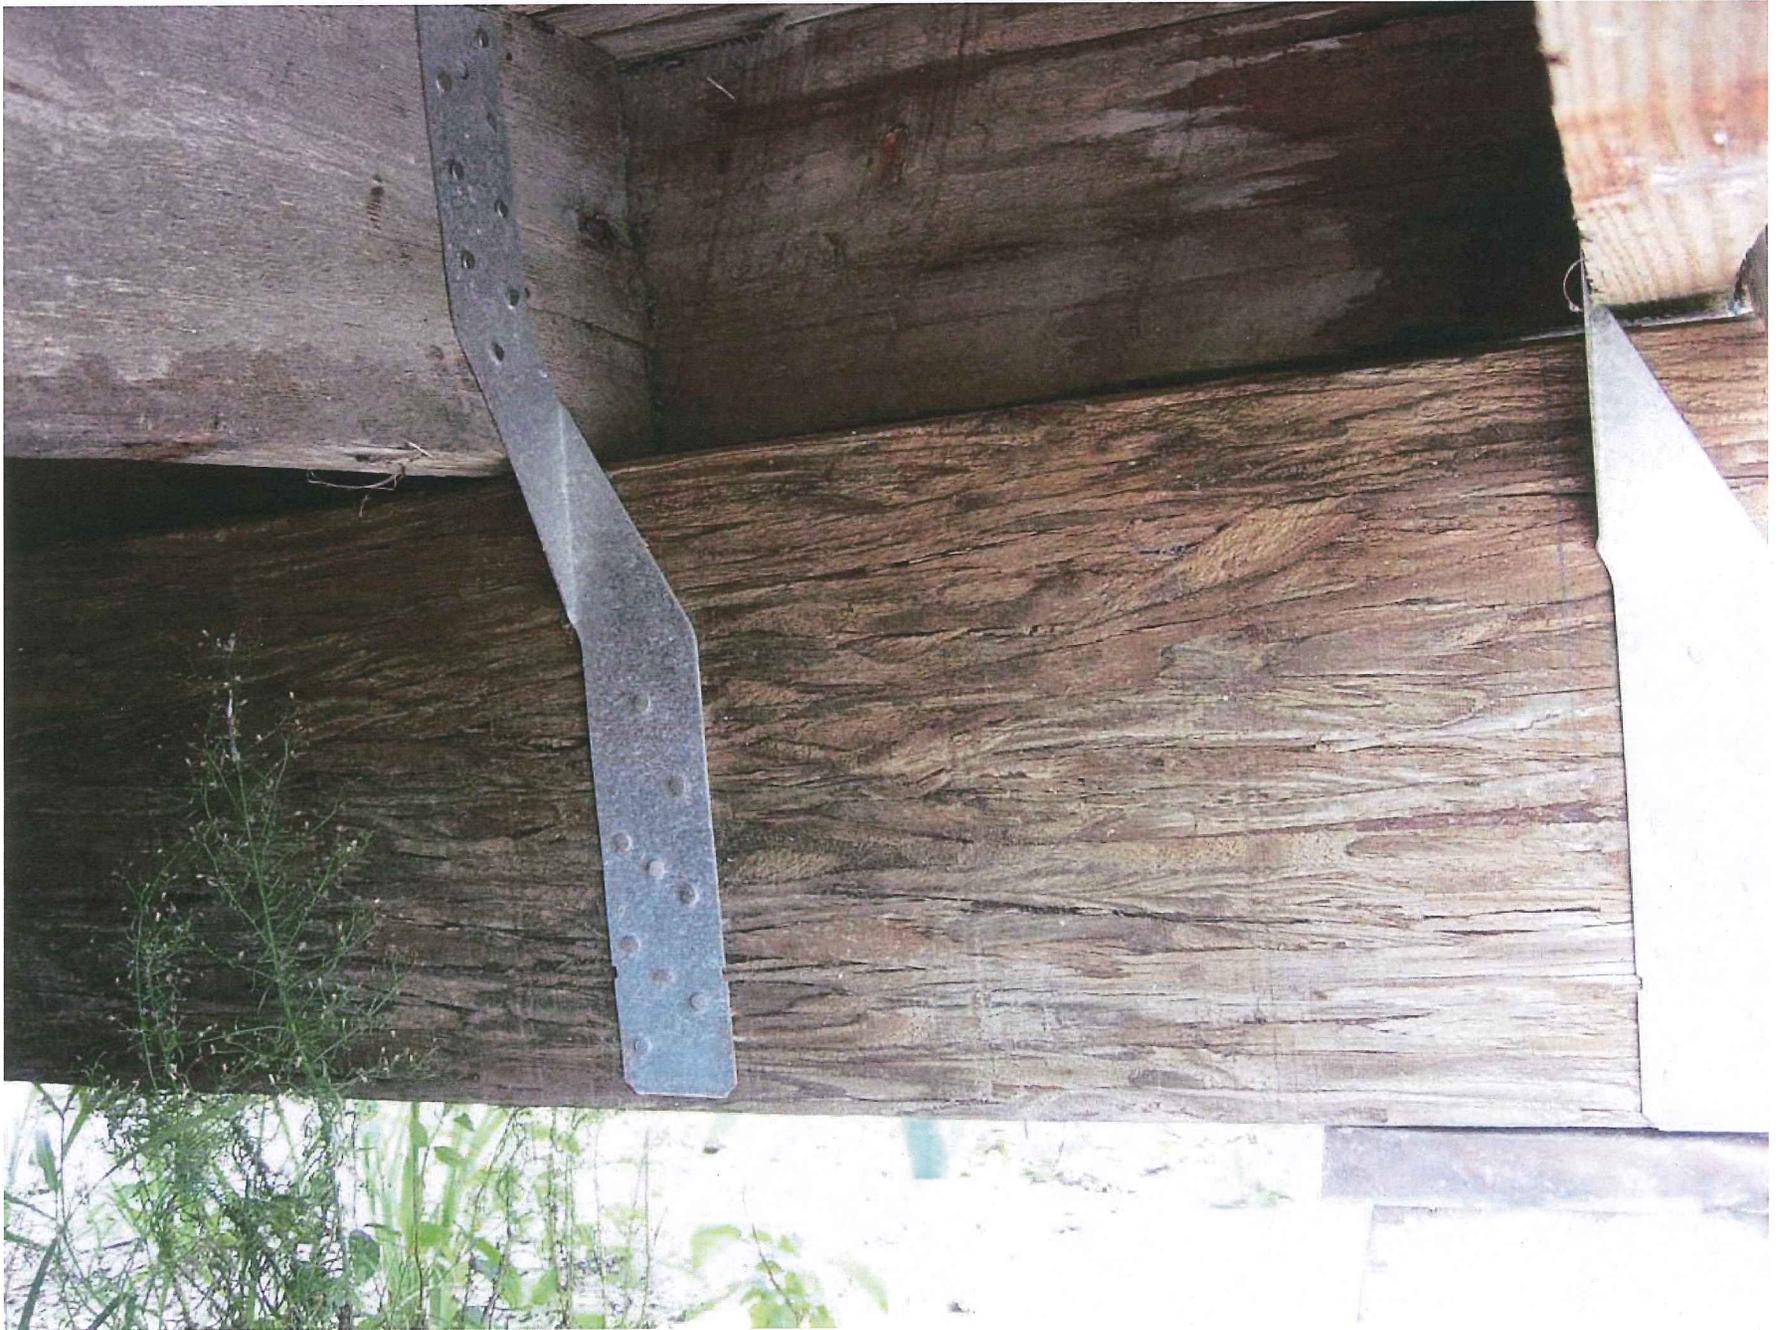
North wall – detail of floor joist, band joist, parallam beam, concrete pier at north end

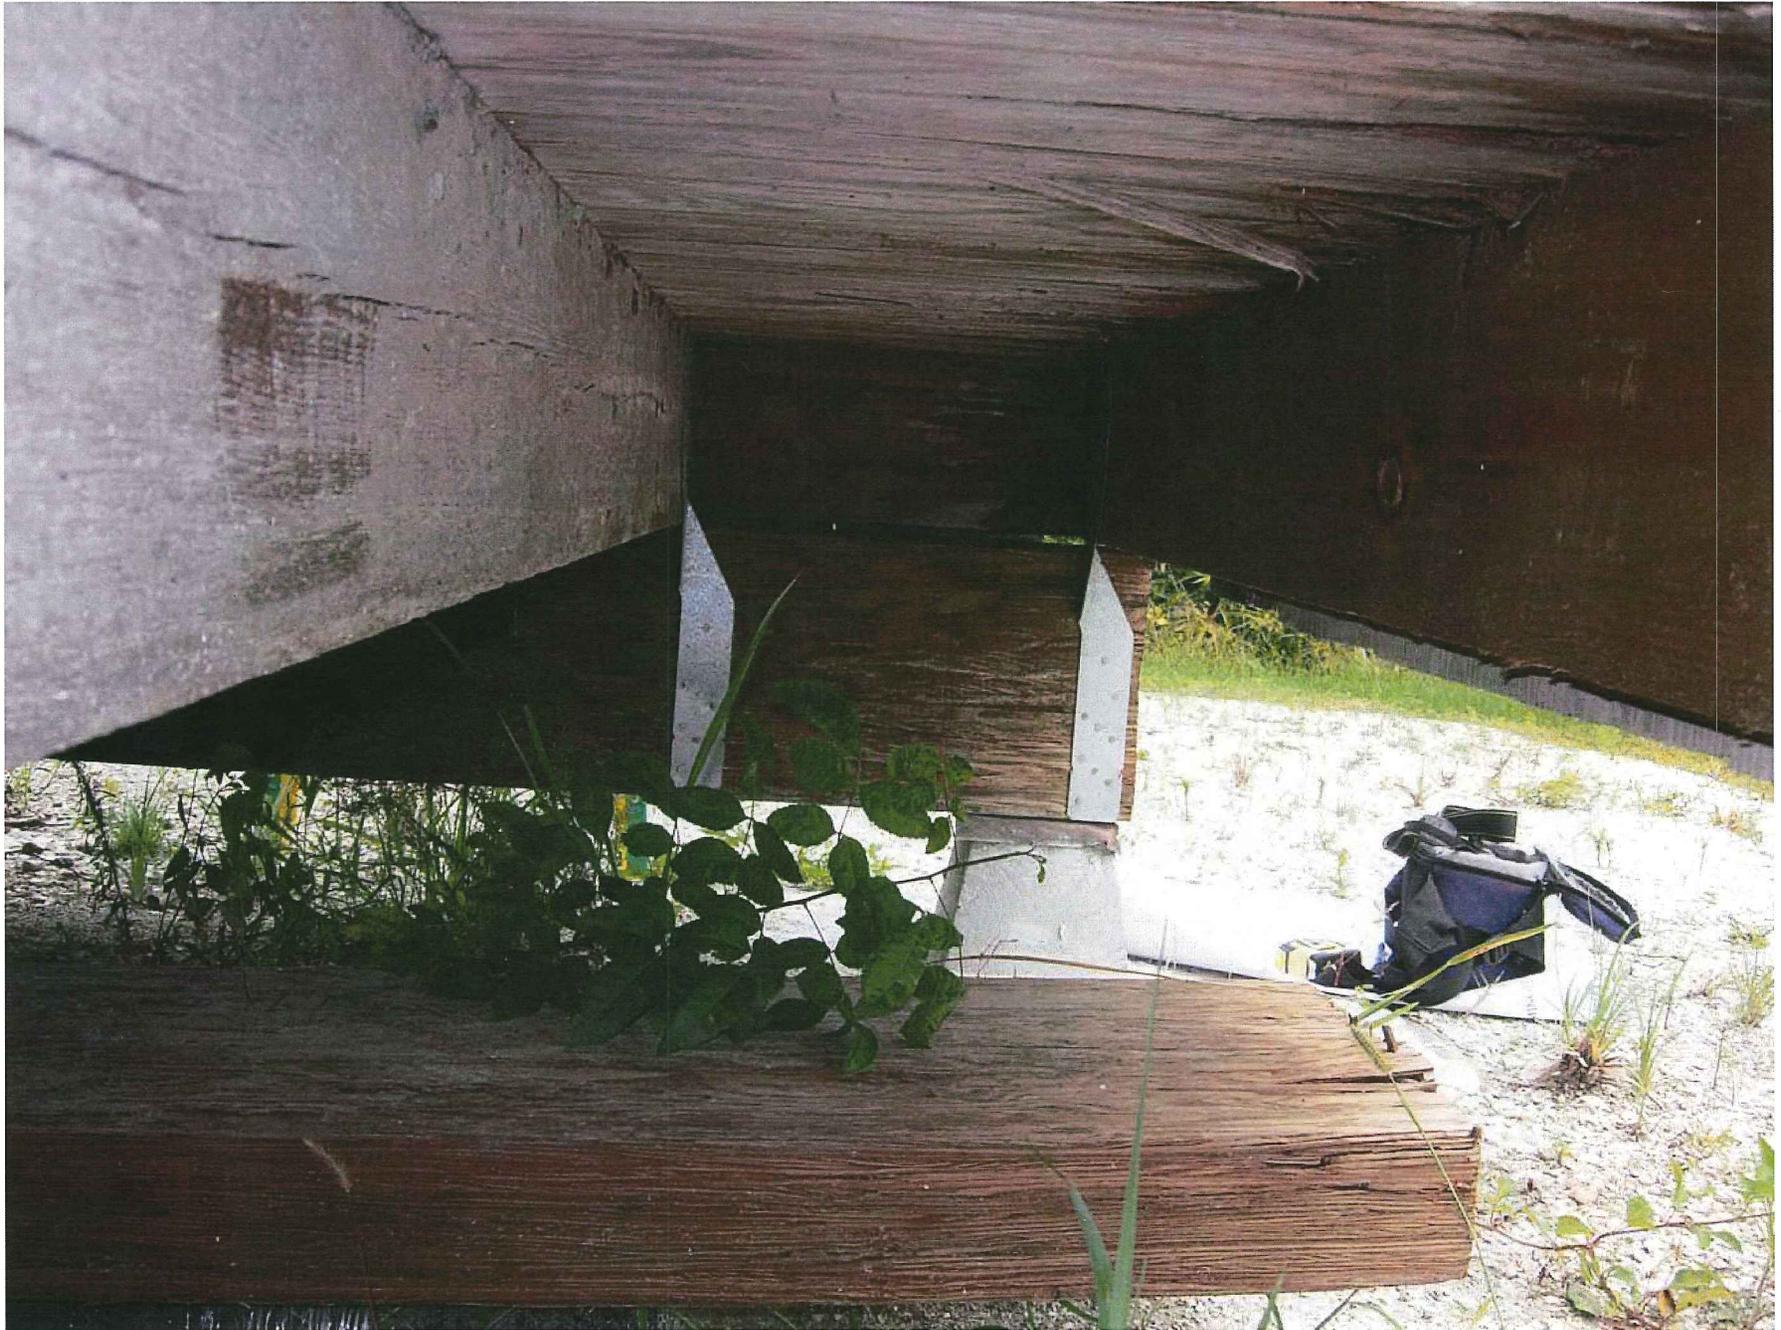
Looking north - East wall on right – note rot in the floor boards at edges, typical at cross grain of wood floors

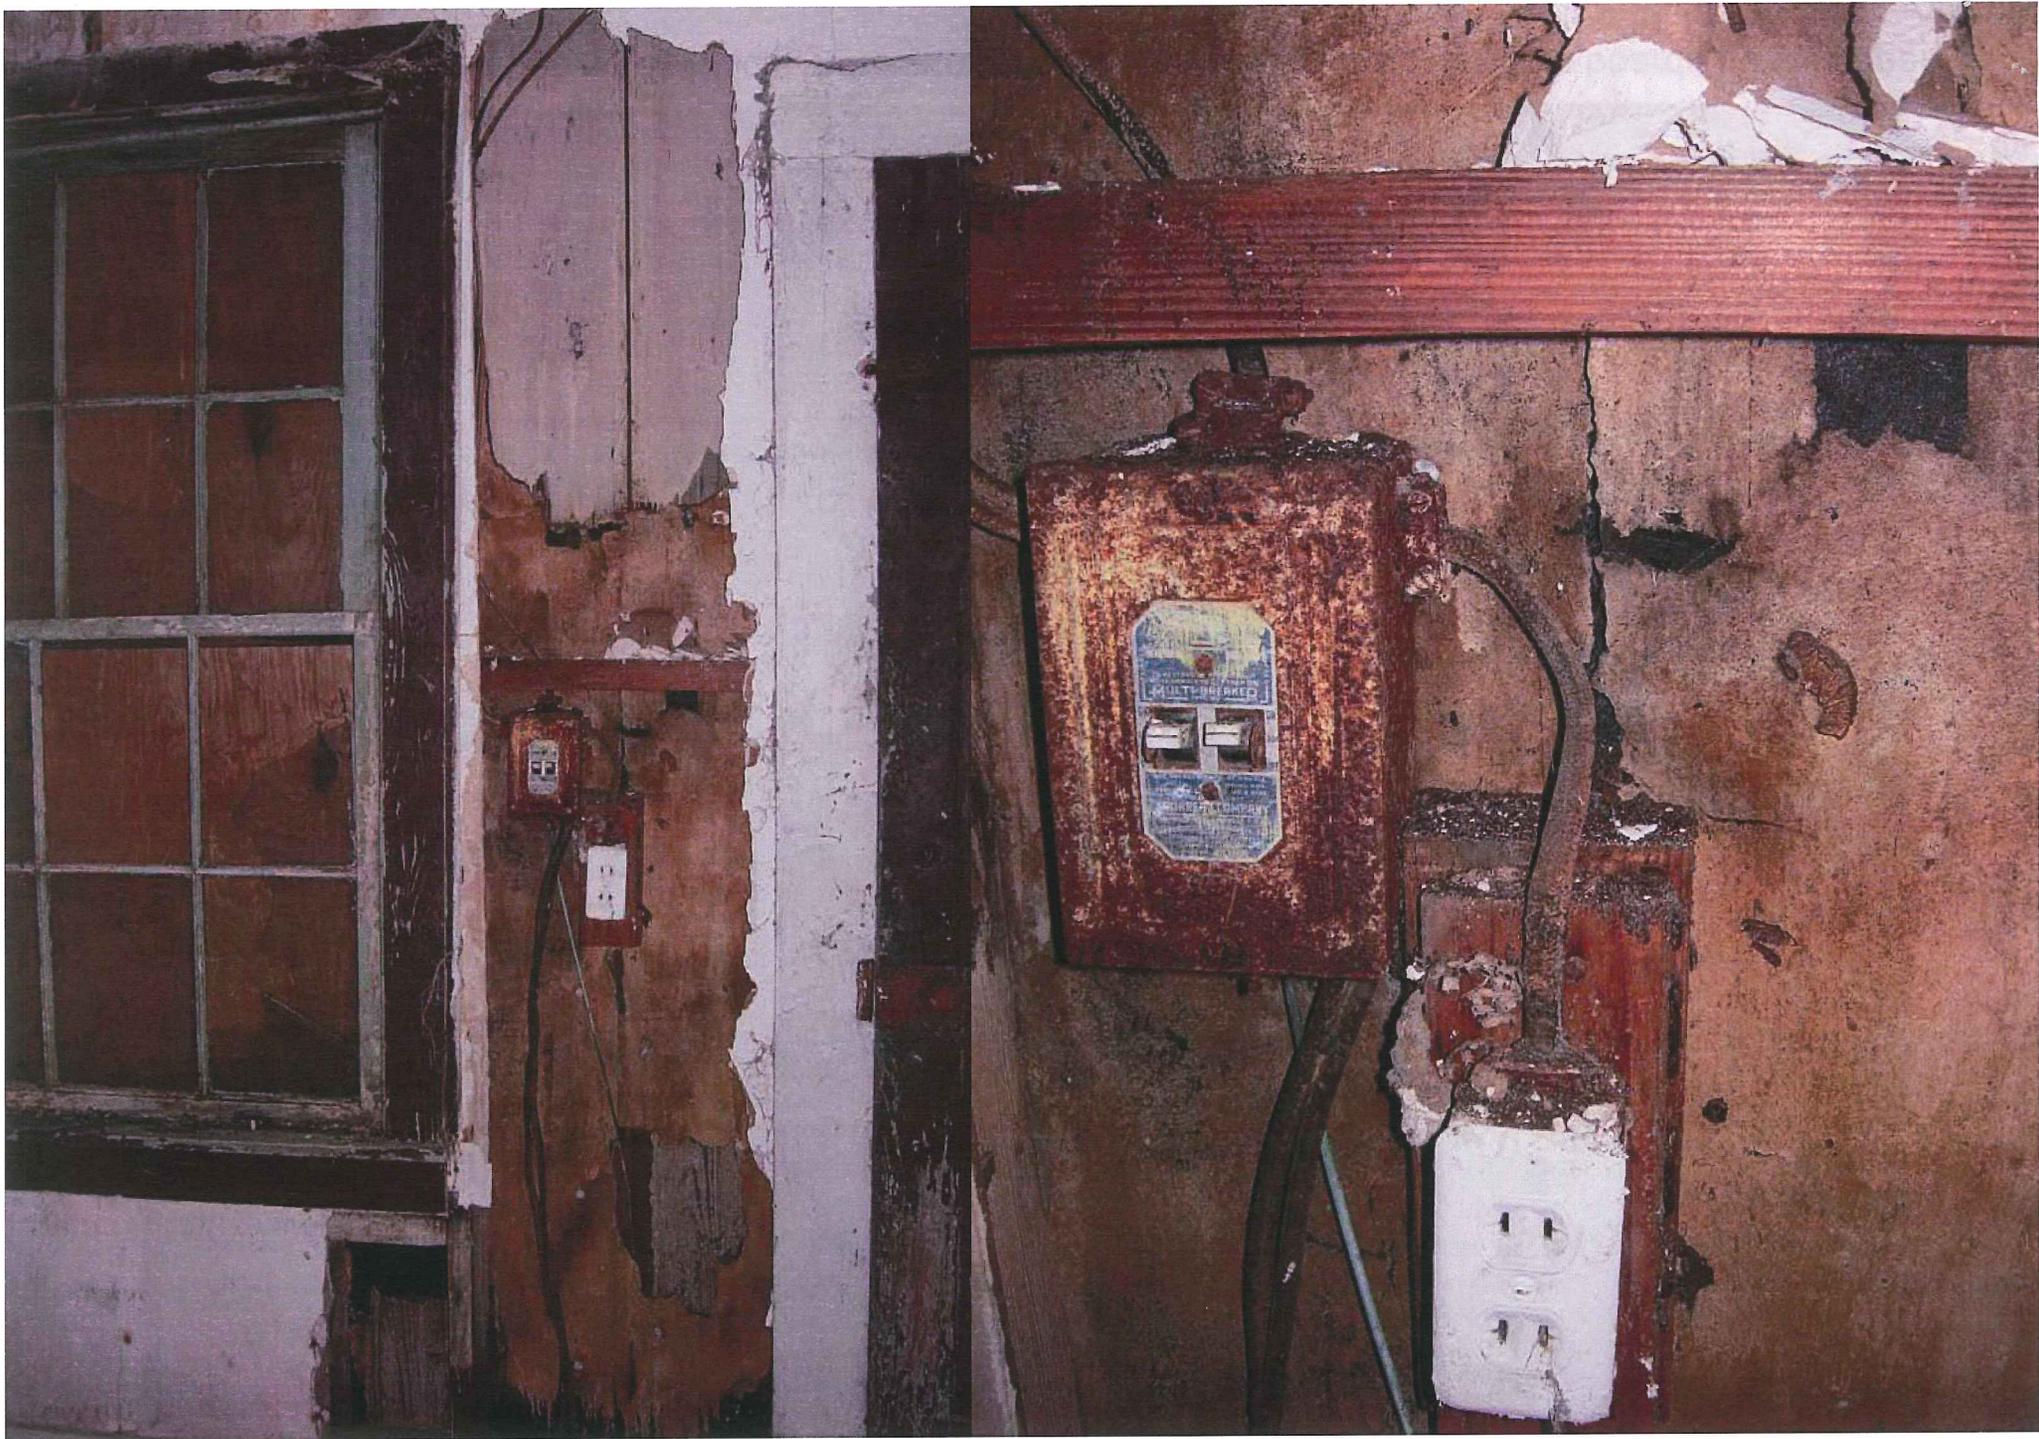
North wall – paper added to the wall in remodeling and 1950 electrical work

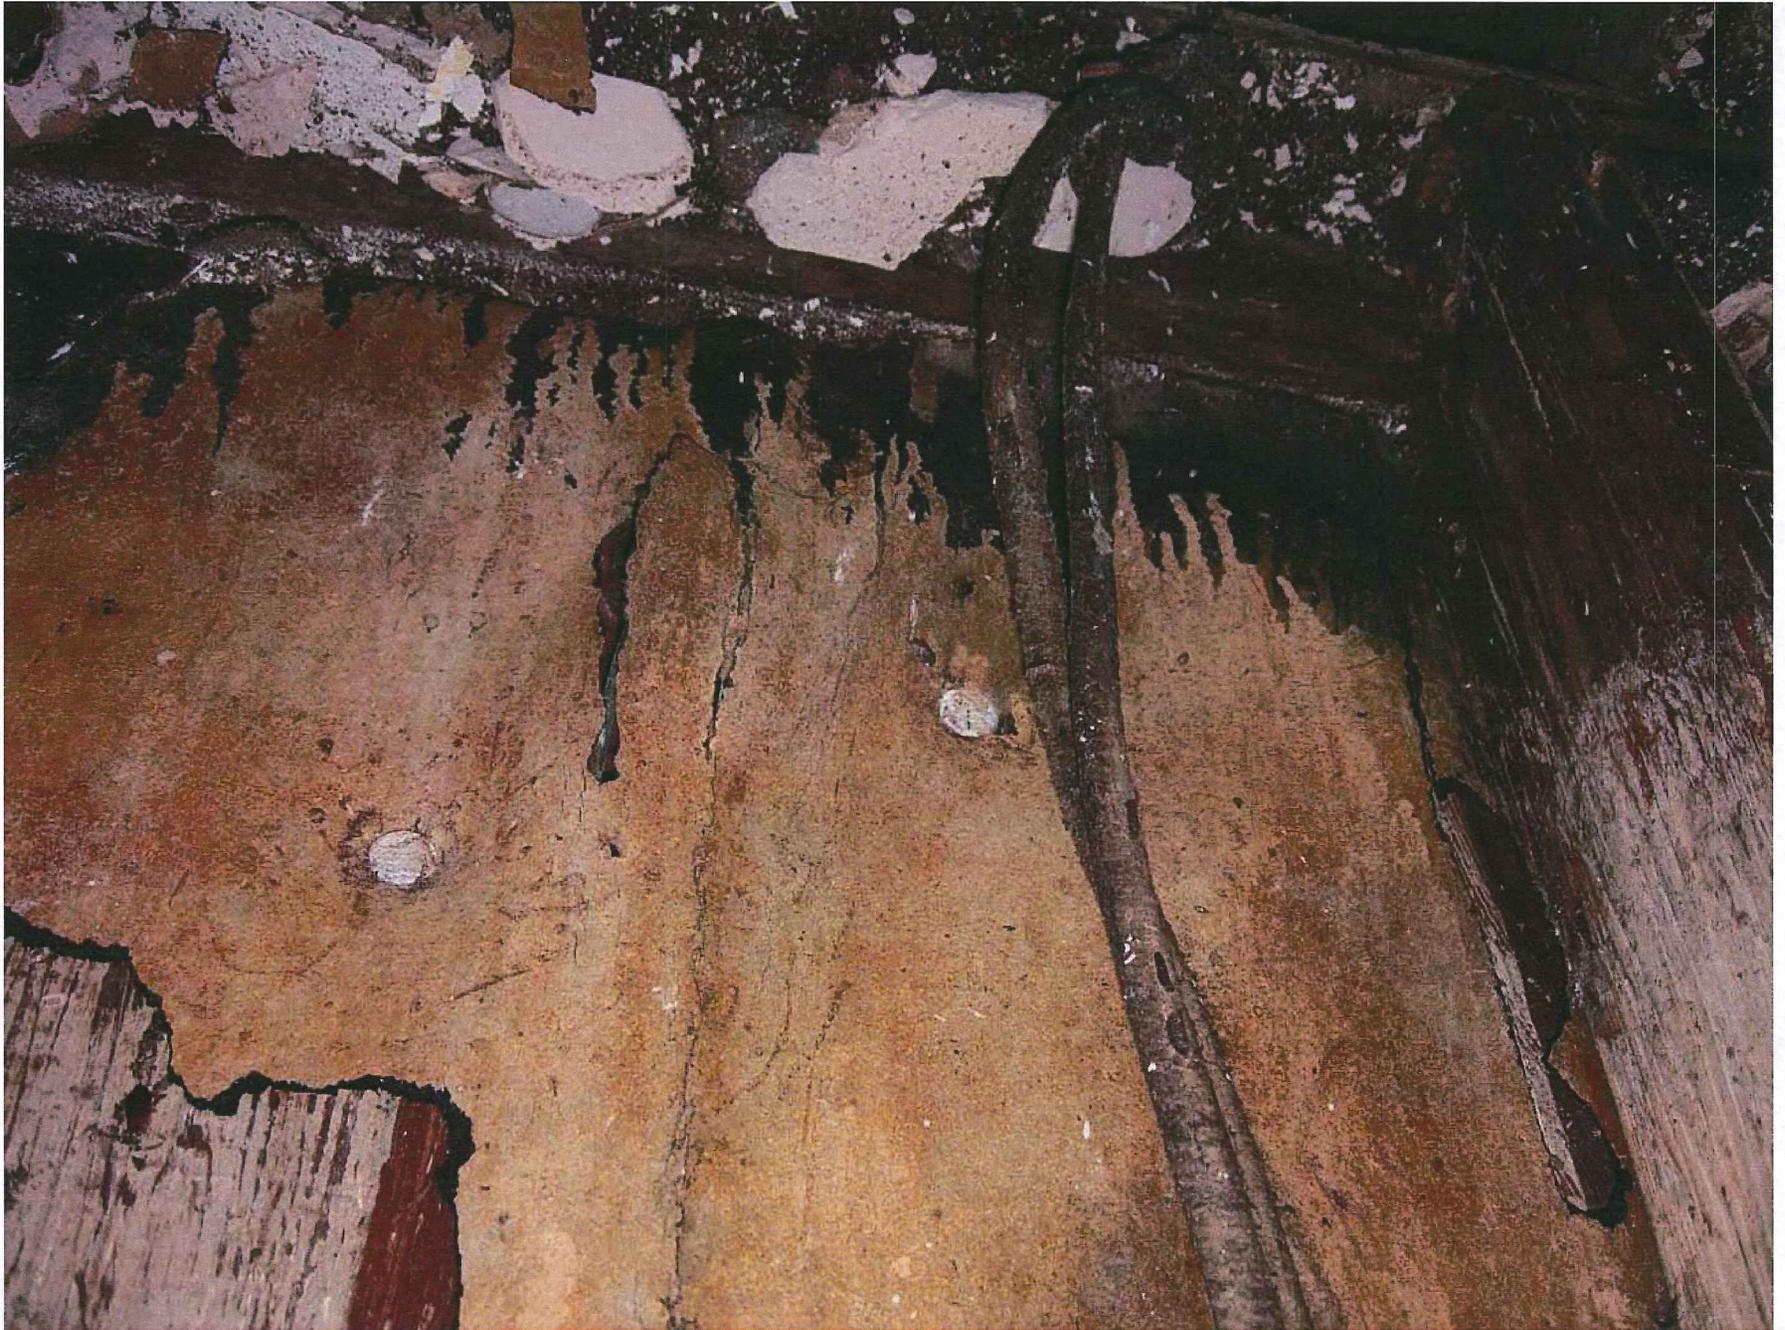
North wall – detail of paper behind electrical, note interior batten has been removed from boards below paper

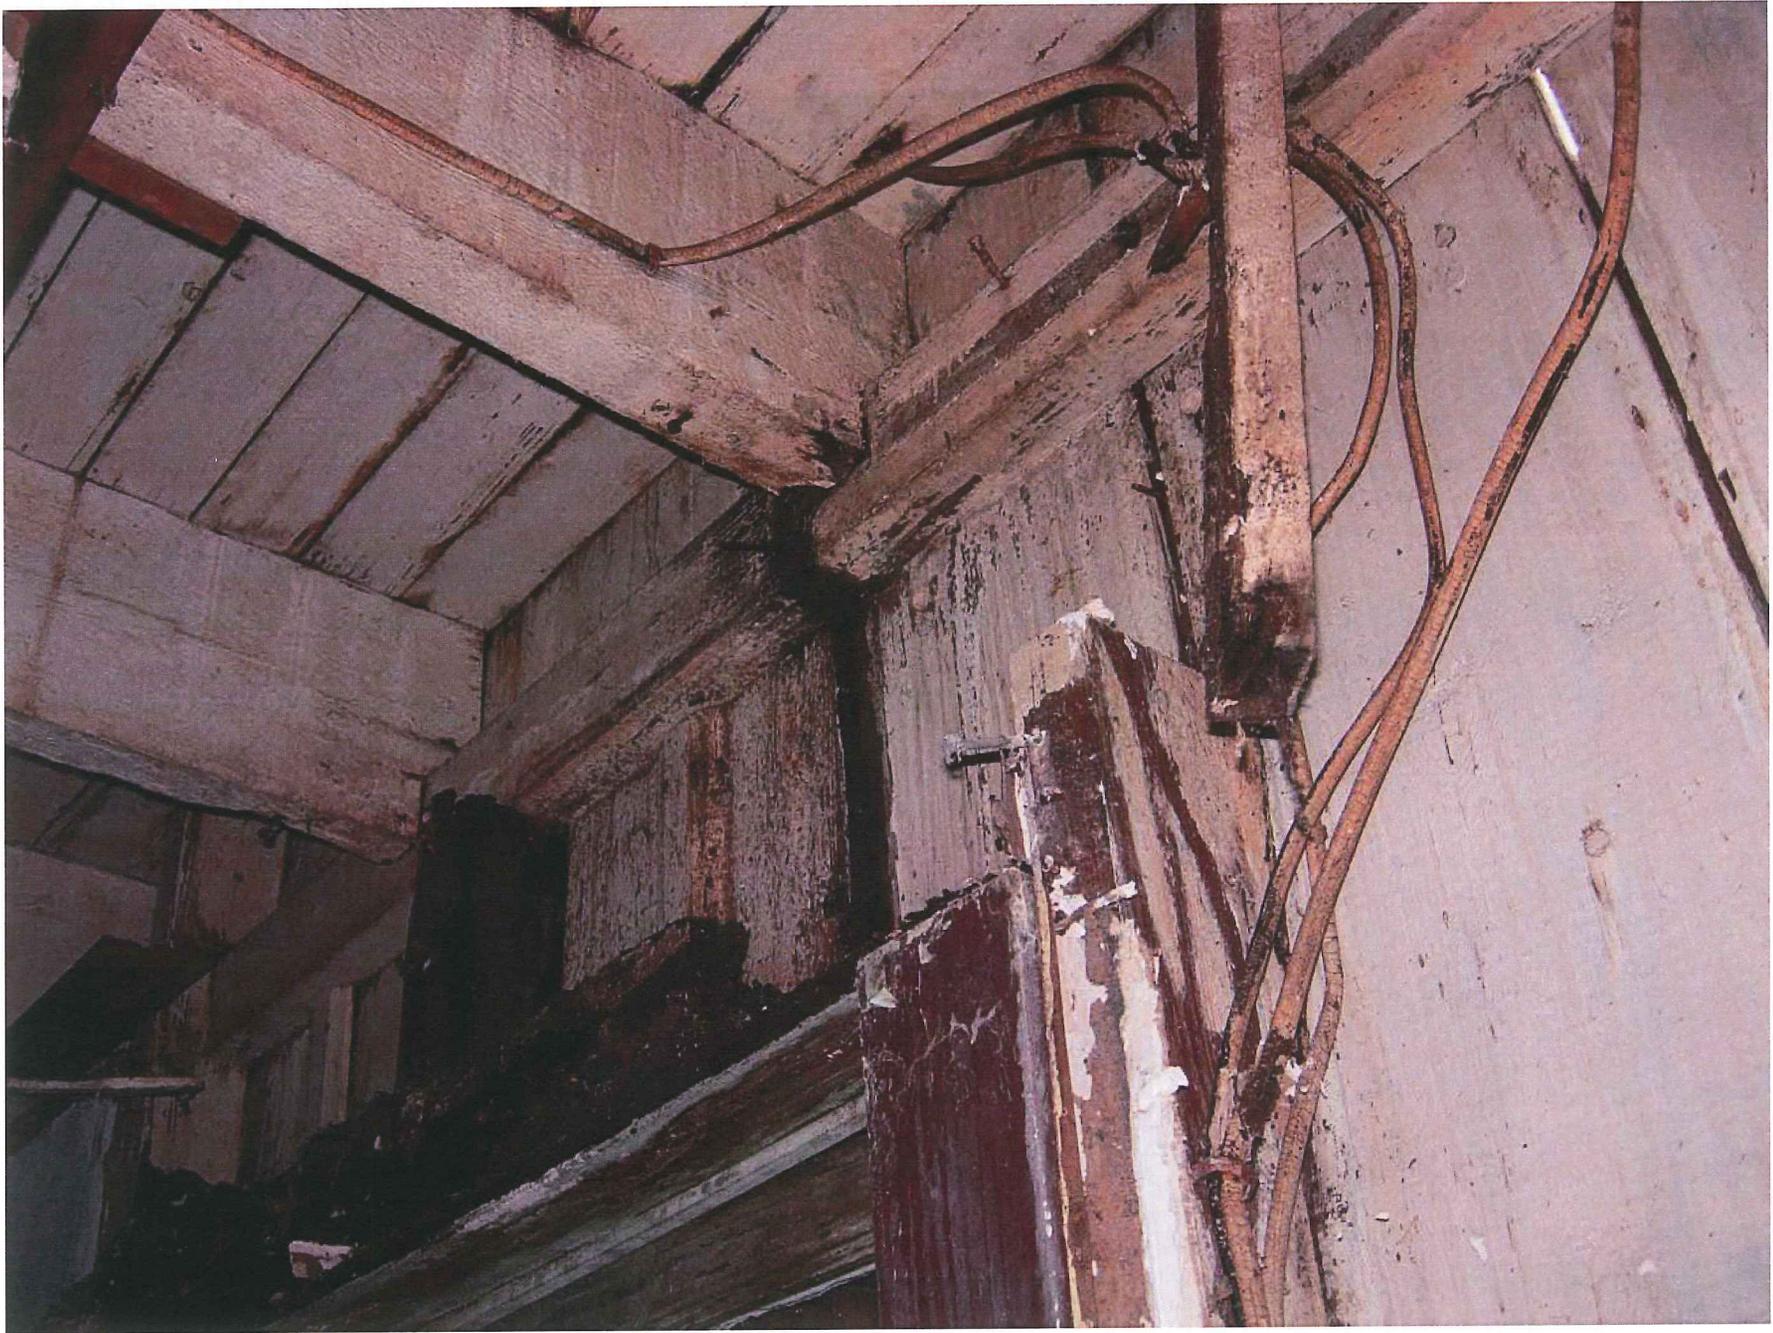
North wall – detail above window of ledger that supports joists. Studs cut off, interior battens removed

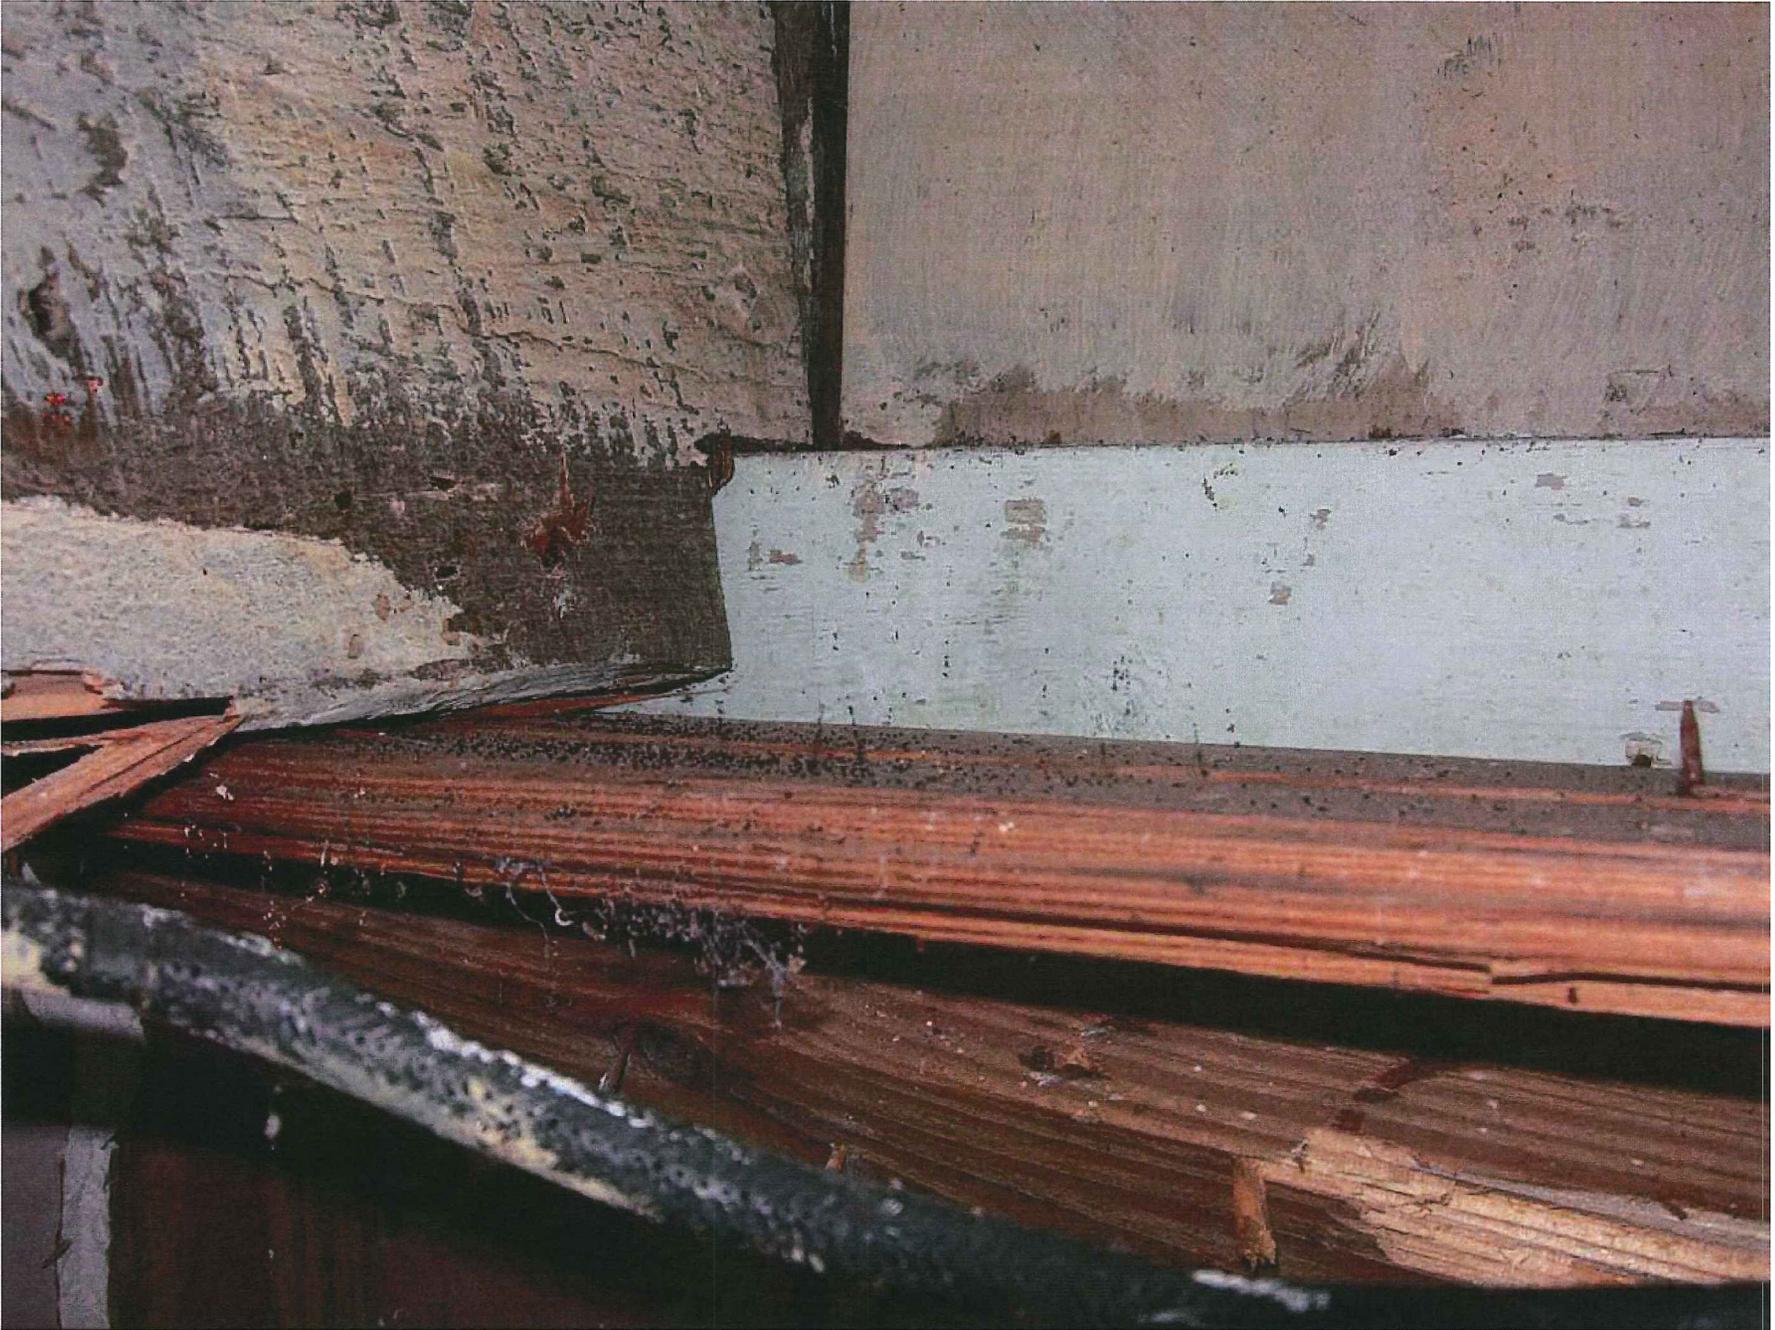
South wall east room two story section – detail of joist notched over ledger

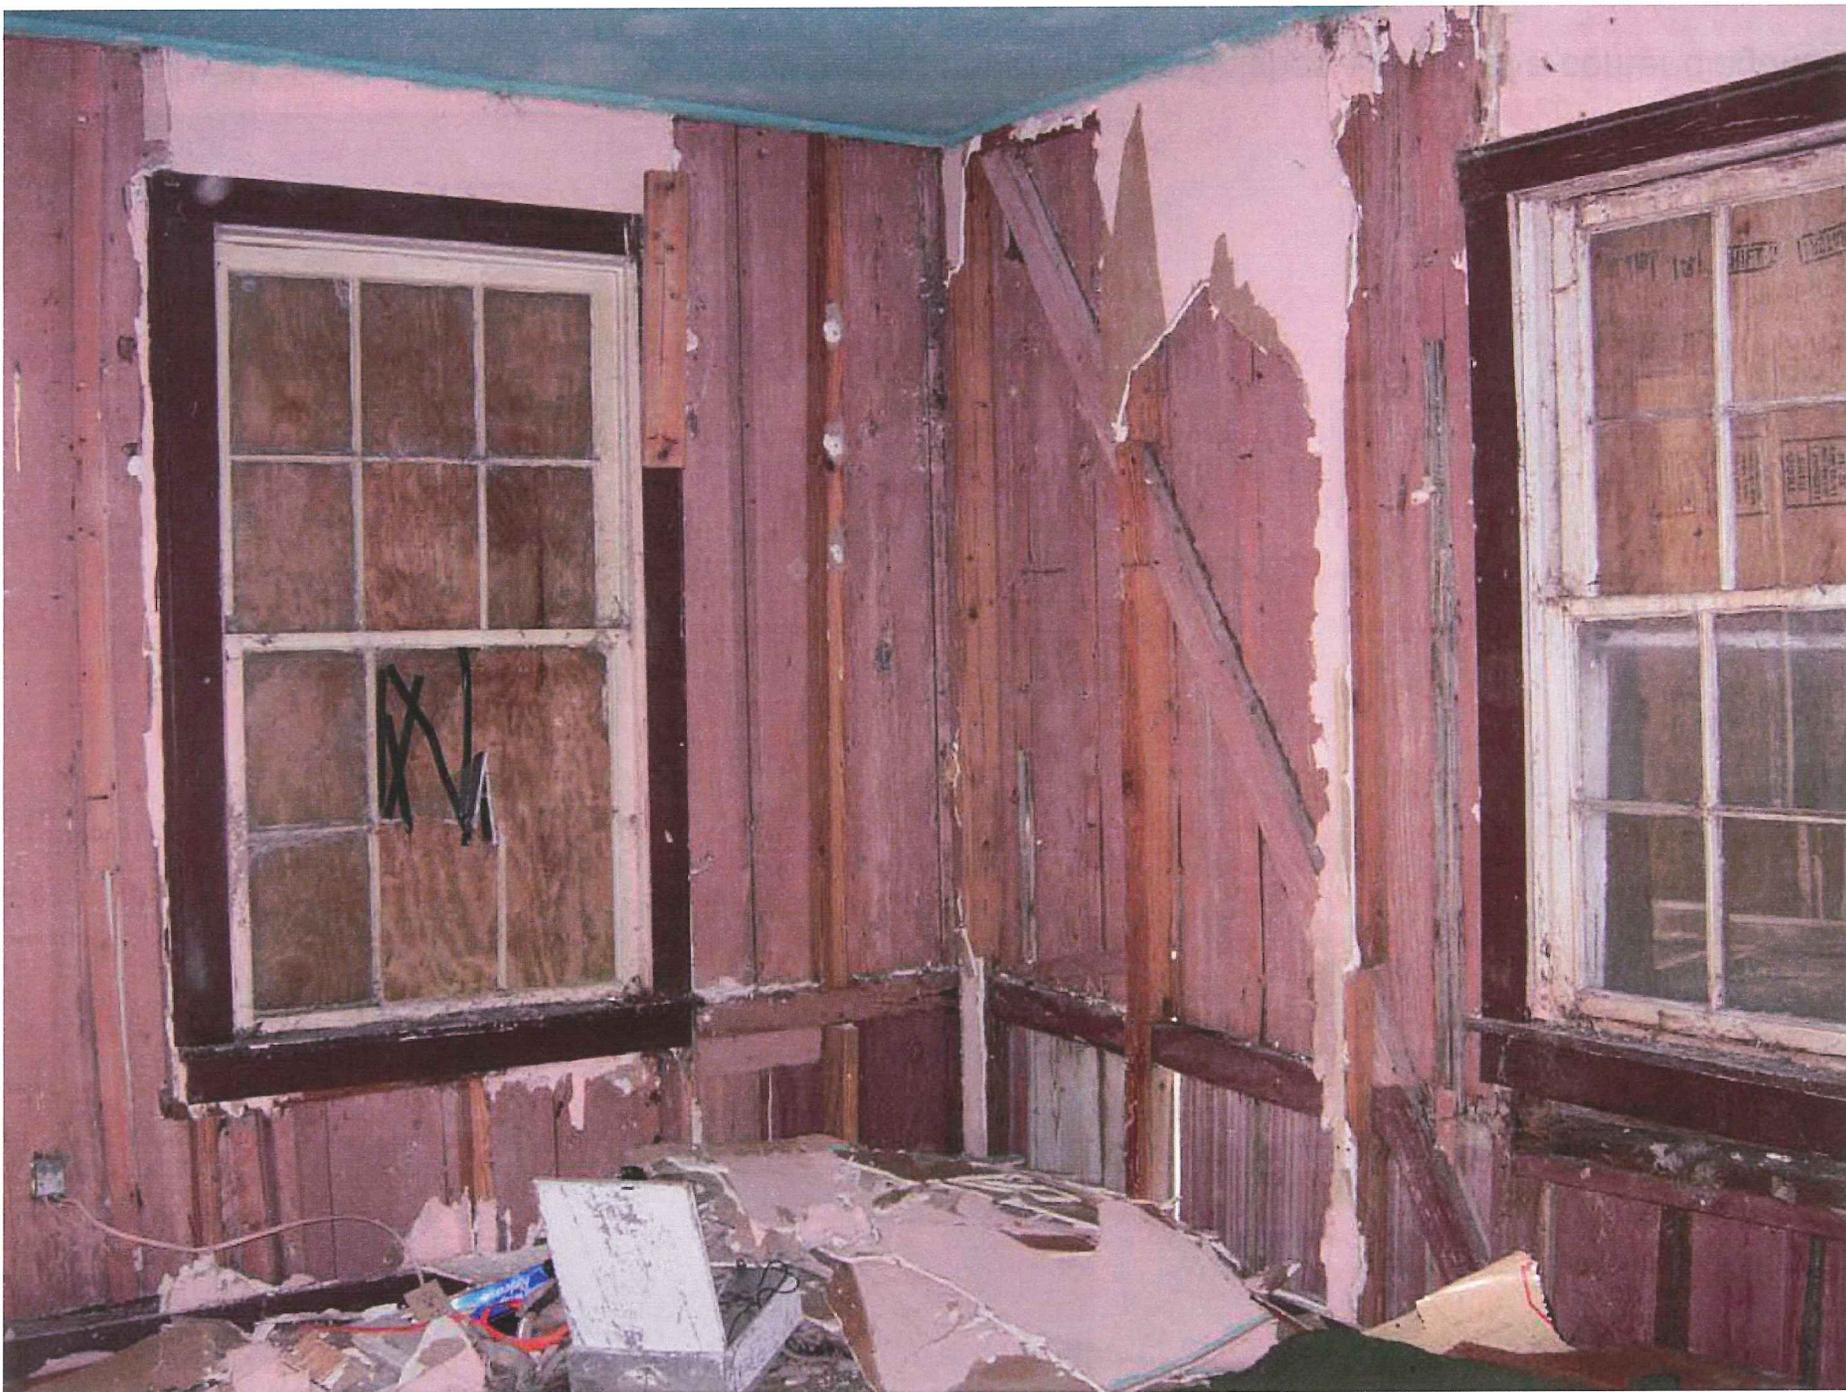
North east corner – diagonal brace let into framing at east gable end – modern studs added to support gypsum board from post 1950s remodeling, some interior batten strips remaining

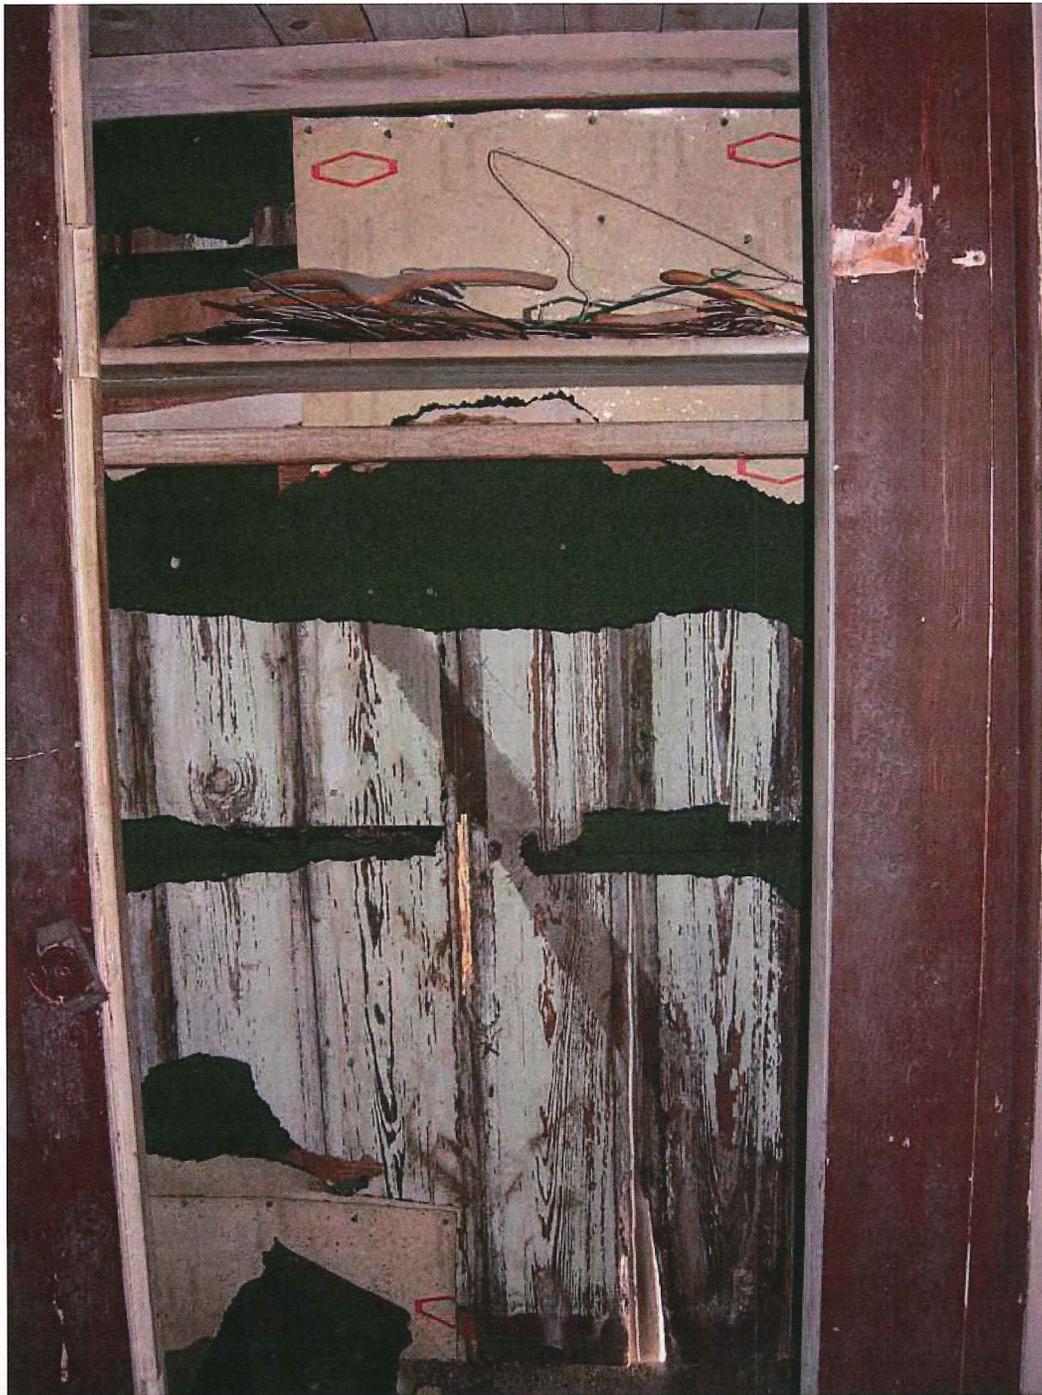
East wall – at closet – detail of exposed wall boards under modern finishes – ghost of a corner diagonal brace
