**BUNK HOUSE FIELD REVIEW &
CONDITION NOTES 09/19/08 SAI**

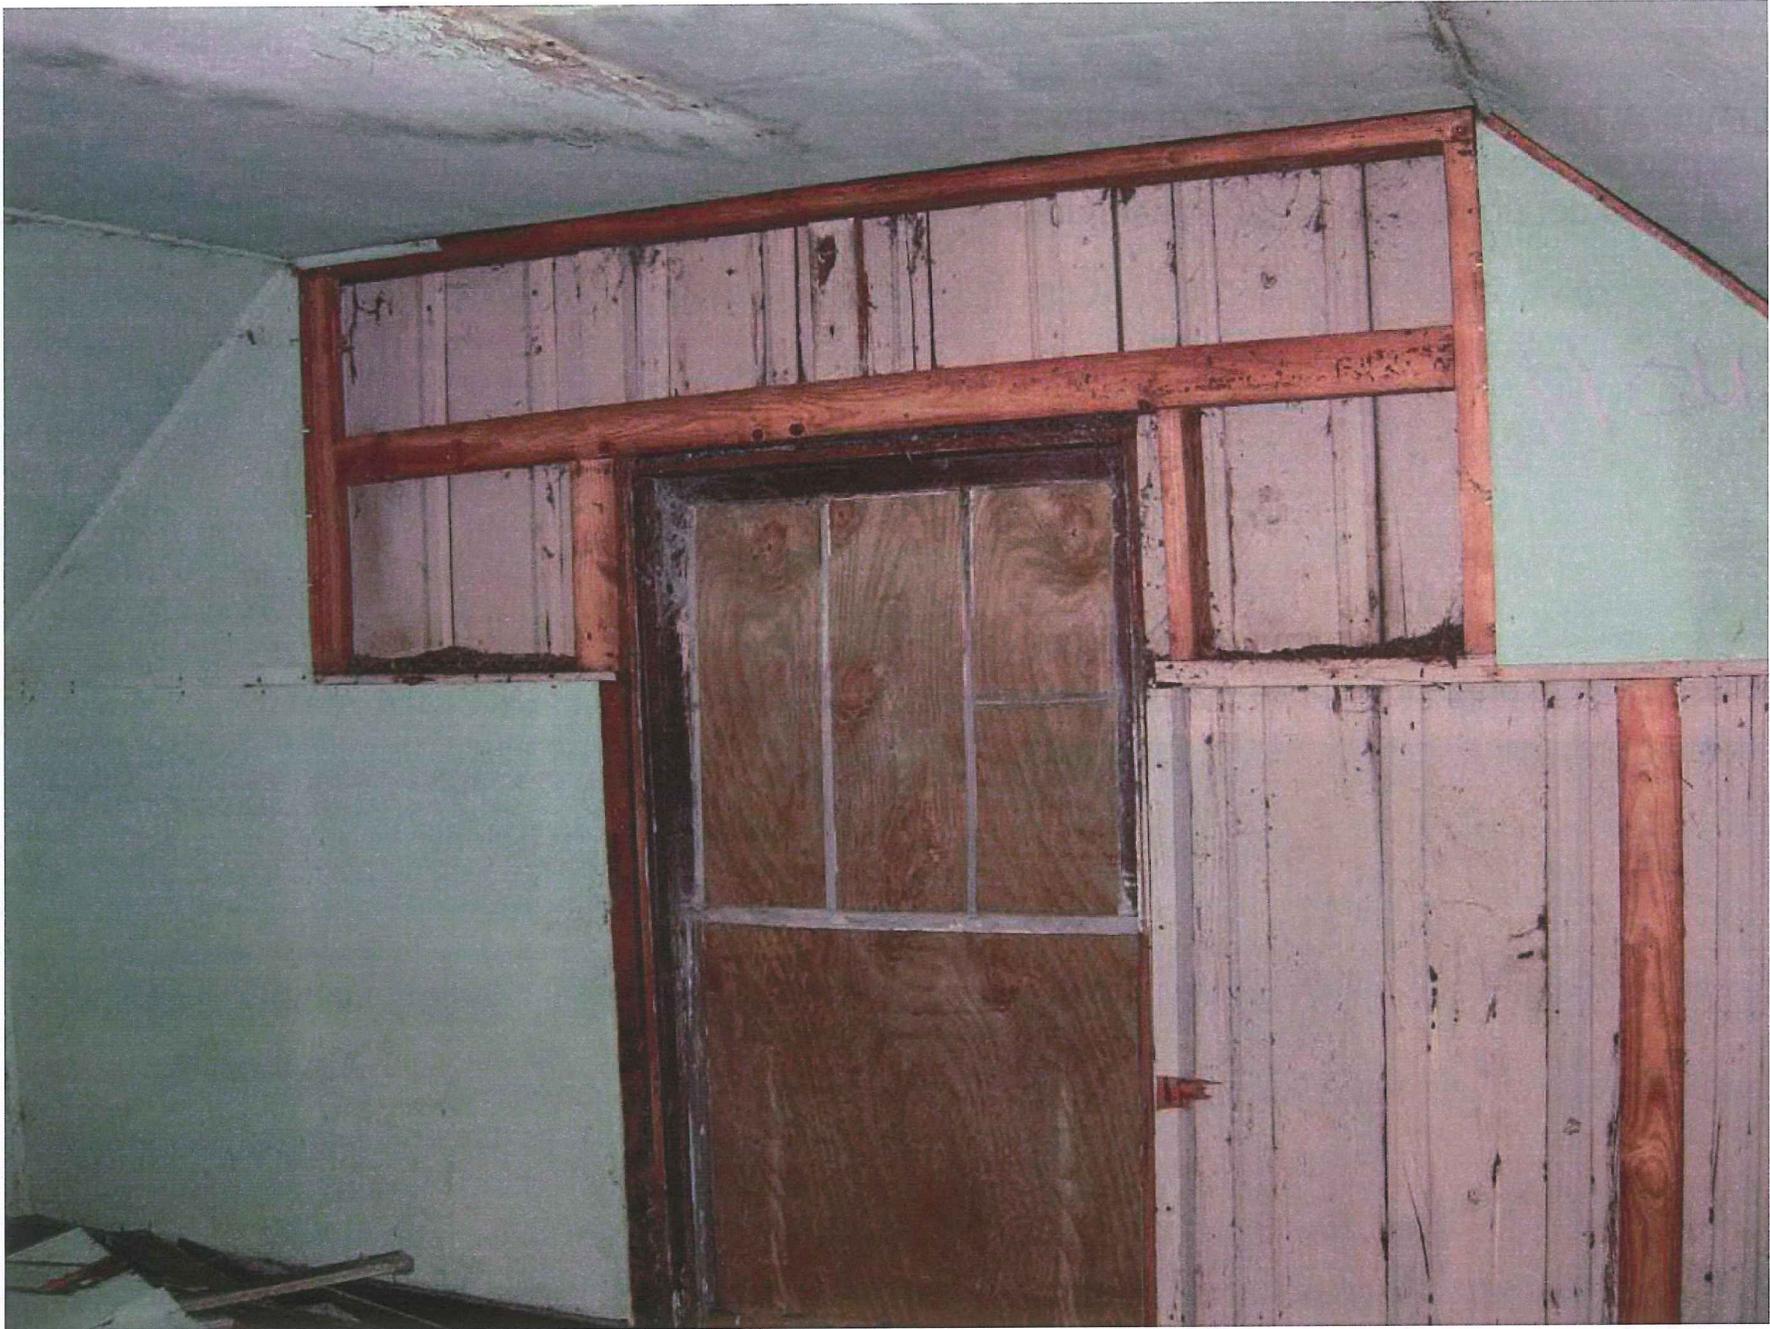
West wall of attic – battens were originally applied to the interior face to cover wall board joints - note modern wall framing for modern plywood paneling on walls and ceiling

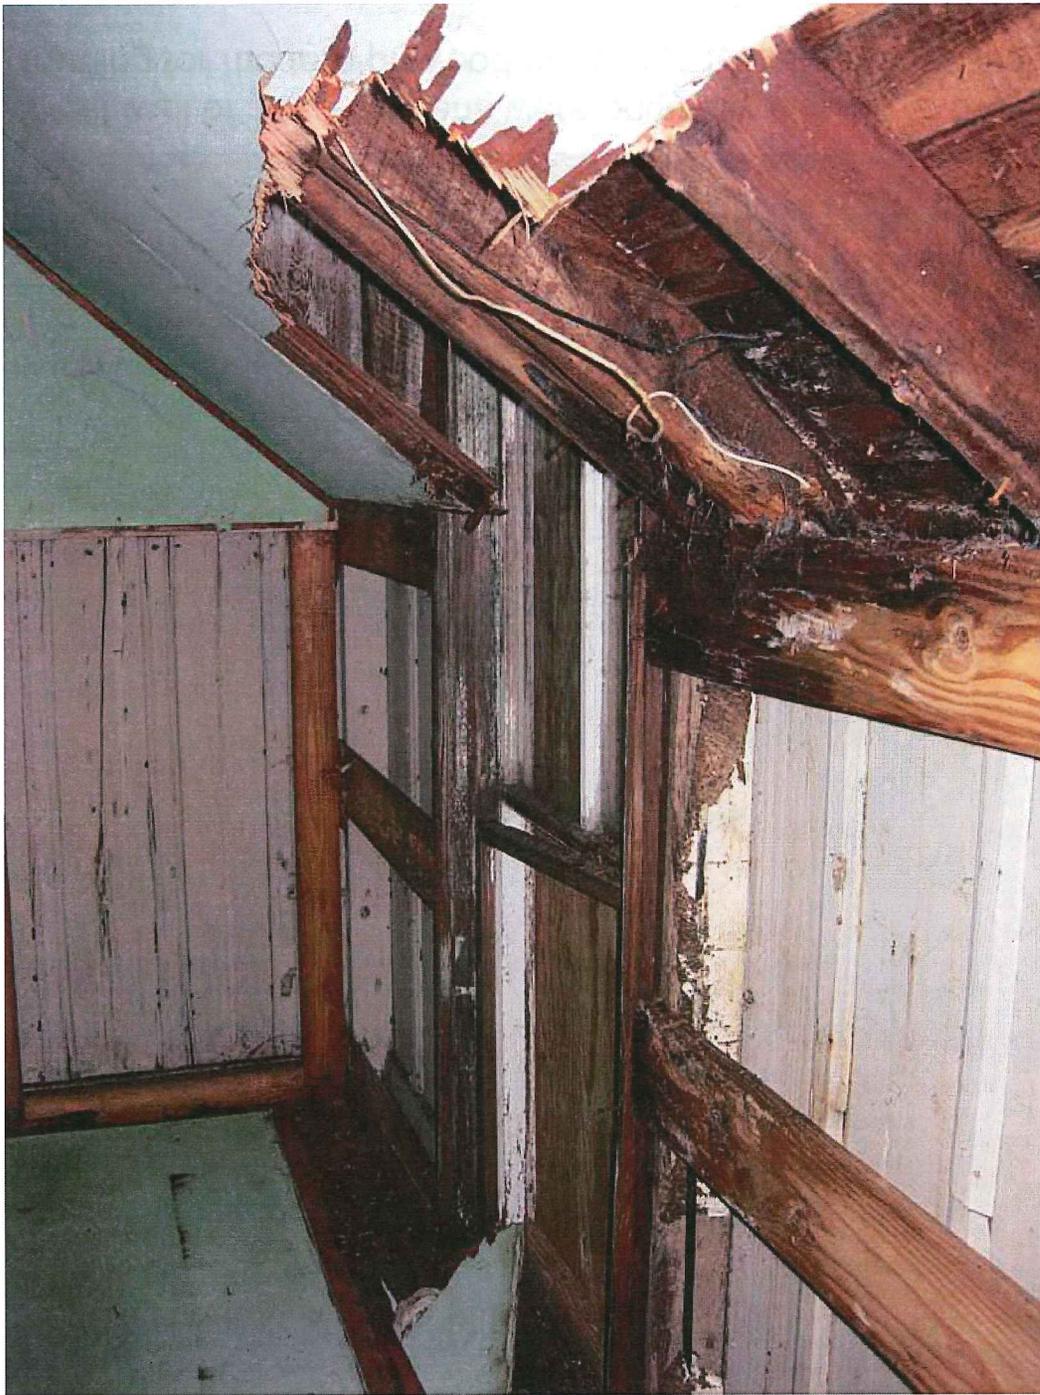
North wall – inside wall face of west dormer with vertical wall boards

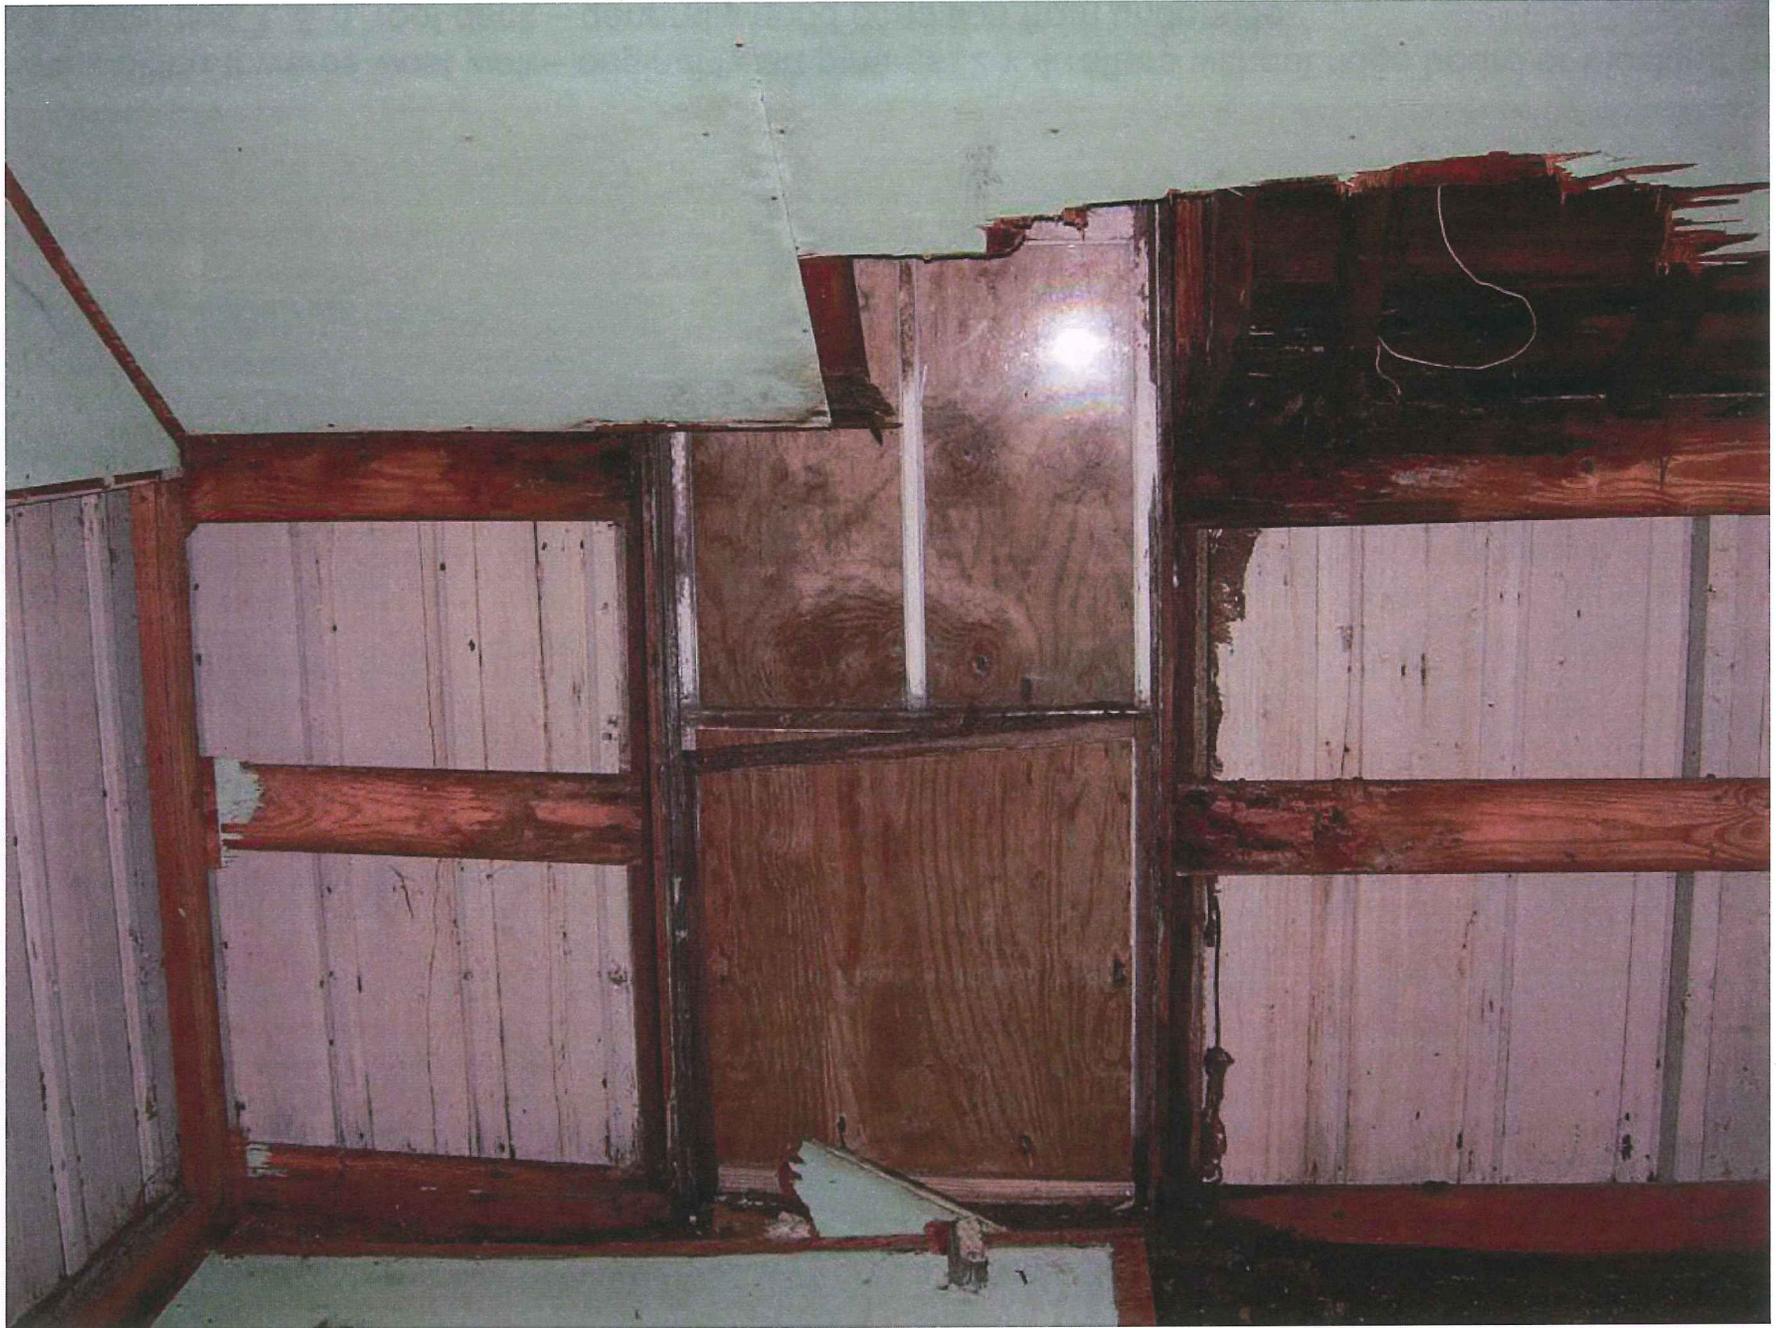
North wall – detail of west end window and inside face of vertical board wall with batten strips – early whitewash finish. Modern framing for modern strips for the modern plywood that covered ceiling and walls

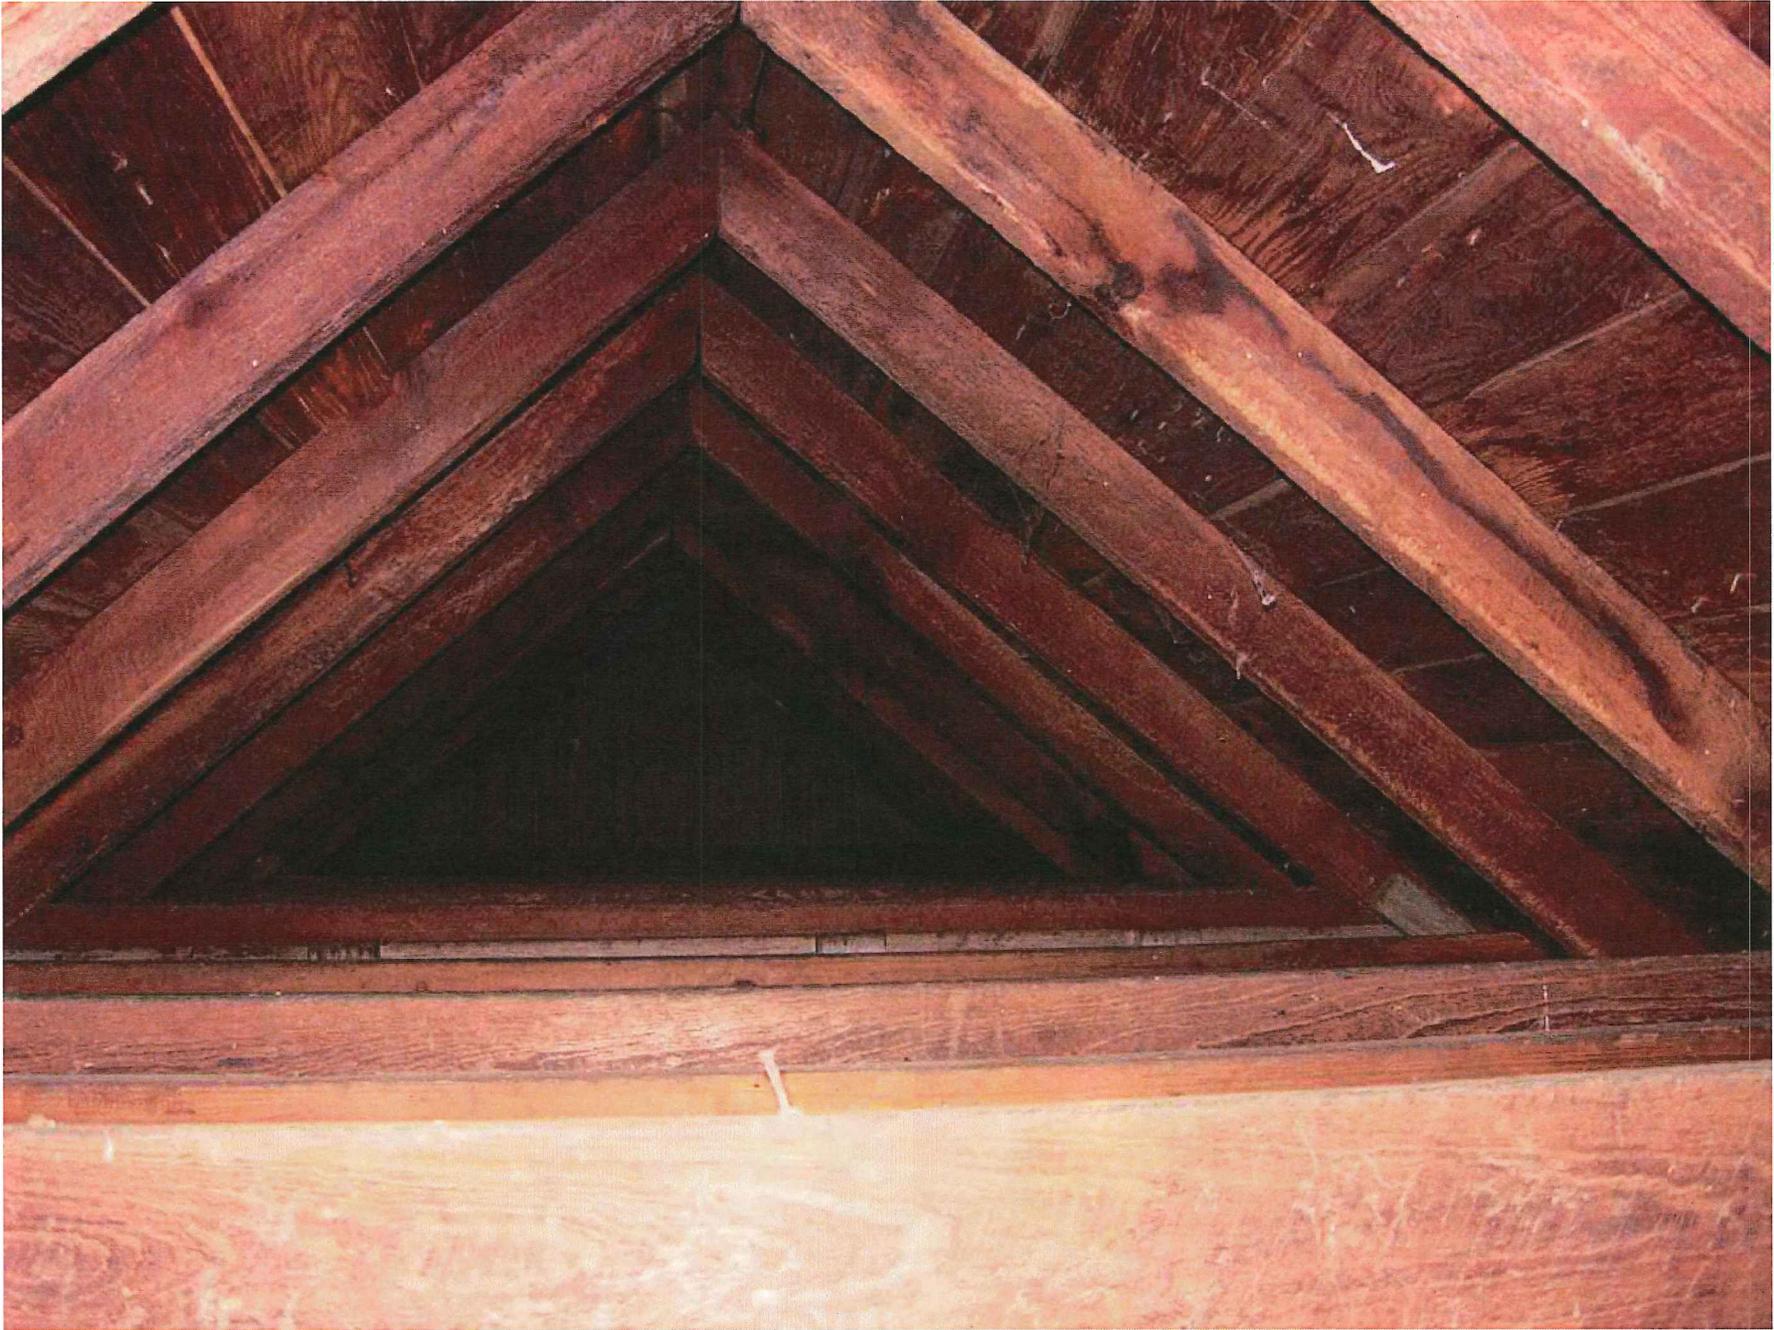
Attic view looking towards west wall – original heart pine r.s. 2 x 4 rafters without ridge board or blocking and r.s. 2 x 6 collar ties, t. & g. roof deck – generally good condition from underside

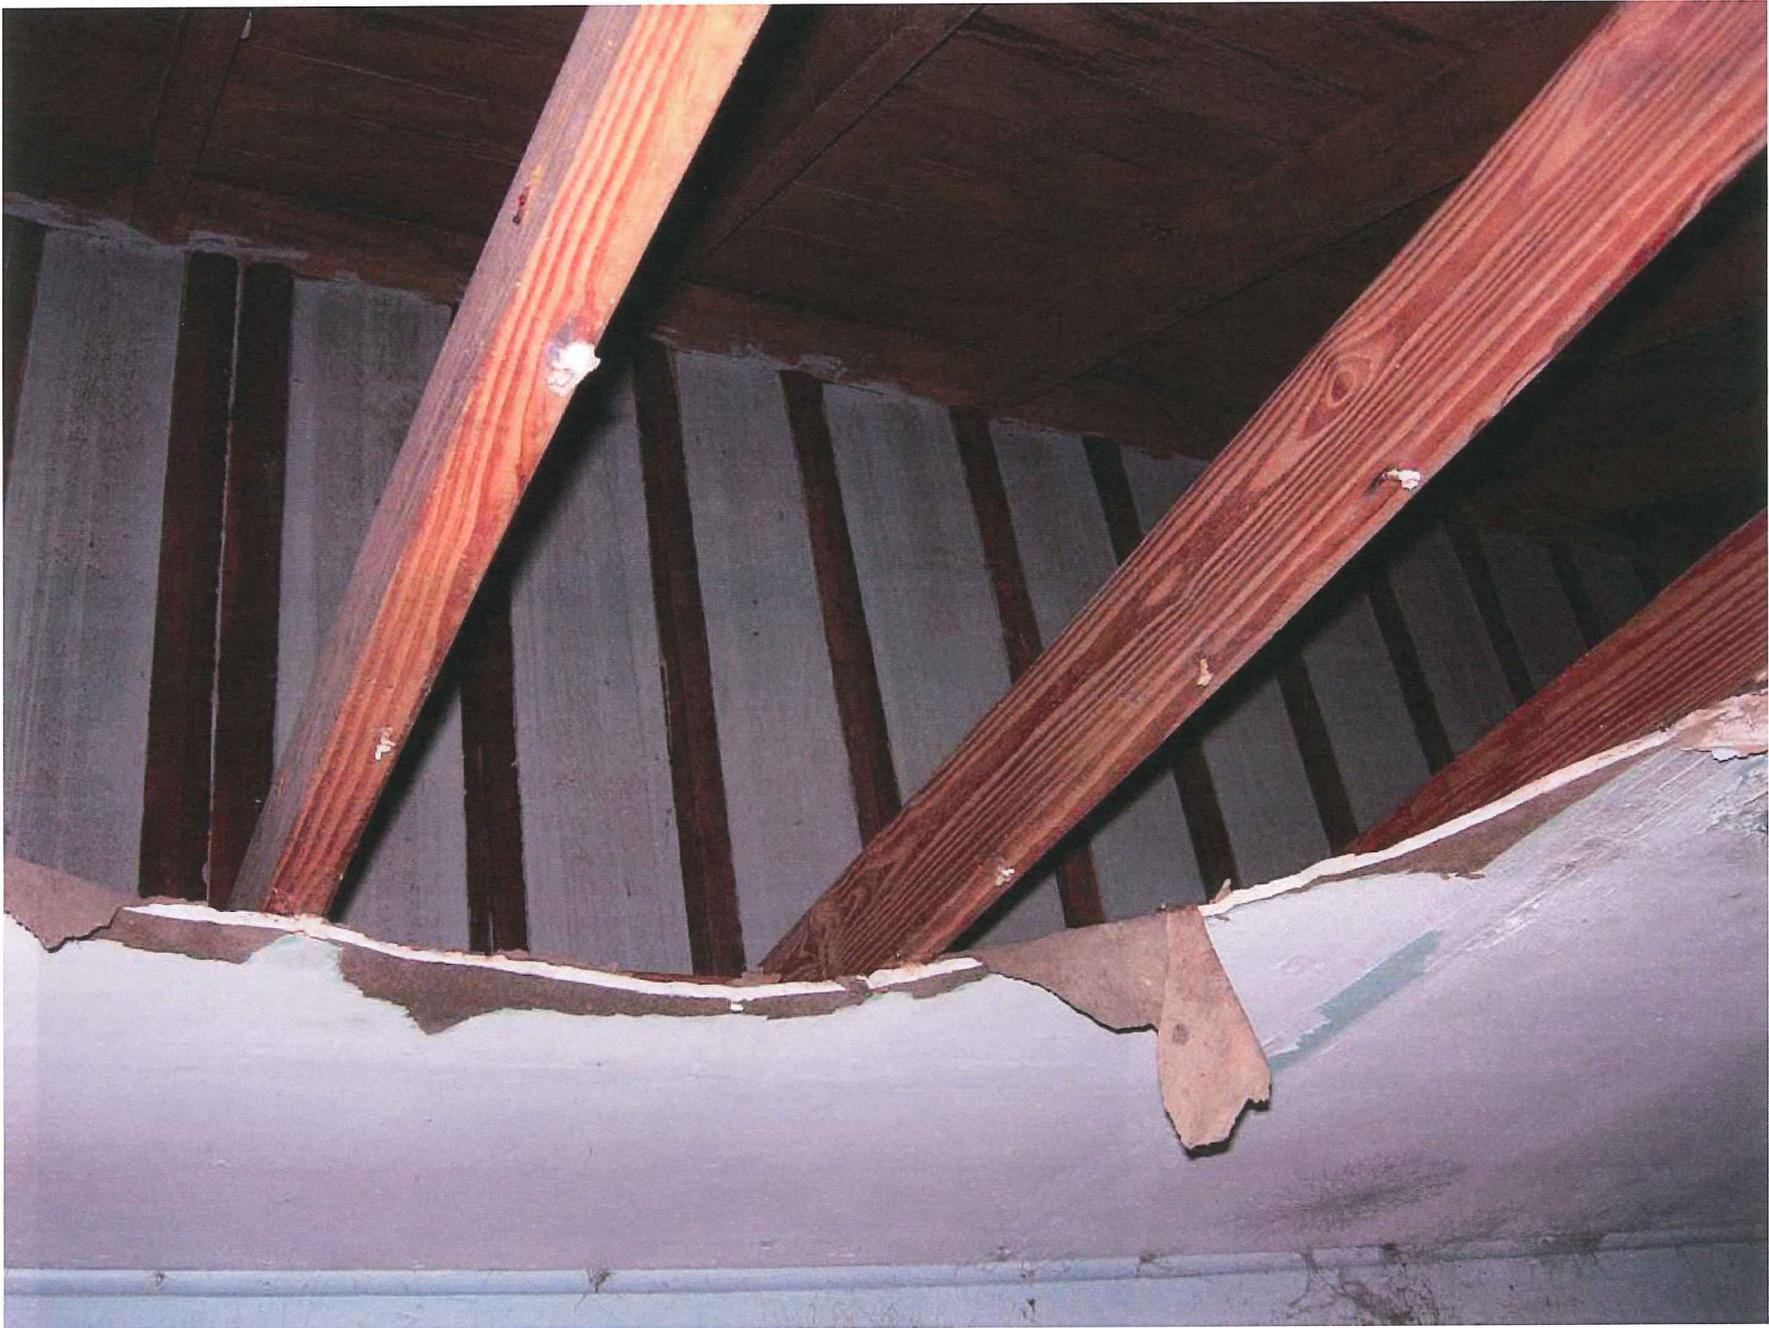
South face of two story wall east end – batten strips were removed – r.s 2 x 4 rafters on ledger nailed to wall
Modern ceiling joists support modern gyp. board ceiling

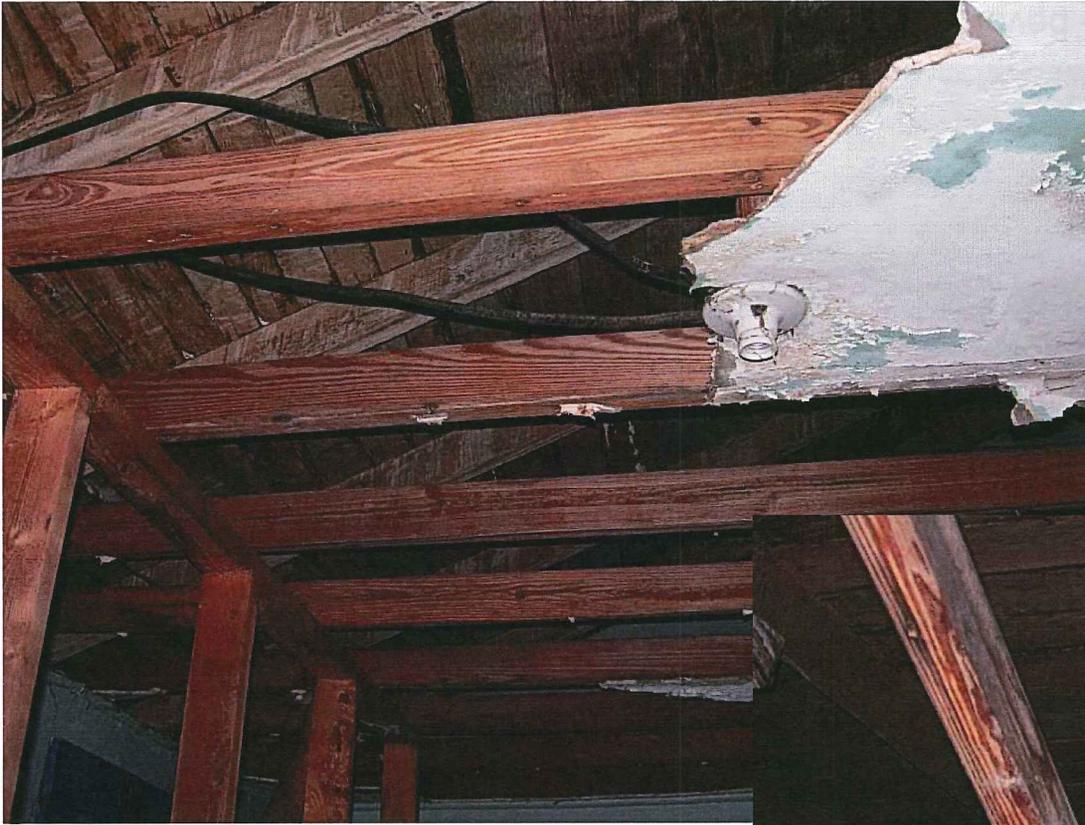
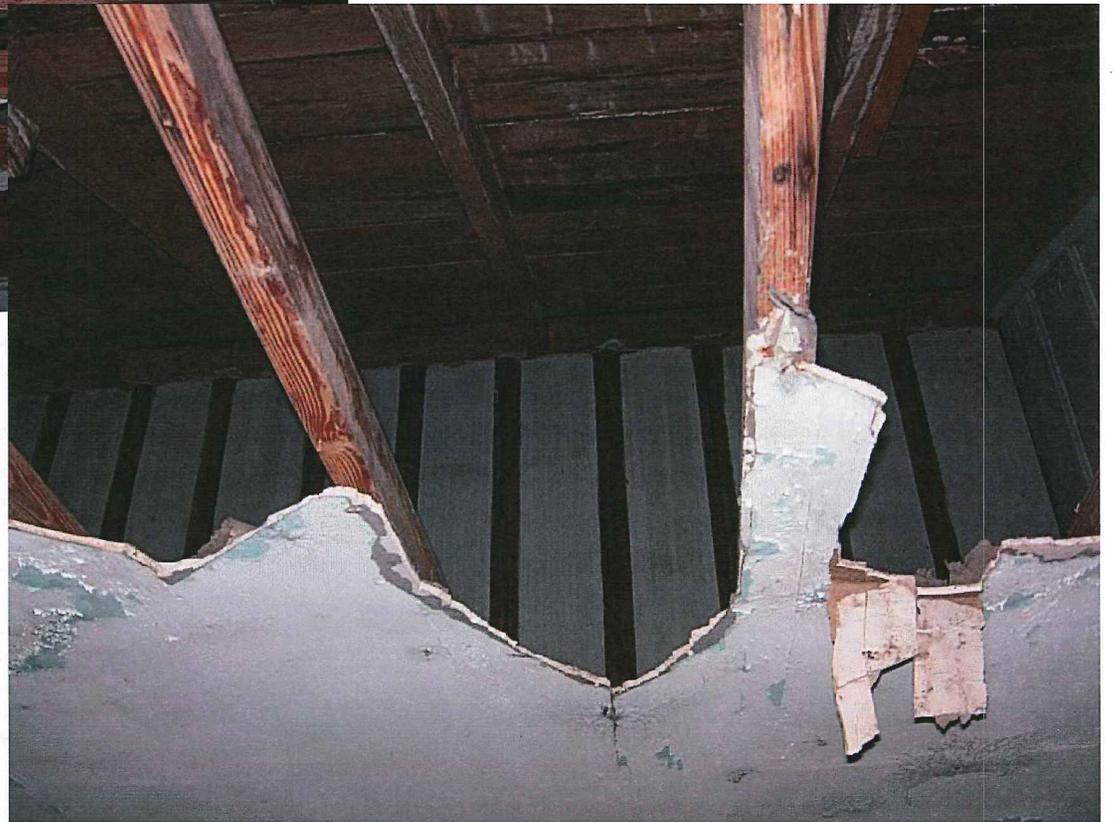
Lower roof framing – roof deck has water damage

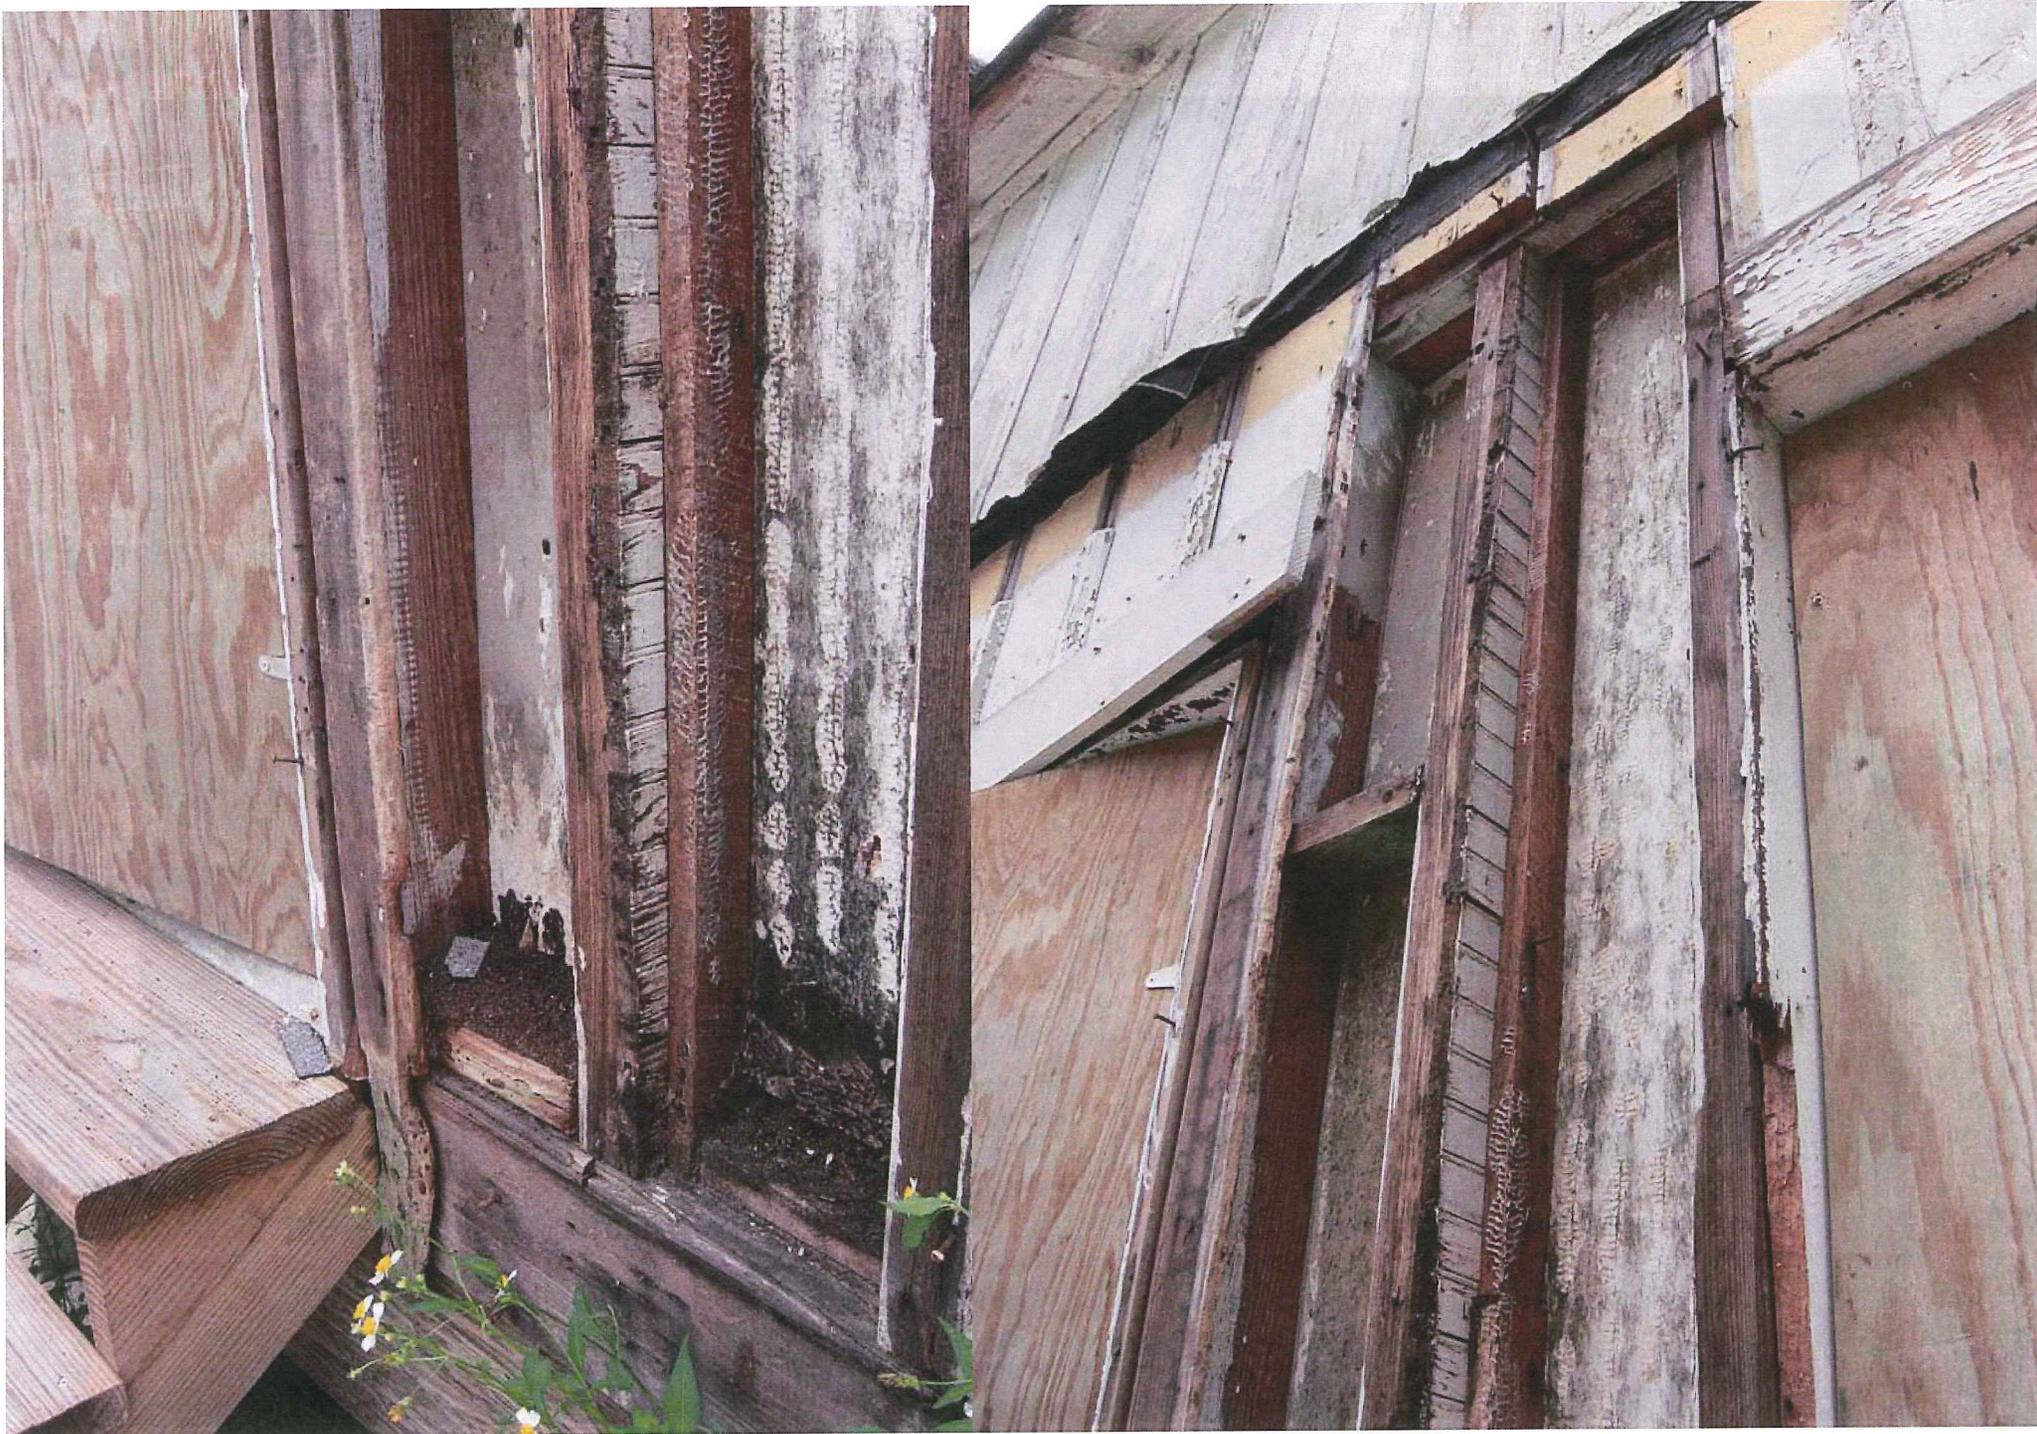
North wall – beadboard at the east wall of stair partition runs entire length of this wall and covers stud

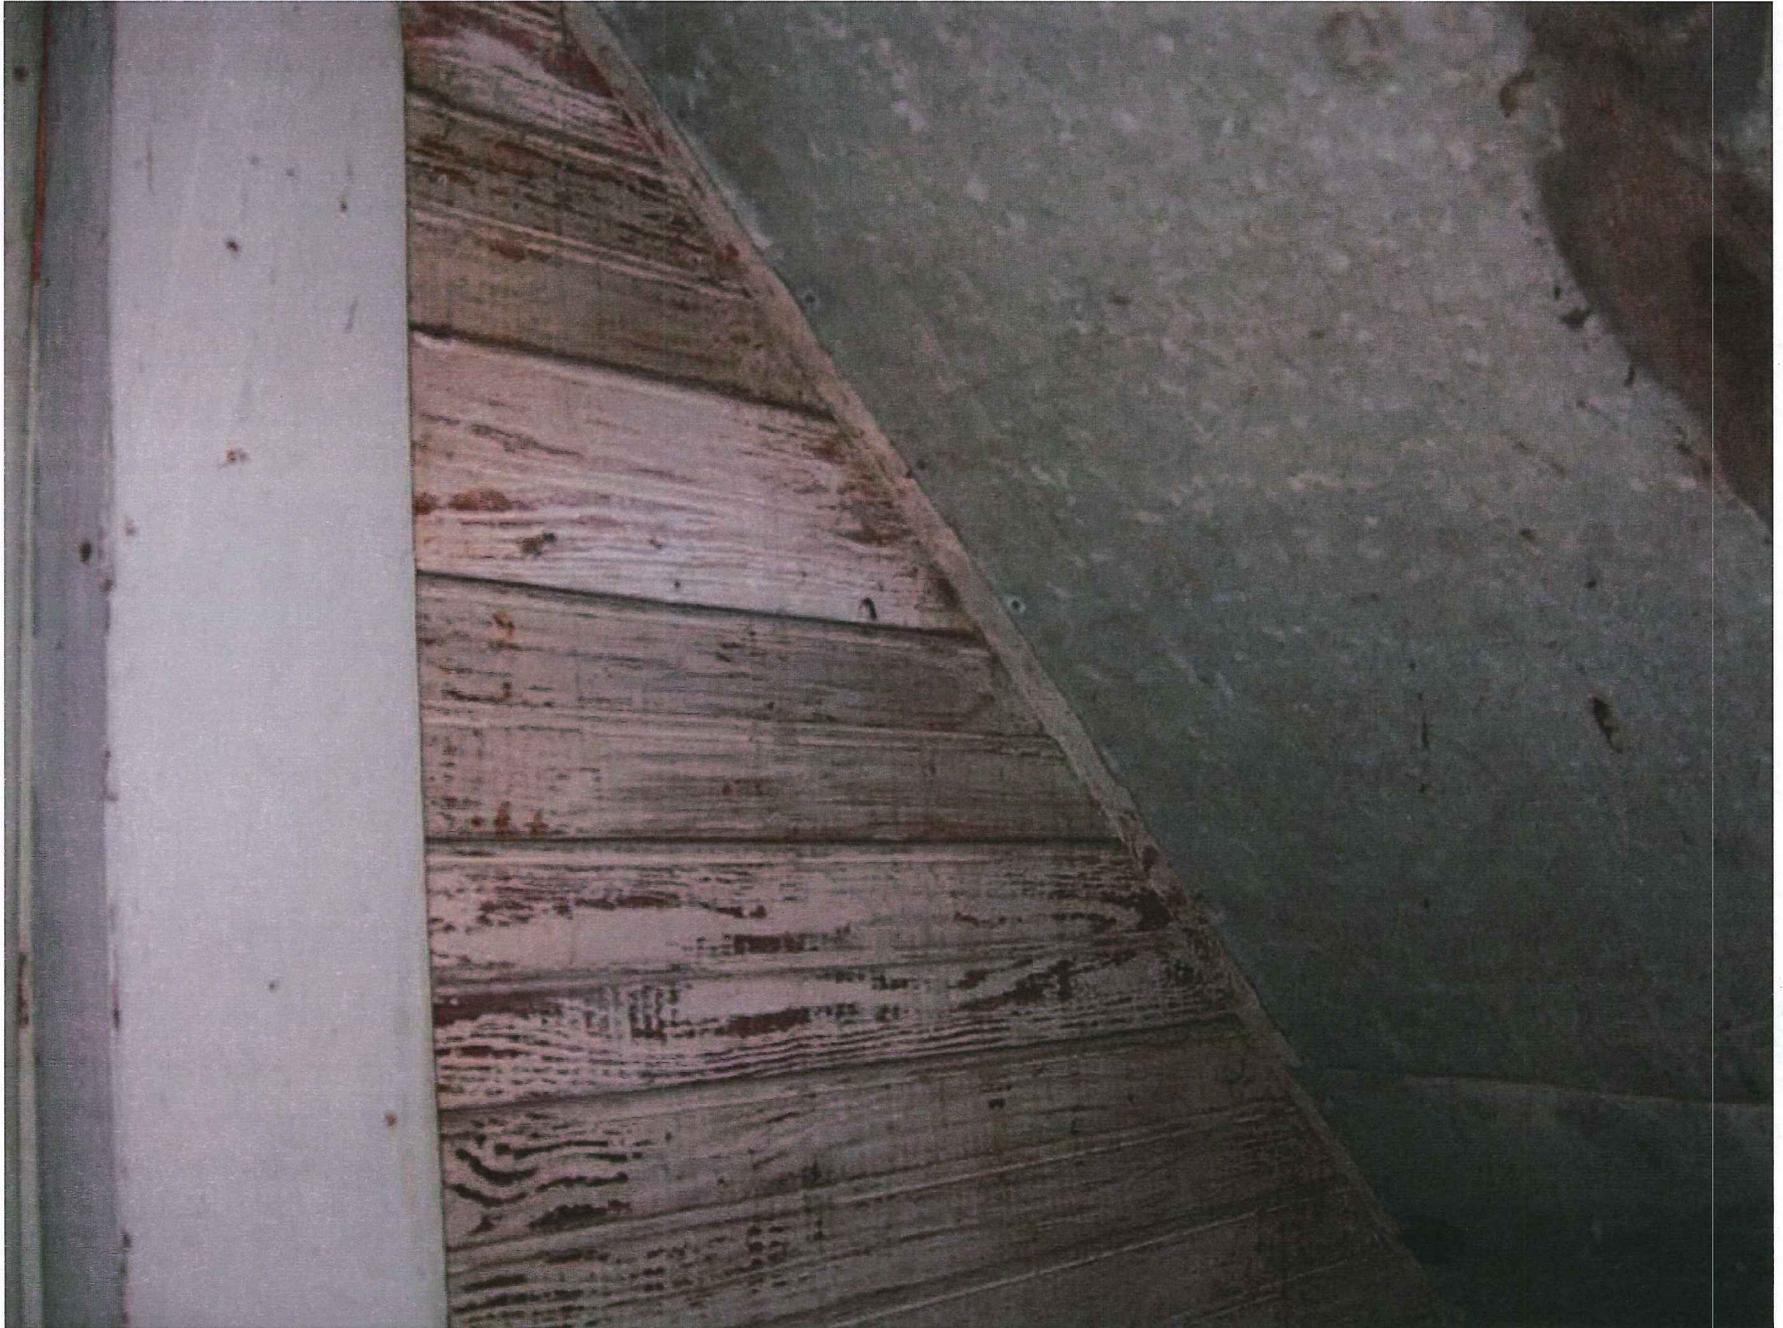
Bead board on east wall of stair continuous along this wall

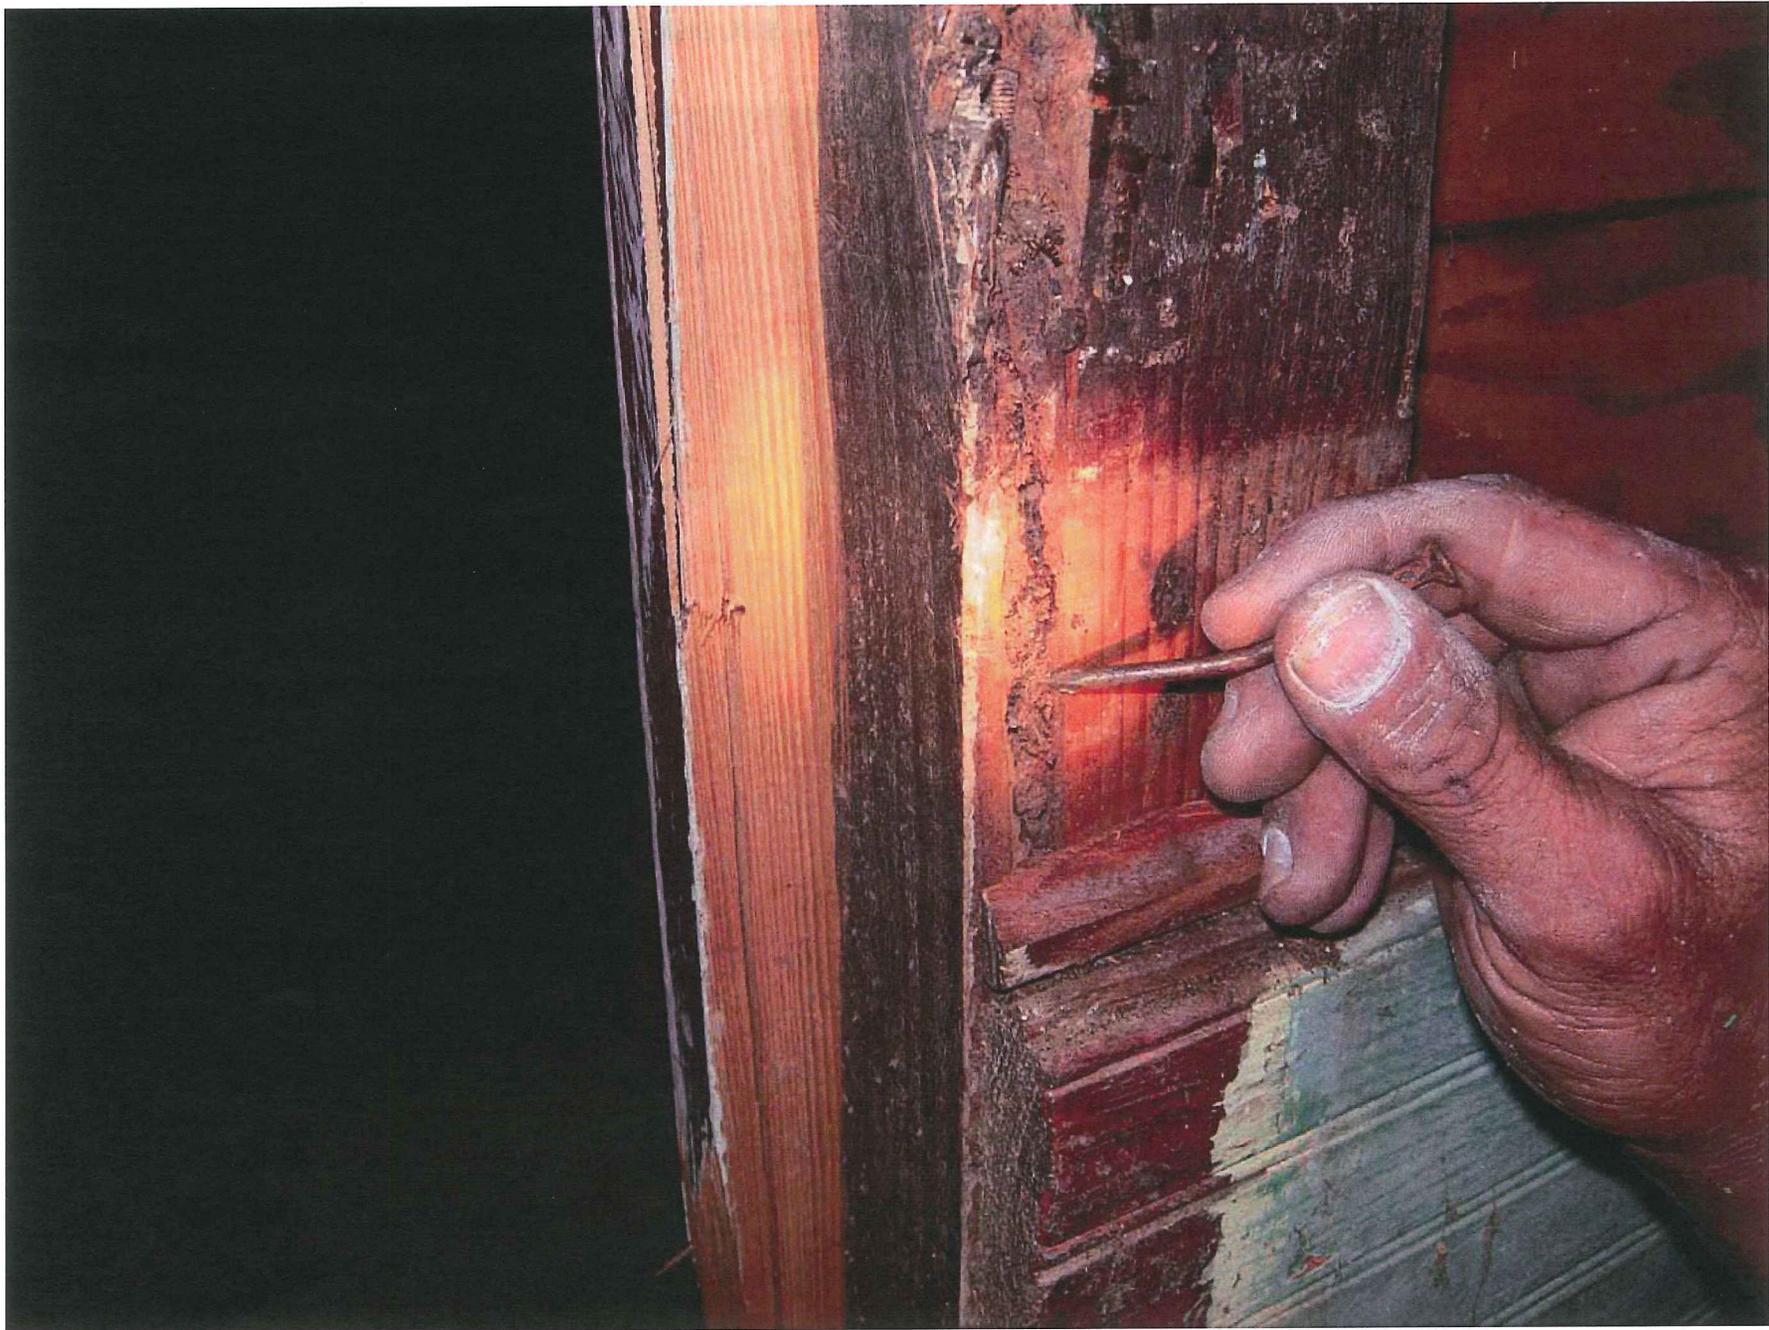
Attic east wall of stair – beadboard continues about 30" above floor and has 3 layers of finishes

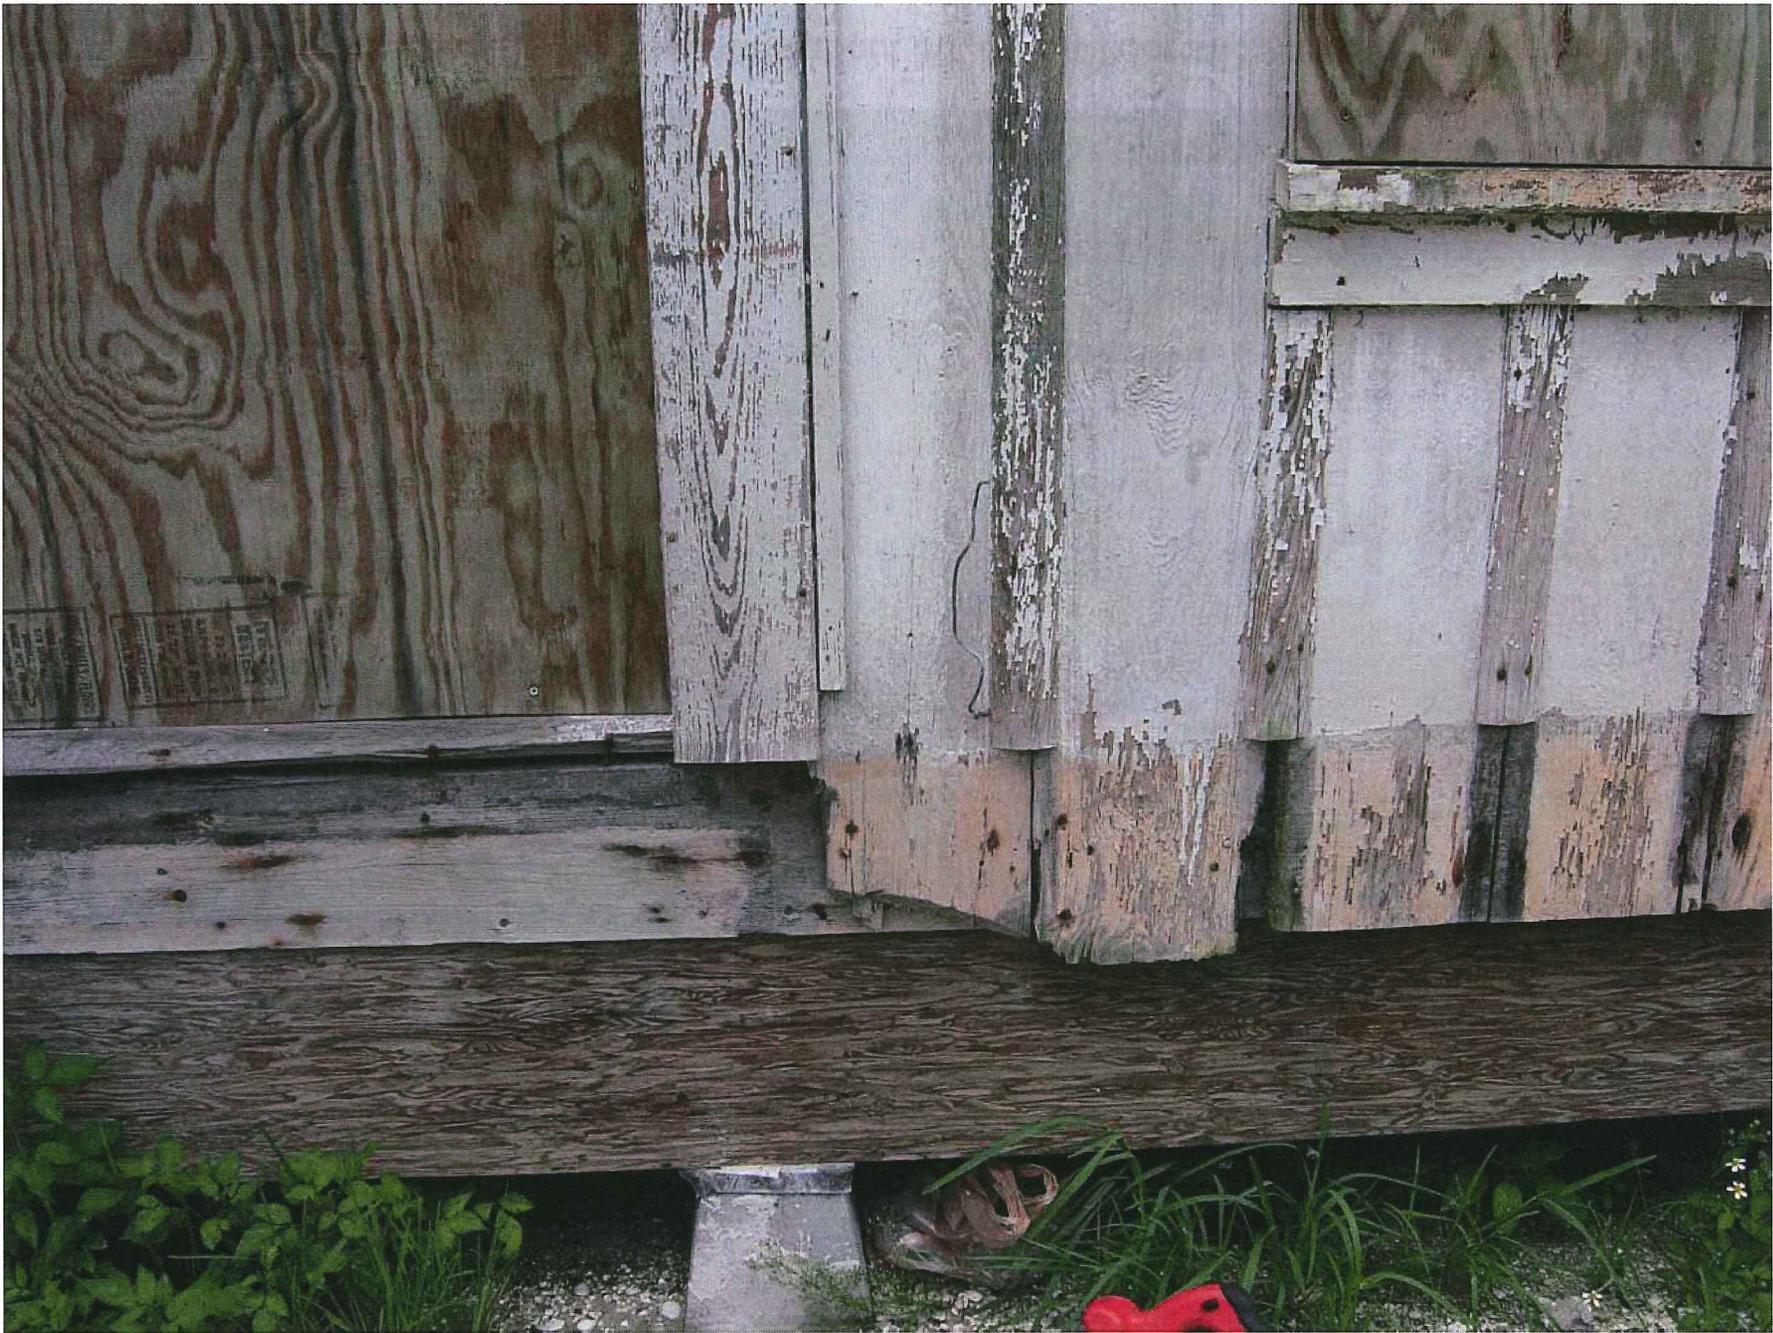
North wall has at least two layers of finishes – “railroad” yellow and white paint on top
