PIRATE HARBOR ENTRANCE CHANNEL DREDGING
SEAGRASS MONITORING REPORT

**FOURTH ANNUAL SURVEY OF MITIGATION, CONTROL, AND IMPACT
SITES**

DEP Permit 0128695-008-EI

USACE Permit SAJ-2006-01964(SP-ACM)

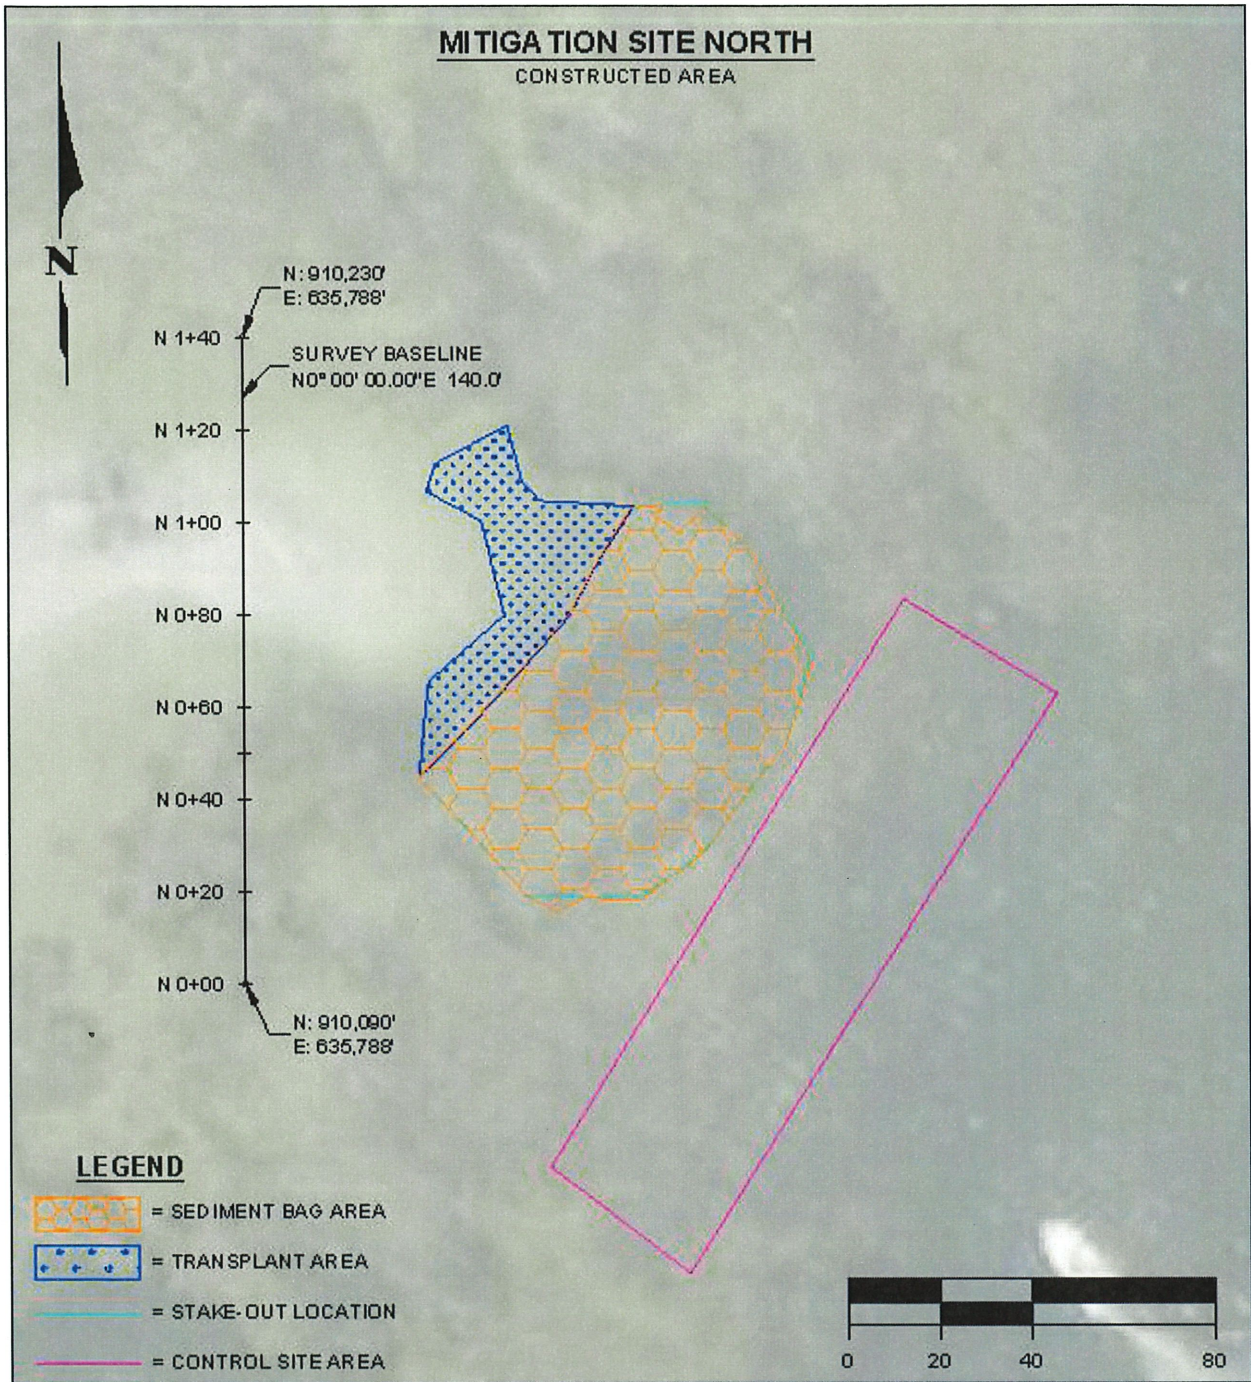
Figure 6. Post-Construction Survey of Mitigation Site North

Mitigation Site	Accepted Area SF (AC)	% Greater Than Design Elevation
North	4,085 (0.094)	92%
South	13,057 (0.300)	90%
Total	17,142 (0.394)

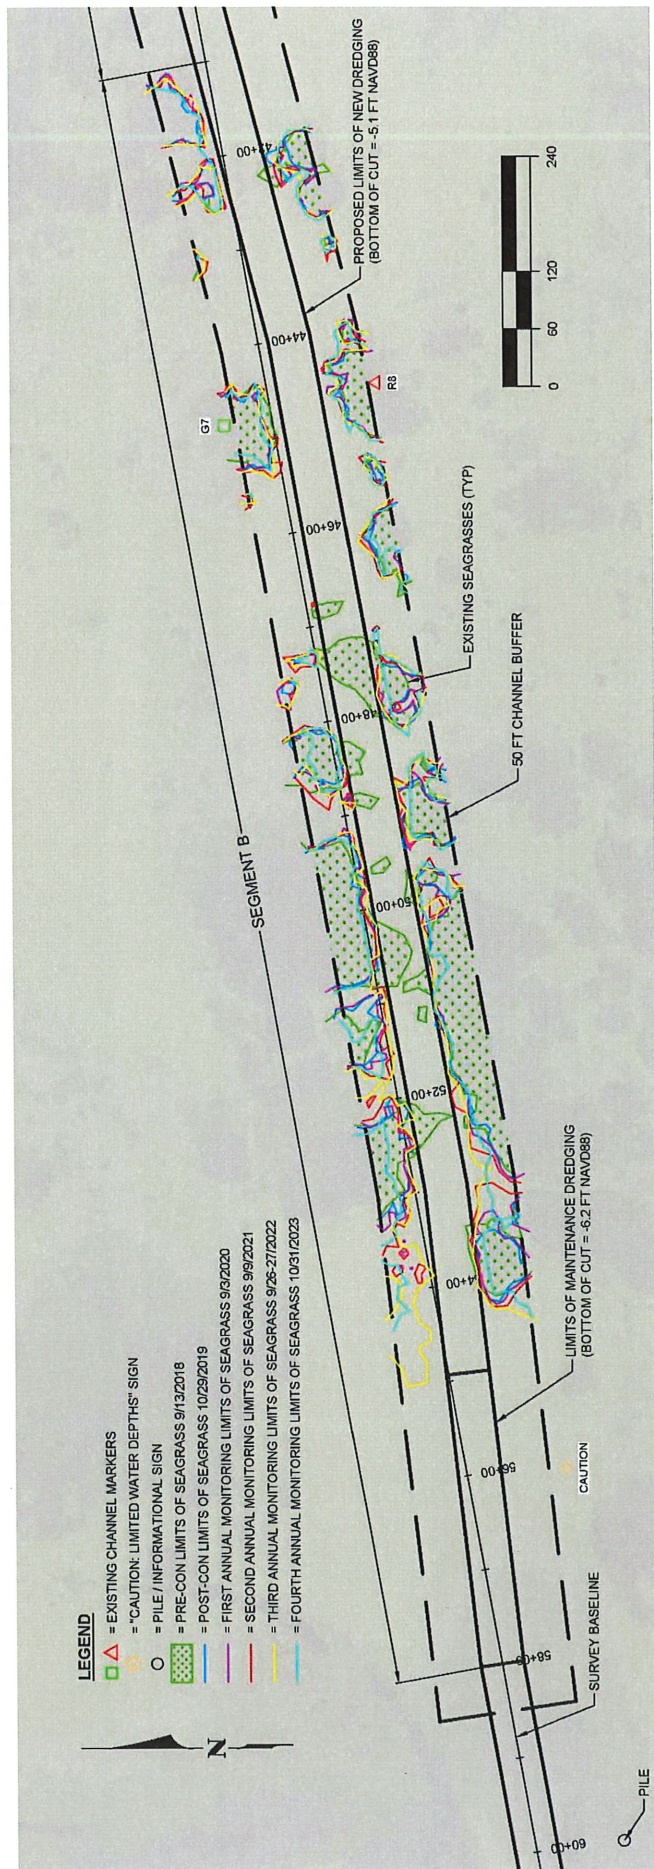
Figure 8. Seagrass Monitoring Surveys of Buffer Zone Adjacent to Impact Site

The conditions of the seagrass areas were typical of what has been observed in previous surveys; a mix of *Thalassia testudinum*. Generally, the seagrass beds maintained a shape similar to that documented in the post-construction survey, however the seagrass beds receded in size when compared to the third-year monitoring survey. Based on the monitoring results, the seagrass beds within the 50-foot buffer zone have increased in size, approximately 5 percent, since the post-construction survey. A dense mat of filamentous algae was observed covering the channel bottoms

and extending up the channel side slopes. This had not been observed in prior monitoring surveys. The recruiting seagrass adjacent to the channel may have been impacted by the filamentous algae.

Monitoring data of the 50-foot buffer zone adjacent to the Impact Site indicated the seagrass beds have remained healthy and their size has increased since post-construction conditions.

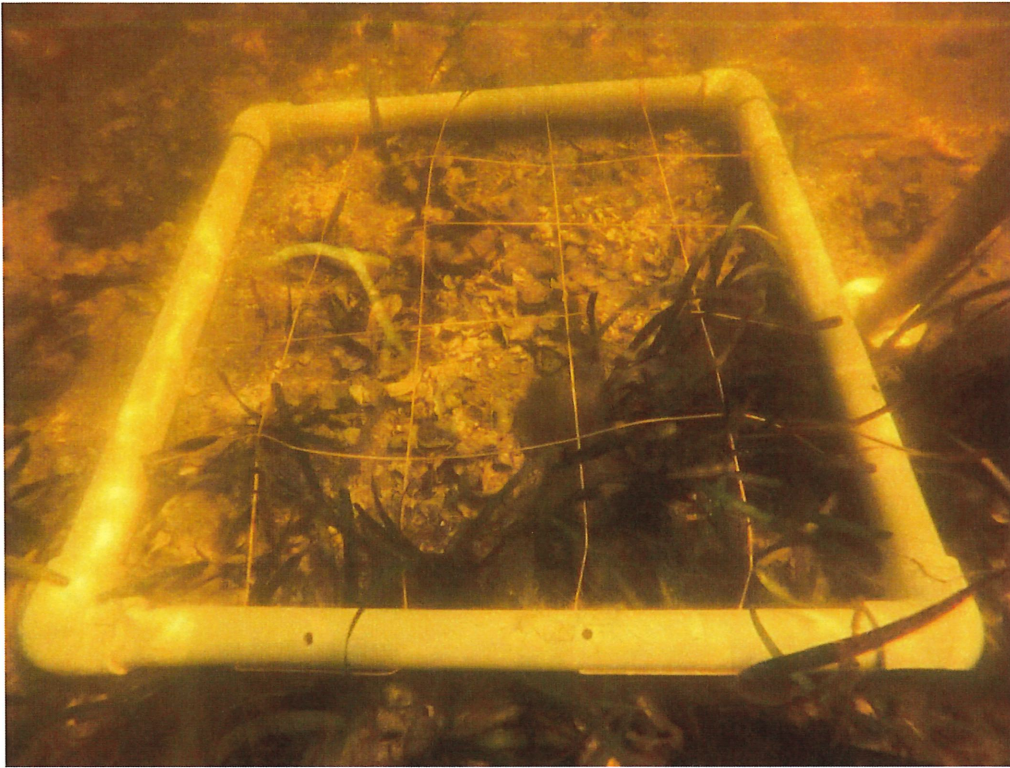
PHOTO 1: *Thalassia testudinum* MSN, 10/31/2023

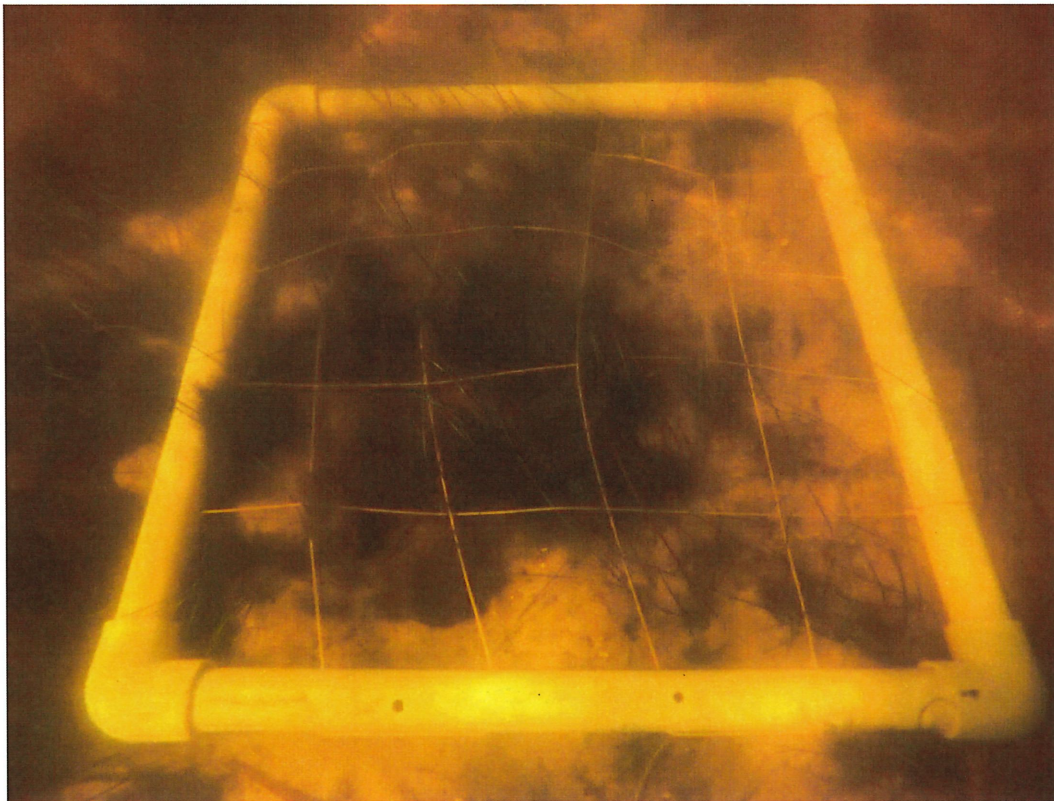
PHOTO 2: *Halodule wrightii* and filamentous algae, 10/31/2023

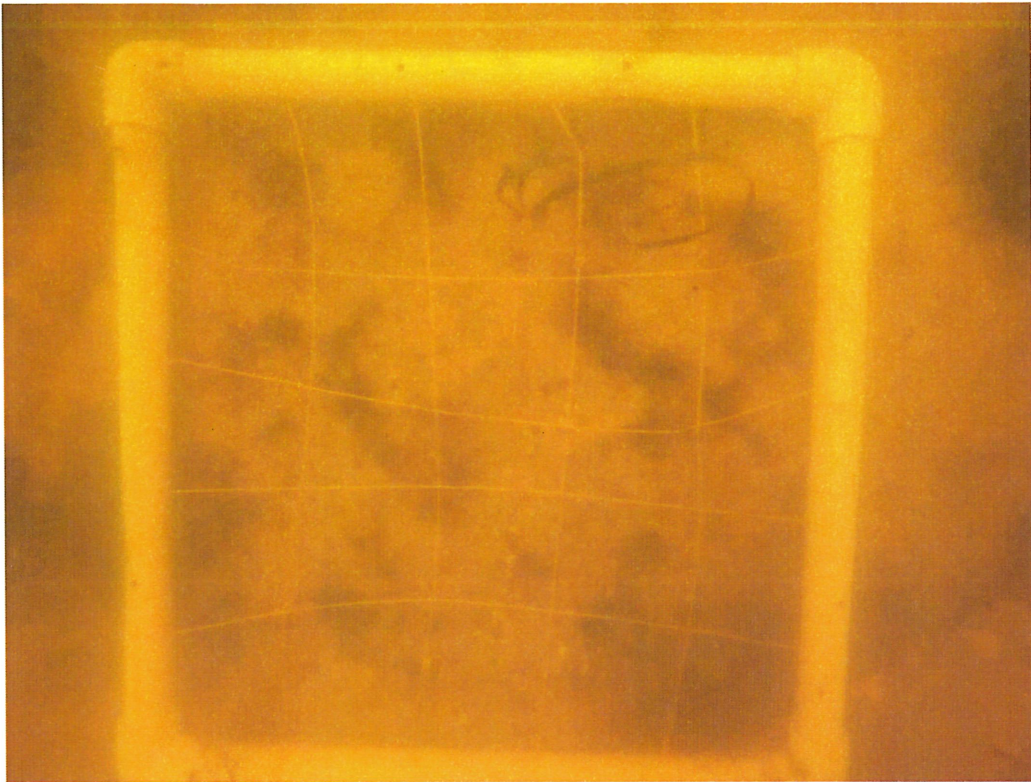
PHOTO 3: *Thalassia testudinum* MSS, 10/31/2023

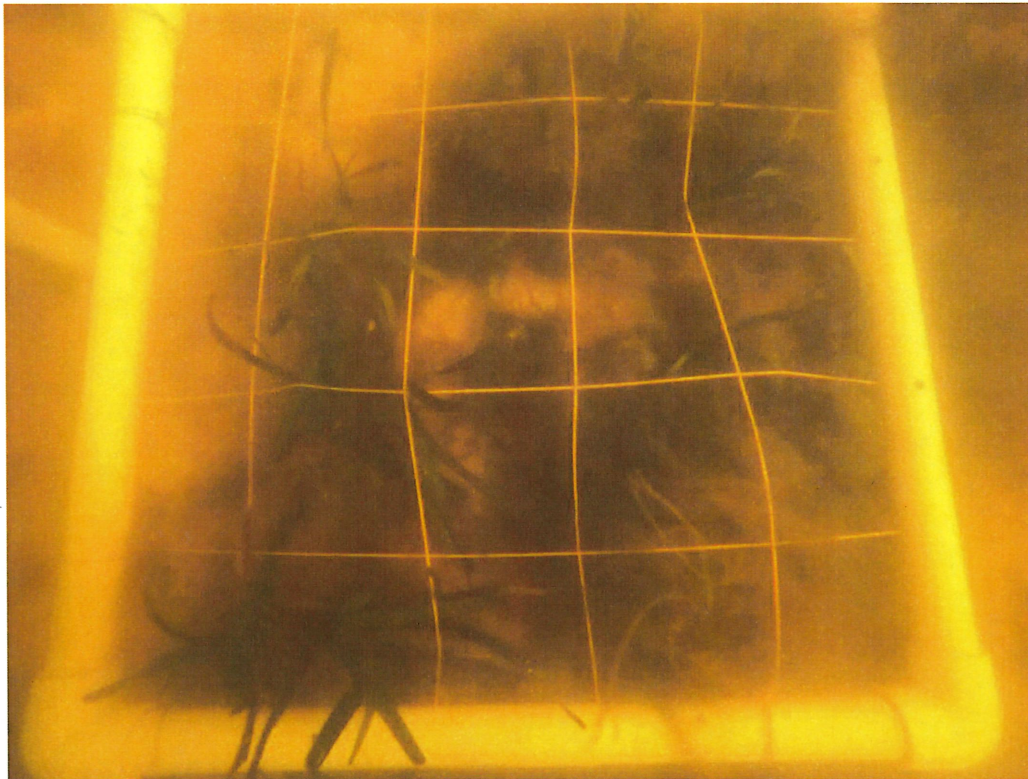
PHOTO 4: *Thalassia testudinum* and sparse drift algae MSS, 10/31/2023
