Charlotte County Utilities Department

2023 Annual Report

March 2024

Jones Edmunds Project No.: 03405-029-07

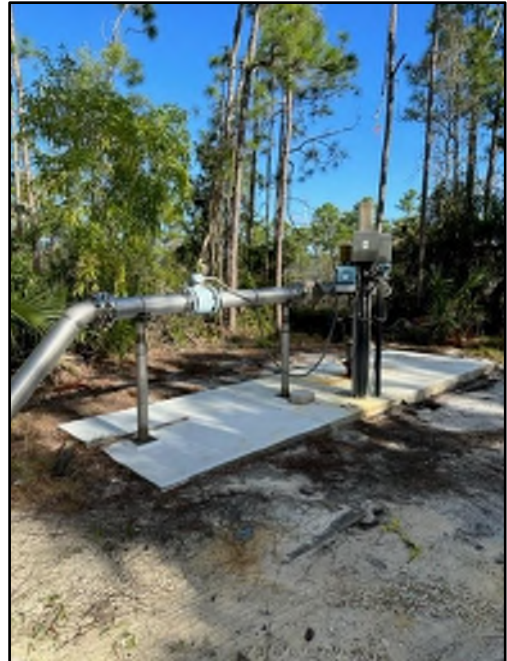
- Well No. 16 is a 12-inch-diameter well on the east side of the site. The well pump is in excellent condition.

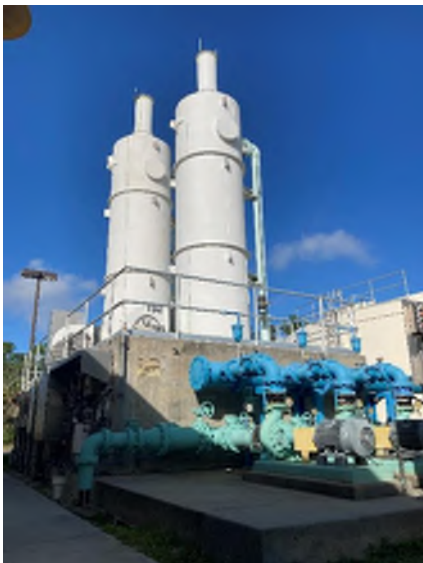
Hydrogen sulfide is removed from the RO permeate via packed-tower degasification. Three packed-tower degasification units with blowers are on top of the concrete clearwell and can be operated automatically or manually. The degasifier media was replaced in FY 2023. CCU should regularly exercise the isolation valves between the two clearwell tanks.

Degasified water is transferred from the clearwells to the GSTs by three horizontal centrifugal pumps. All three pumps are operational, but the operator noted that they struggle to pump against high head; therefore, the pumps should be serviced or replaced. The variable-frequency drives (VFDs) that control these pumps were replaced in FY 2023. Two in-line static mixers in the transfer pipe leading to the GSTs mix sodium hydroxide, corrosion inhibitor, and sodium hypochlorite. These injection points should be labeled. Air-release valves (ARVs) are also downstream of the pumps. We recommend that the pumps and piping be covered to prevent sun damage and to prolong the equipment life.

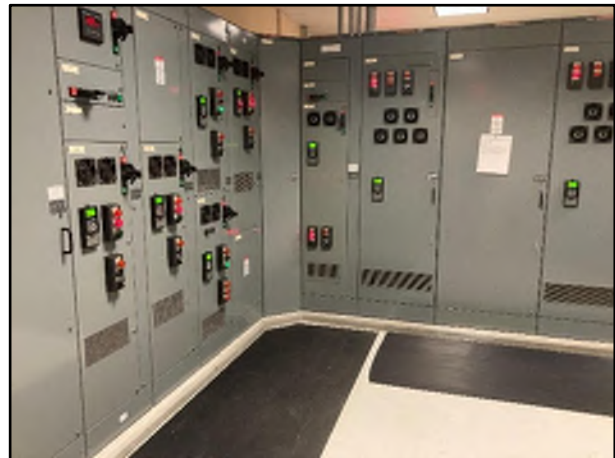
The main electrical components of this facility include the electrical components of the RO process buildings, one 1,250-kW standby generator, and two 80-kW portable generators. The distribution transformer, which provides power to the site, appears to be in good condition with no obvious signs of significant concern. CCU's Risk and Resilience Assessment (RRA) in 2020 recommended bollards be installed around the influent transformer box.

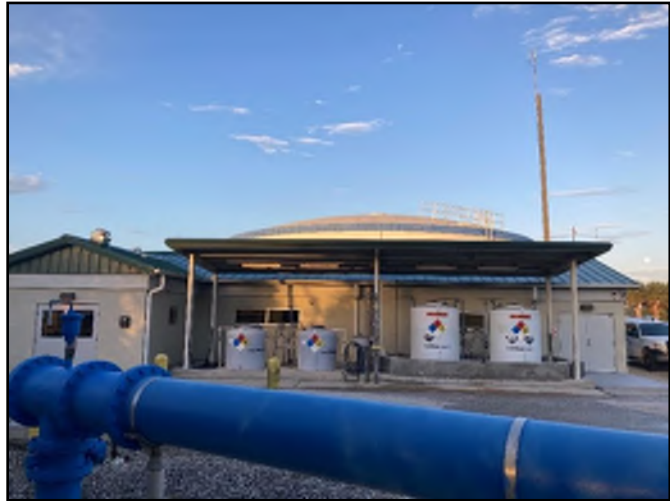
4.1.3.1 Port Charlotte Golf Course – WBS #2

- The computer inside the building is damaged from a water leak through the roof of the building.
- The lower portion of the ladder cage on the side of the aboveground storage tank is torn off and laying on the ground.
- The flow meter screens are damaged from sunlight exposure.
- The hazard warning labels on the diesel fuel tank is torn and illegible.
- Lights for the covered storage area are missing vapor covers and are exposed to the environment.
- The VFDs frequently fault-out when maintenance is performed on the generator set.

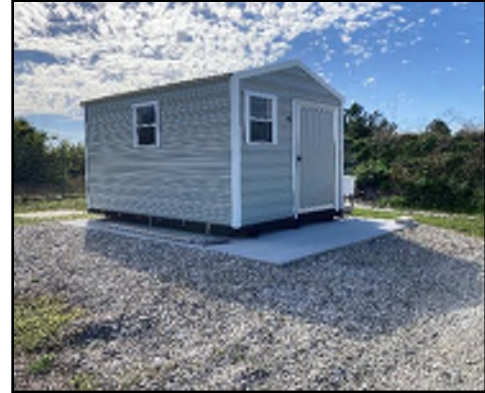
The station appears to be in fair condition. Roads and landscaping appear to be in good condition. Graveled areas around the facility infrastructure are free from weeds. The indoor buildings are kept clean, and tools and equipment are organized and stored properly. Operations staff is currently painting the wall that contains the human-machine interface (HMI) in the pump room. Hurricane Ian damaged the plumbing, waterlogged the roof of the building, and blew away the awning over the chemical storage tanks.

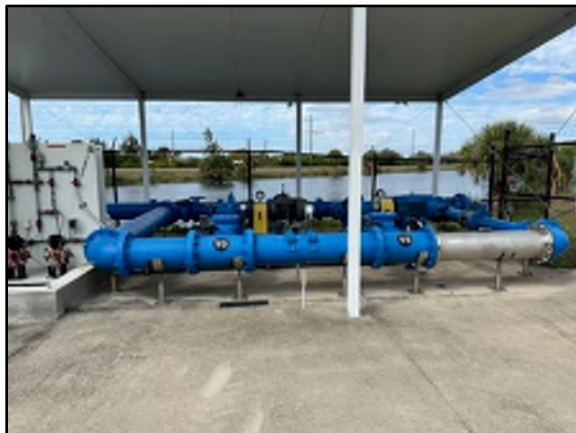
4.1.3.6 Englewood – WBS #8

Due to damage done by Hurricane Ian, the interconnect has not been in operation since the storm. The control panel was flooded, and evidence of a small electrical fire was present. The small office building used as an operator laboratory was blown away.

- The operator laboratory/office building is completely gone.
- The control panel is powered but shows signs of water damage and previous fire.
- Conduit to the control panel is rusted.
- The perimeter fence is damaged and needs repair.

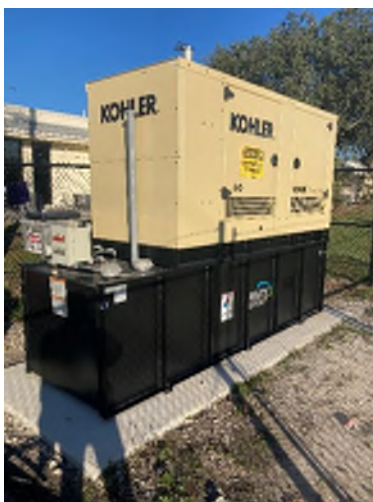
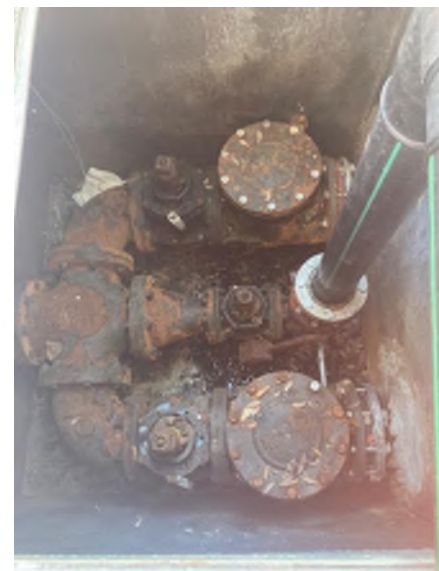
5.2.2 MASTER LS-309 BRIDGEWATER

The wetwell hatches are in good condition and provide adequate access to remove the pumps on the 2-inch cylindrical rail-retrieval system. Being last coated in the 1980s, the wetwell was in fair condition, exhibiting signs of corrosion. Two additional floats were installed in FY 2022 for additional redundancy and pump control. The discharge piping includes 8-inch Dezurik plug valves, 8-inch Kennedy check valves, and dedicated discharge in an underground concrete vault north of the wetwell. The pump discharge check valves are in poor condition due to wear, are sticking, and require repair and/or replacement. The operator noted replacement of check lever arms and valve reseating is planned to address the issue. In general, the piping and valves in the valve vault are showing signs of

corrosion. Additionally, the station currently has an above-grade bypass piping configuration installed to the dedicated discharge connection from the valve vault, with a camlock connection at the exterior fence line for access from the adjacent vacant lot.

A Siemens Whisper biological odor-control unit with a fan draws air from the wetwell and reduces the hydrogen sulfide odor generated. The unit includes a scrubber tower that uses water injection with nitrate and anti-algae additives. The station receives wastewater with long detention times in numerous tributary pumping stations. The concrete around the odor-control system is showing signs of significant concrete wear and cracks.

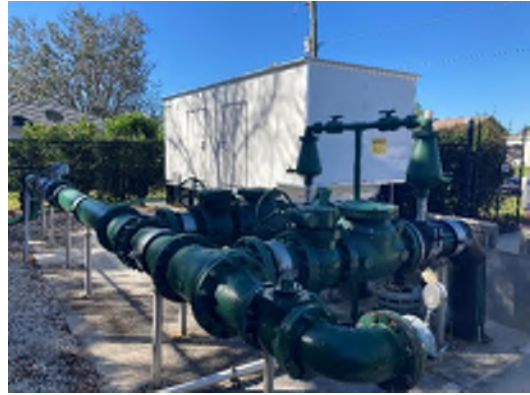
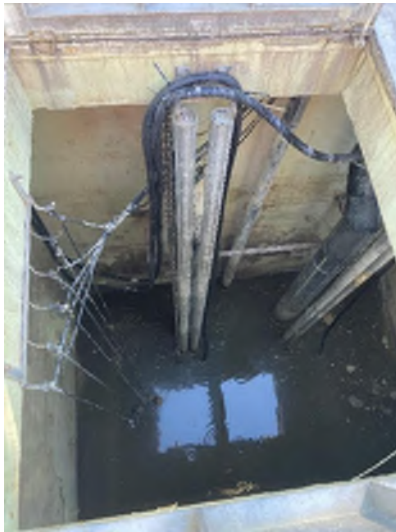
5.2.3 MASTER LS-321 ANGOL

The wetwell hatches are in good condition and provide adequate access to remove the pumps on the 3-inch cylindrical rail-retrieval system. The wetwell is lined in good-to-fair condition with early signs of corrosion. Two additional floats were installed as part of the station upgrades for additional redundancy and pump control. The dedicated suction and wetwell vent are showing signs of corrosion. The discharge piping is above grade and includes 10-inch Mueller plug valves, 10-inch Kennedy check valves, ARVs, and 6-inch dedicated discharge camlock connection. The discharge appurtenances are in good, operating condition. The discharge force main manifolds to a header where an abandoned flow meter is located.

The station has a hydrogen peroxide chemical injection system for odor-control purposes that has been removed from service and will not be used until further notice. However, a carbon filtration odor-control system still remains. The station is secured with a locked fence and barbed wire; damage to the barbed wire was noted at the time of the site visit. The station receives 480-volt, three-phase power service with a pole-mounted transformer. The control panel is equipped with seal-offs, and the station has a DFS Tac II TCU SCADA system with a telemetry transmitter/receiver. The station now contains a 200-kW Caterpillar generator rated at 250-kVA. It is mounted atop a 1,268-gallon diesel fuel tank that is tested every Monday to ensure the generator is in working condition. The station is equipped with potable water service and dedicated site lighting.

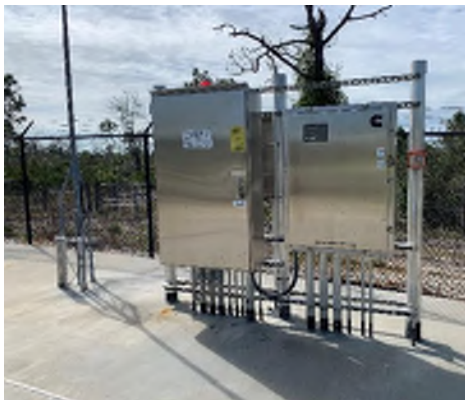
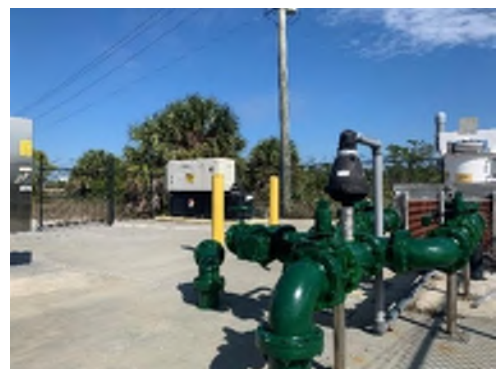
5.2.4 MASTER LS-815 "Z"

The wetwell hatch is in good condition and provides adequate access to remove the pumps on the 2-inch cylindrical rail-retrieval system. The wetwell is in good condition, exhibiting slight signs of grease with a total of five floats operating in the wetwell. A small crack in the concrete pad next to the wetwell suggests signs of settlement. The discharge piping includes 6-inch Dezurik plug valves, 6-inch Kennedy check valves, and dedicated discharge with a camlock connection. Adjacent to the aboveground discharge piping and valve assembly is the dedicated suction. The valve assembly is in good condition but showing slight signs of paint wear.

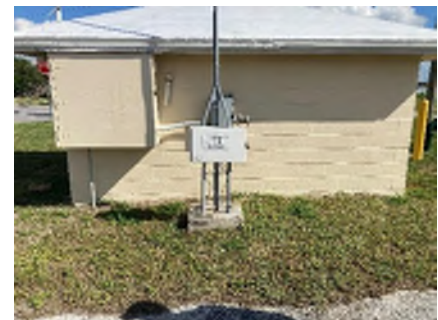
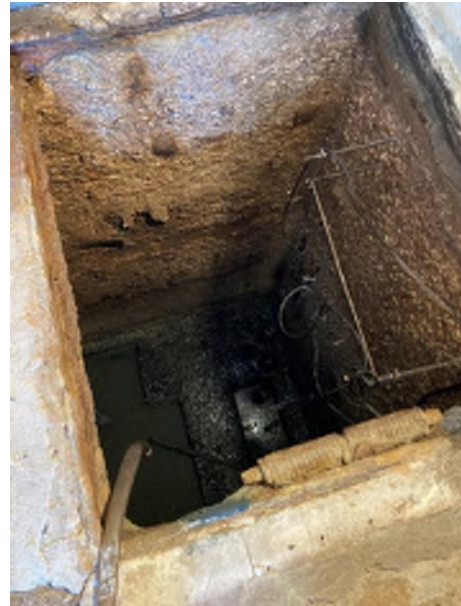
5.2.5.1 LS-1 Community Center

Originally built in 1959, LS-1 is housed in a concrete building on an open easement with no fencing. A large amount of insects, feces, and eggs were observed in and around the station. The wall of the structure contains visible cracks. This LS contains two above ground, self-priming, belt-driven pumps, one being a 15-HP Gorman-Rupp model T4A3-B and the other being an All Prime model XS-4. The original Gorman Rupp was installed, in 1980 and the All Prime was installed in 2022. The Gorman Rupp has an estimated capacity of 220 gpm at approximately 65 feet of head and

the All Prime has an estimated capacity of 440 gpm at approximately 28 feet of head. The 13-foot 9-inch deep, 7-foot by 6-foot rectangular wetwell interior shows signs of corrosion from hydrogen sulfide. The wetwell has no ventilation, so emitted gases are contained within the wetwell and the building. One of the wetwell hinges are separated from the wall. The 4-inch Dezurik plug valves and 4-inch ADF and Mueller check valves are located vertically above the pumps.

- The concrete building has cracks, including visible daylight through pipe penetrations.
- Signs of corrosion on the wetwell interior wall.
- An access hatch hinge is separated from the wall.
- Notable wear of paint on pumps and piping.
- Conduit running out of the top of the electric meter is no longer connected and exposed.

- Assuming the station will be completely replaced in the near future, the following improvements are recommended to the existing LS in the interim:
 - Seal cracks in building and gaps in pipe penetrations.
 - Evaluate the significance of the corrosion to wetwell.
 - Anchor the access hatch hinge back to the wall.
 - Paint the aboveground pump and discharge piping.
 - Restore and seal the conduit connection to the electric meter.

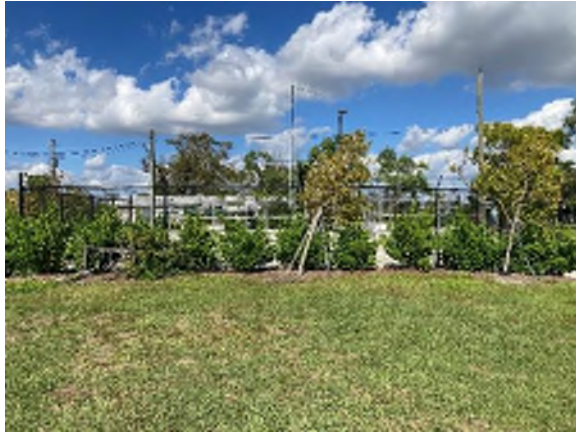
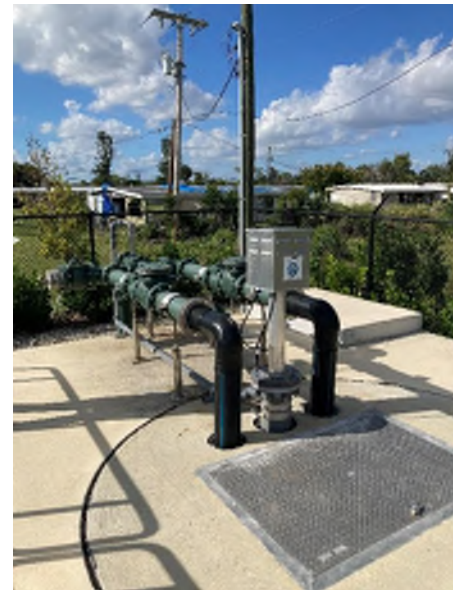
5.2.5.2 LS-2 Dalton

The lined concrete wetwell is in good condition with early signs of corrosion and is vented. The wetwell hatches are in good condition and provide adequate access to remove the pumps on the 2-inch cylindrical rail-retrieval system. The 6-inch Mueller plug valves, 6-inch Kennedy check valves, and dedicated suction and discharge connections are above grade, west of the wetwell and in good condition but showing early signs of paint wear.

- Evaluate need for painting discharge piping appurtenances.
- Evaluate need for barbed wire restoration.

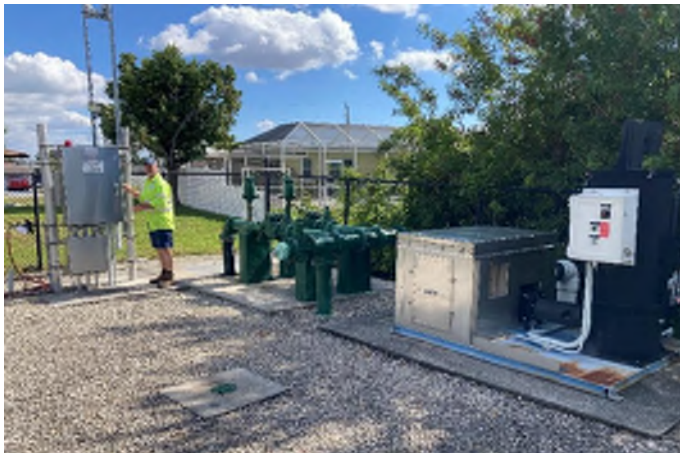
5.2.5.3 LS-6 Higgs

The station contains two 10-HP Flygt Model 3127 submersible pumps with 484-mm impellers in a 6-foot-diameter, 19-foot-11-inch-deep, lined concrete wetwell. Each pump has an estimated capacity of 369 gpm at approximately 46 feet of head (based on the County's drawdown reports). The pumps were noted as not having run times as long or as frequently as they have been experiencing in previous years. The wetwell lining is in good condition and appears to be largely unaffected by hydrogen sulfide. Cracking was notably present in the square formwork at the top of the well. The wetwell hatches are in good condition. Maintenance access is adequate for removal of the pumps from the 2-inch cylindrical rail-retrieval system. The discharge piping and valve assembly include 6-inch Dezurik plug valves, 6-inch Kennedy check valves, and dedicated discharge connection. The discharge piping appurtenances are in good condition but showing early signs of paint wear.

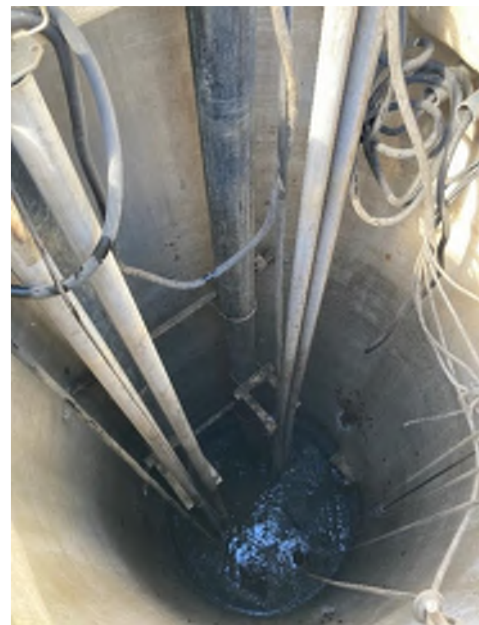
The station is fenced with barbed wire although small gaps were noted between the fence and gravel. Site lighting is limited to a single light mounted to the communications antennae tower. The station has a Siemens Carbon Adsorber odor-control system. The power service to the station is 240-volt, three-phase with a pole-mounted transformer northeast of the station outside of the fence. The control panel has seal-offs and is equipped with a portable generator receptacle with a mechanical interlock between the main breaker and generator breaker. The station has a DFS Tac II

- Adequate lighting is not available for evaluating the control panel or wetwell.
- Eroded rock base along southwest fence line has introduced a slip-and-fall hazard. Noticeable gaps are between the grade and the bottom of the fence in various locations.
- Slight paint wear on the discharge piping appurtenances.
- Cracking was observed in the square formwork at the top of the wetwell.

- Evaluate site lighting for lift station employee serviceability.
- Re-establish level grade along southwest fence line and along perimeter fence line.
- Evaluate need for painting discharge piping appurtenances.
- Evaluate significance of cracks in concrete formwork at the top of the wetwell.

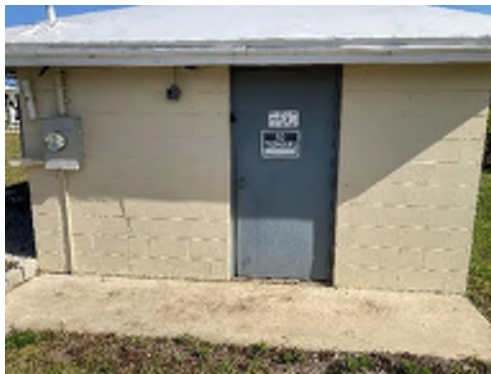
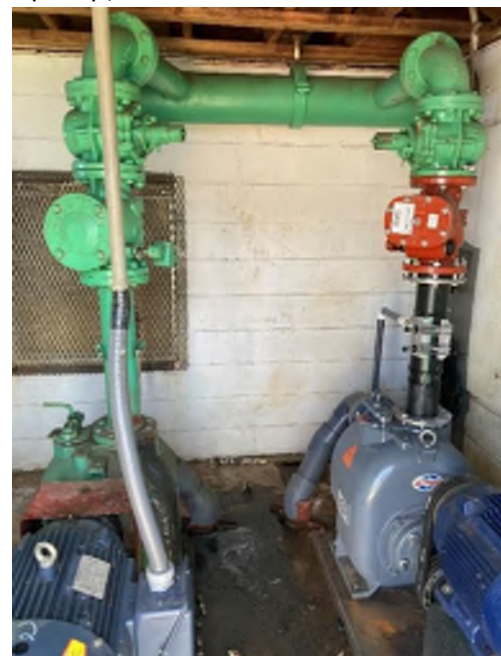
5.2.5.4 LS-7 Pure Oil

The station is housed in a concrete building and has a plastic-wrapped roof that is pending roof repairs from damage reported as a result of Hurricane Ian. The station contains two above ground, self-priming, belt-driven 20-HP pumps; one is a Gorman-Rupp model T4A3B pump, and the other is an All Prime model XS-4. The motor and pump for the All Prime configuration have both been replaced recently. The pumps have an estimated capacity of 440 gpm at approximately 50 feet of head. The All Prime discharge was revamped with new 4-inch HDPE and a 4-inch American Flow Control swing check valve with the existing 4-inch Dezurik plug valve. The existing Gorman Rupp discharge has a 4-inch Kennedy check valve and a 4-inch Dezurik plug valve. The Gorman Rupp pump and related discharge piping is showing signs of corrosion. The 12-foot-8-inch-deep, 6-foot-by-13-foot-diameter concrete wetwell is corroded by years of hydrogen sulfide exposure, and metal reinforcement is exposed near the access hatch. The wetwell has an older trough design and is not vented. The station has no odor-control and no dedicated well suction bypass piping, although a circular penetration in the wall directly above the

wetwell cover is available for pump trucks to access. A portable pump connection is in a valve box outside the building. The space inside the building is exposed to sewer gases because access for the wetwell entry and float switches are open holes in the floor of the building.

Power service to the station is 230-volt, three-phase, and a pole-mounted transformer directly west feeds the station. The main control panel is housed in a wooden box mounted outside the building. The station does not include seal-offs on the conduit but does have a mechanical interlock and a portable generator receptacle with a manual transfer switch that was added in recent years. The station has a DFS Tac II SCADA system with a telemetry transmitter/receiver. Surge protection is provided for SCADA but not for the control panel. Additionally, the surge protection equipment at the telemetry unit is dated; CCU should consider replacement in accordance with current CCU standard LS equipment.

The station is not fenced, and metal reinforcement had to be installed behind the vented window after the plexiglass panels were broken by vandals. The building door and panels are typically locked, and the station has inadequate indoor hang lighting. The County's easement to access the station only extends 10 to 15 feet from the curb and is mostly obstructed with multiple electrical power poles that provide overhead electric. The County currently accesses the station through the parking lot of the adjacent gas station; however, the employee parking, a parked food truck, and a dumpster often partially block this access. Additionally, the nearby overhead power lines present potential danger to County staff when operating a crane truck in this area. A large number of insects was observed at the lift station along with insect feces and eggs inside the control panel box and around the lift station site. The station is equipped with potable water service.

- Missing seal-offs from the control panel conduit.
- Obstructed access for a crane truck.
- Existing aerial power supply.
- Corrosion on Gorman Rupp pump.
- Outdated and lack of surge protection observed.
- Inadequate indoor lighting.
- Float terminal blocks are exposed.

- Evaluate replacement of this station to meet current CCU standards. A replacement lift station should also provide the following to address current deficiencies:
 - CCU standard lift station design for new wetwell and new discharge piping and appurtenances.
 - Electrical controls and panel features to meet CCU standards and electrical codes including outdoor-rated panel, phase monitors, SPD, and seal-offs.
 - SCADA integration.
 - Permanent security fencing to prevent unwanted access and dedicated site lighting for accessibility and safety.
 - Potable water service.

- Assuming the station will be completely replaced in the near future, the following improvements are recommended to the existing LS in the interim:
 - Install seal-offs on any electrical equipment within 10 feet of the wetwell to conform with current codes.
 - Evaluate possibilities for a dedicated access to the station.
 - Evaluate switching to underground power supply.
 - Evaluate the significance of the corrosion on the Gorman Rupp pump.
 - Install new and/or up to date SPDs to protect the pumps and SCADA system.
 - Install proper indoor lighting.
 - Rehabilitate float terminal blocks to meet NEC codes.

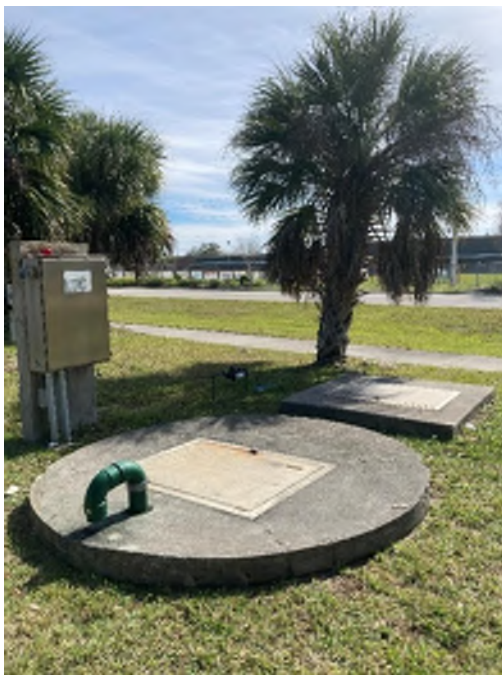
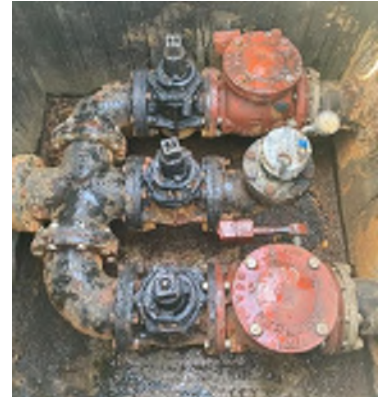
5.2.5.5 LS-19 Port Charlotte High School

LS-19 contains two 20-HP Flygt pumps model CP3152 with 454-mm impellers. Each pump has an estimated capacity of 908 gpm at 70 feet of head. These pumps are submerged in a 20-foot-7-inch deep and 8-foot diameter lined concrete wetwell. The wetwell contains four floats and is showing signs of corrosion. The valve vault is in fair condition and contains corroded ductile iron piping, 6-inch Dezurik plug valves, 6-inch Kennedy check valves, and dedicated discharge.

LS-19 receives 480-volt, three-phase power with a pole-mounted transformer. LS-19 does not include a fence and lock, dedicated site lighting, or an odor-control system. The hatches are in good condition but showing signs of corrosion and have a 2-inch cylindrical rail-retrieval system. The PVC vent appears to be held together by duct tape. The control panel does not have seal offs or SCADA present but does include a portable generator receptacle and mechanical interlock between the generator and main breaker. The station is equipped with an outdated SPD. While on site, an unfamiliar white waste was observed entering the wetwell from the invert to the northwest. The station is equipped with potable water service.

- Surficial corrosion to valve vault and fittings within the vault.
- Missing seal-offs from the control panel conduit.
- Wetwell vent is held together by duct tape.
- Outdated SPD.

- Evaluate the significance of the corrosion of the piping and fittings within the valve vault.
- Install seal-offs on any electrical equipment within 10 feet of the wetwell to conform with current codes.
- Repair or replace the vent piping.
- Install new and/or up-to-date surge protection device (SPDs) to protect the pumps and SCADA system.

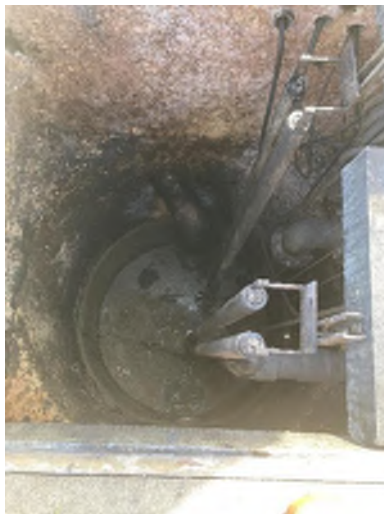
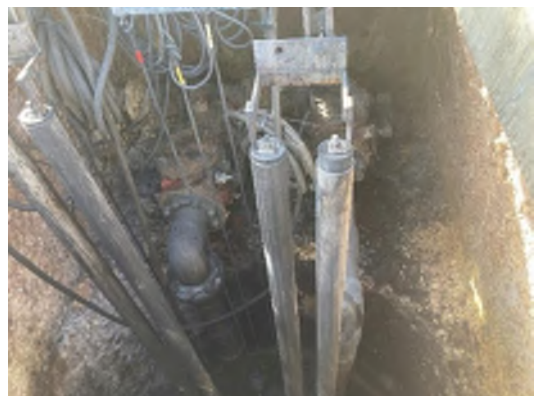
5.2.5.6 LS-24 Charlotte Square

LS-24 contains two 3-HP ShinMaywa 4CNWX42.2T2E submersible pumps inside a lined concrete 6-foot-diameter, 14-foot-10-inch deep wetwell. Each pump has an estimated capacity of 100 gpm at 47 feet of head. The wetwell is heavily corroded, and the lining is separated from the wall in some places. A strong hydrogen sulfur odor is prevalent. Additionally, the surface of the liquid in the well shows some signs of grease. The station is equipped with a 2-inch cylindrical rail-retrieval system. The wetwell is an older design in which the valve vault is not separated by a wall and is instead a shelf built into the side of the wetwell (shown in photograph below). This design can be dangerous to operators who need access during high-water levels in addition to confined space issues and sulfide exposure. LS-24 can

experience flash flooding. The heavily corroded 4-inch Dezurik plug valves and 4-inch Kennedy check valves are on this shelf.

The site is not fenced in and has a large buildup of debris and trash from surrounding businesses. Additionally, the site does not have dedicated site lighting or an odor-control system. The wetwell hatch is in good condition and padlocked for safety. The valve vault hatch is a detachable cover secured by four bolts and nuts, which hinders accessibility, as opposed to the traditional hinged hatch design with handle. The power service to the station is 208-volt, three-phase with a pad-mounted transformer just south of the wetwell. The station has a DFS Tac II SCADA system with a telemetry transmitter/receiver. The control panel does not have seal-offs but is equipped with a portable generator receptacle, and a mechanical interlock is between the generator and main breaker. The station is equipped with potable water service.

- Heavy corrosion of the lined concrete wetwell and equipment.
- Flooding events during heavy rainfall in short periods (flash flooding).
- The valves are on an adjacent shelf at the top of the wetwell without dedicated discharge.
- Missing seal-offs from the control panel conduit.
- Missing dedicated site lighting.

- Evaluate the wetwell for potential structural repair and restoration of wetwell lining.
- Evaluate sealing the wetwell and/or raising the wetwell elevation to avoid I/I.
- Evaluate the construction of a separate, isolated valve vault for operator safety, including standard dedicated discharge.
- Install seal-offs on any electrical equipment within 10 feet of the wetwell to conform with current codes.
- Evaluate incorporating dedicated lift station lighting.

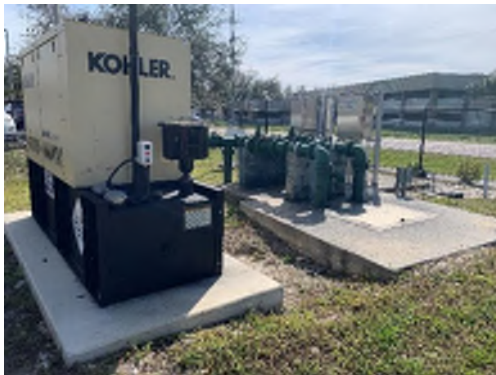
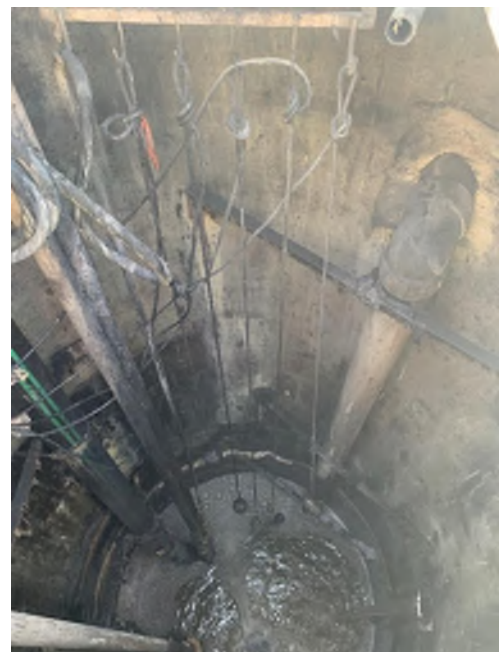
5.2.5.7 LS-25 Vo-Tech

The Vo-Tech LS includes two 10-hp Flygt submersible pumps. Pump No. 1, installed in 2001, is a model NP3127.180 with 484-mm impeller. Pump No. 2, installed in approximately 2021, is a model NP3127.060 with a 489-mm impeller. Each pump has an estimated capacity of 238 gpm at 46 feet of head. The pumps are housed in a lined concrete 8-foot-diameter, 18-1/2-foot-deep wetwell. The overall condition of the wetwell was good, with early signs of corrosion and grease buildup. The wetwell hatch was observed as being in good condition and includes a 2-inch cylindrical rail-retrieval system. Each pump discharges through a 6-inch-diameter above-ground piping configuration, which includes a 6-inch Dezurik plug valve and a 6-inch AFC flapper-style check valve. Slight corrosion was noted on the exterior of the valve bodies. The AFC check valves were reported as functional by the operator; however, this equipment is

outdated, and only a few similar models exist at County LSs today, making availability of parts and maintenance experience limited.

- Lined concrete wetwell is showing early signs of corrosion.
- Grade settlement observed near generator and between discharge piping and generator.
- Potentially crushed invert east of the wetwell.
- Missing ARVs on the discharge piping.
- Conduit and rebar protruding through the grade.
- Antiquated check valves.
- Missing SPD.

- Evaluate the significance of the wetwell corrosion.
- Evaluate potential solutions to grade settlement to re-establish grade near the generator and between discharge piping and generator to original condition.
- Evaluate the invert east of the wetwell.
- Replace the removed ARVs on the discharge piping.
- Remove the conduit and rebar protruding through the grade.
- Replace the check valves with those specified in CCU standards.
- Install new and/or up-to-date SPDs to protect the pumps and SCADA system.

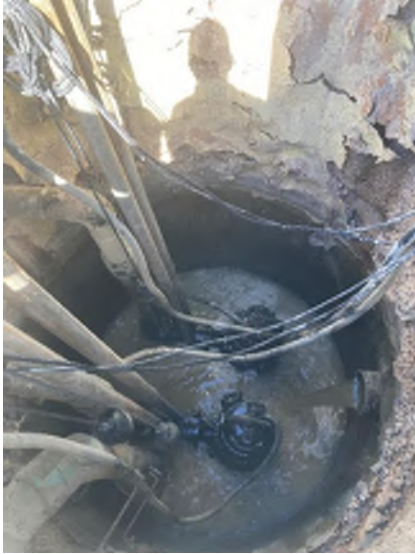
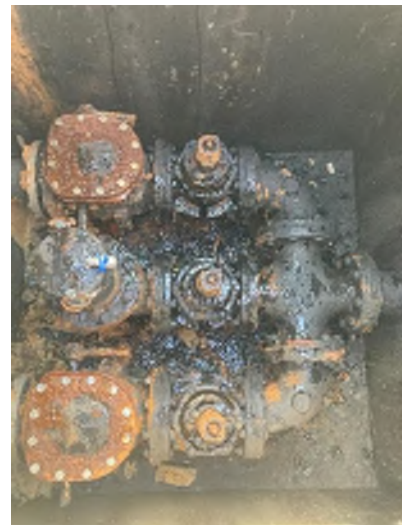
The lift station contains two 20-HP Flygt model CP 3152 submersible pumps with 454-mm impellers; one of the pumps is not seated correctly and is experiencing blowback. The pumps are submerged in a 6-foot-diameter, 10-foot-2-inch-deep wetwell. Each pump has an estimated capacity of 454 gpm at approximately 45 feet of head.

The wetwell is extremely corroded with cracks along the lining of the wall, and lining separation from the wall. The wetwell hatch is in good condition and provides adequate access to remove the pumps along the 2-inch cylindrical rail-retrieval system. The wetwell is vented but a strong odor was present at the time of the site visit. The adjacent lined valve vault includes 4-inch ductile iron discharge piping, Dezurik plug valves, and Mueller check valves with a dedicated discharge. Heavy corrosion is evident within the vault, particularly on the check valves. The hatch of the valve vault is in good condition.

The power service to the station is 230-volt, three-phase, with a pole-mounted transformer. The control panel has seal-offs although becoming corroded likely due to the high exposure to hydrogen sulfide and is equipped with a portable generator receptacle. The station did not appear to have a mechanical interlock. The station has a DFS Tac II SCADA system with a telemetry transmitter/receiver.

The site has barbed-wire fencing. The overall condition of the fencing is fair; the fence is showing signs of corrosion, some barbed wire disconnects occur, and a gap between the gravel and the bottom of the fence creates easy access for small animals. The only access to the lift station is across the sidewalk through the school entrance, which does not allow vehicular access. The station is equipped with potable water service. The station does not have dedicated site lighting.

- Wetwell has severe lining peeling and corrosion.
- Piping, check, and plug valves in the vault are heavily corroded.
- Being next to the school makes access difficult during peak school traffic.
- Fence is corroding at brackets and hinges, has barbed wire damage, and has gaps between grade and fence line.
- Blowbacks from the pump.
- Strong hydrogen sulfide odor from wetwell.
- Seal-offs are corroded.
- Missing dedicated site lighting.

- Evaluate and perform full replacement of wetwell, valve vault, and associated appurtenances to meet CCU standards.
- Evaluate the significance of the corrosion on fittings within valve vault.
- Evaluate incorporating dedicated access for operations staff.
- Restore corroded fence materials and repair the fence damage. Re-establish the grade between the fence and gravel.
- Re-establish the pump to its original seating to prevent blowback.
- Evaluate the addition of an odor-control system.
- Replace the seal-offs on the control panel due to heavy corrosion and immense sulfide odor.
- Evaluate incorporating dedicated lift station lighting.

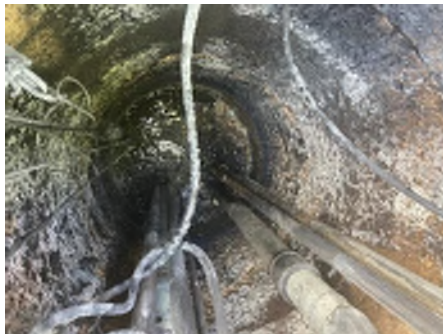
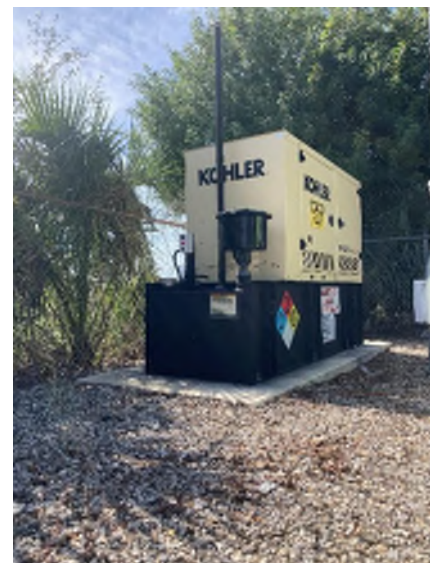
5.2.5.9 LS-45 Woodbury

LS-45 contains two 10-HP Flygt pumps. Pump No. 1 was replaced in 2023 and is a model NP 3127 submersible pump with 438-mm impeller, whereas Pump No. 2 is the model CP 3127 with a 432-mm impeller. The pumps are installed in a 6-foot-diameter, 18-foot-3-inch-deep, lined concrete wetwell. Each pump has an estimated capacity of 176 gpm at approximately 24 feet of head. The wetwell interior is in fair condition, showing signs of corrosion and early structural degradation and has a strong odor. The station is equipped with a 2-inch cylindrical rail-retrieval system. The station has a dedicated discharge in the valve vault that also houses a 6-inch AFC plug valve and 6-inch Mueller check valve, which is missing or has a damaged swing mechanism. The concrete valve vault is in good condition, but debris is beginning to accumulate on the bottom surface.

The site is completely fenced, showing minor signs of corrosion and damage. The site does not have dedicated lighting or an odor-control system. The power service at the station is 480 volts, three-phase, with a pole-mounted transformer across street from the station. The station has a DFS Tac II SCADA system with a telemetry transmitter/receiver. The control panel is equipped with a mechanical interlock and a portable generator receptacle that is no longer necessary due to the recently installed 42-kW, 52.5-kVA, 279-gallon, Kohler diesel generator. The existing concrete support for the control panel, power feed, and main disconnect is visibly cracking and contains a hollow portion. The station is equipped with potable water service.

- Missing seal-offs from the control panel conduit.
- Strong hydrogen sulfide odor from wetwell.
- Broken invert between the LS and manhole to the immediate east (on Woodbury Drive). The operator reported repairs to the invert and/or manhole are pending through CCU.
- The fence and barbed wire are showing signs of corrosion and have some damage.
- Missing or damaged swing mechanism for the check valve.
- Wetwell is showing signs of corrosion.
- Outdated SPD.
- Missing dedicated site lighting.
- Support for control panel, power feed, and main disconnect is damaged.

- Install seal-offs on any electrical equipment within 10 feet of the wetwell to return to conformance with current electrical codes.
- Evaluate the addition an odor-control system.
- Evaluate and complete rehabilitation of the invert and/or manhole to immediate east to restore normal operating conditions.
- Replace corroded fence materials. Repair fence and barbed wire damage.
- Rehabilitate or replace check valve.
- Evaluate the significance of the wetwell corrosion.
- Install new and/or up-to-date surge protection device (SPDs) to protect the pumps and SCADA system.
- Evaluate incorporating dedicated lift station lighting.
- Evaluate the damaged electrical support for repair or replacement.

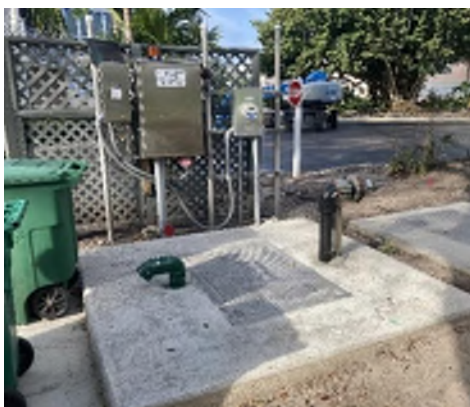
5.2.5.10 LS-809 Placida Harbour

The station contains two 7.5-HP ShinMaywa model 4CNWX45.512E submersible pumps inside a 6-foot-diameter, 20-foot-8-inch deep concrete wetwell. Each pump has an estimated capacity of 254 gpm at approximately 44 feet of head. The wetwell, floats, pumps, discharge piping, valves, and electrical equipment were upgraded in the early 2020s and are now in excellent condition. The station is equipped with a 2-inch cylindrical rail-retrieval system. The valve vault is adjacent to the wetwell, containing two 6-inch Dezurik plug valves and two 6-inch Kennedy check valves. The valve vault is in fair condition with sediment and debris built up at the bottom.

- Missing seal-offs from the control panel conduit. This represents a significant code violation as well as a potential explosion hazard.
- Missing battery backup for the Omni Beacon telemetry.
- Poor lift station access.
- Missing potable water service near the station.
- Missing dedicated site lighting.

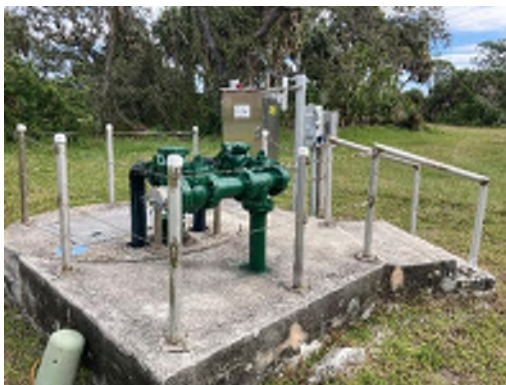
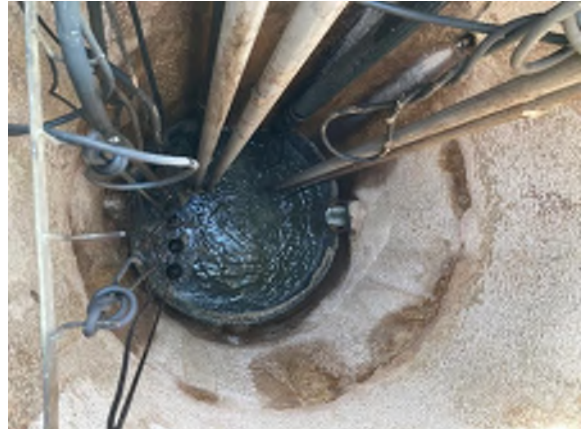
5.2.5.11 LS-812 Annapolis

- Missing seal-offs from the control panel conduit. This represents a significant code violation as well as a potential explosion hazard.
- Poor lift station access.
- Missing potable water service near the station.
- Missing SCADA system.
- Wetwell is cracking and leaking.
- Wetwell is showing signs of corrosion.
- Missing dedicated site lighting.

- Install seal-offs on any electrical equipment within 10 feet of the wetwell to return to conformance with current electrical codes.
- Evaluate incorporating dedicated access for the Operations staff.
- Evaluate incorporating a water service connection near the station.
- Evaluate the addition of a SCADA system.
- Seal cracks and leaks in wetwell.
- Evaluate the significance of wetwell corrosion.
- Evaluate incorporating dedicated lift station lighting.

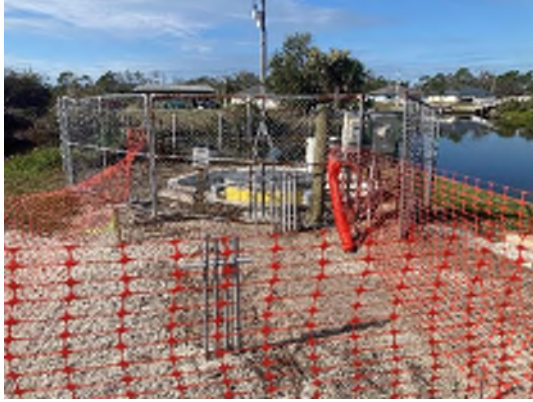
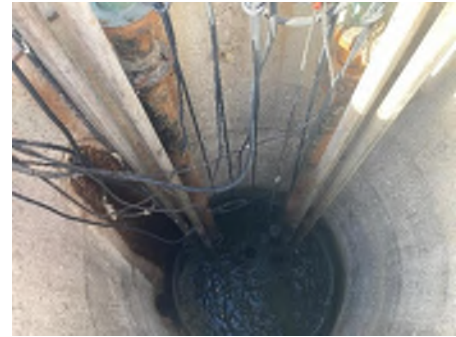
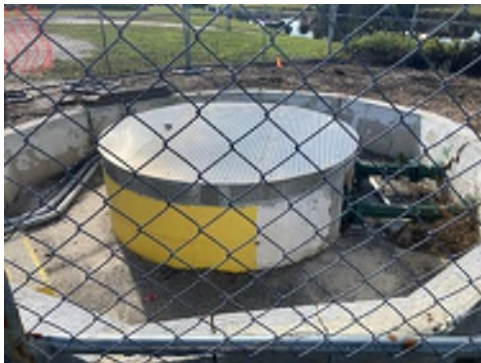
5.2.5.12 LS-813 Marina

This station was significantly damaged during Hurricane Ian in September 2022; the pump housing building was uplifted and carried away, leaving the wetwell temporarily exposed. The County addressed the exposed open top of the wetwell by retrofitting a concrete flat top with a lockable vault hatch, as can be seen in the site photographs. The County is actively rehabilitating the station, inclusive of new electrical, security fencing, and installation of a permanent on-site generator. Temporary security fencing is provided

- Missing dedicated lighting.
- Significant corrosion to dedicated discharge bypass piping and associated plug valve. The plug valve was installed with blue paint, representative of potable water; the fitting paint should instead be green, representative of sewer force main.
- The wetwell is exposed near the discharge piping, posing a safety risk.

- Missing seal-offs from the control panel conduit.
- The lift station building was demolished, and a temporary fence was erected in place of it.
- Mechanical interlock was secured to the dead front instead of behind it, allowing the potential for it to be overridden.
- Missing potable water service near the station.

- The County is actively undergoing a rehabilitation project which includes installation of a permanent on-site generator. The rehabilitation should provide the following in general to address the identified deficiencies:

- SCADA integration.
 - Potable water service.
- Secure the mechanical interlock behind the dead front between the generator and the main breaker.
- Complete surface preparation to remove rust and excess paint and apply standard green paint to dedicated discharge main and plug valve.

- Repair wetwell gaps to eliminate access gaps and excess I/I to the LS. Incorporate drainage provisions as necessary to appropriately capture and divert surface runoff to avoid and prevent flooding.

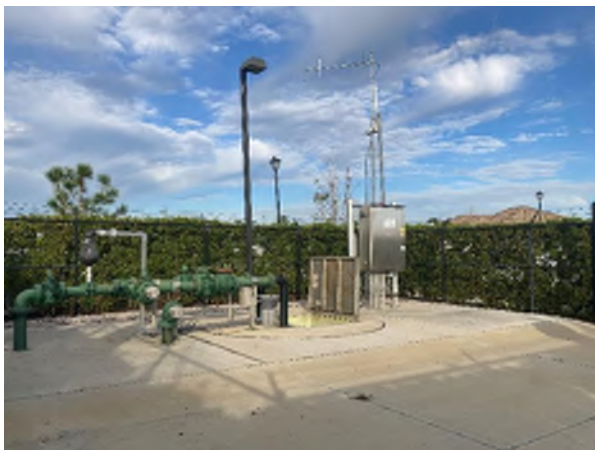
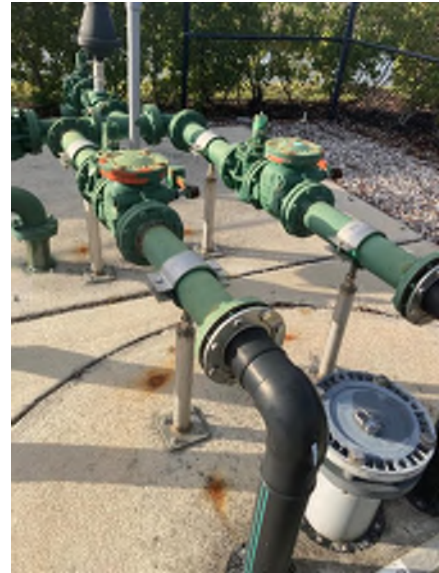
5.2.5.13 LS-818 Harbor West

- Paint chipping and slight corrosion on the discharge piping and appurtenances.

- Evaluate the need for painting the discharge piping appurtenances.

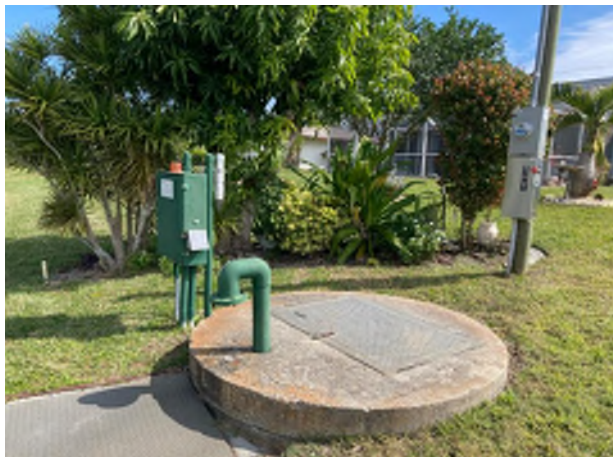
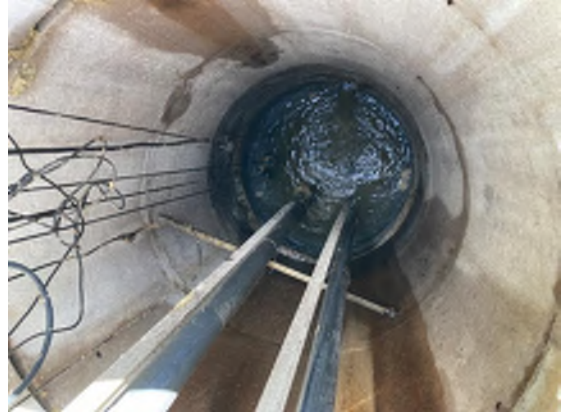
5.2.5.14 LS-819 Rotonda Circle #1

- The wetwell is showing signs of I/I into the wetwell due to gaps between wetwell section rings and cracks in the interior wall; the liner is no longer visible.
- Corrosion of discharge piping and valves.
- Outdated valve vault cover with accessibility issues.
- Outdated control panel without seal-offs.
- Missing SCADA system.
- Missing site lighting and security.
- Missing potable water service.

- Evaluate replacement of this station to meet current CCU standards and to relocate it away from the waterway. The County owns a nearby empty lot at 261 Bunker Road that should be evaluated. A replacement lift station should also provide the following to address current deficiencies:

- Assuming the station will be completely replaced in the near future, the following improvements are recommended to the existing LS in the interim:
 - Seal and re-line the wetwell to reduce excess I/I and prevent degradation of interior wetwell.

- Evaluate the significance of corrosion to the discharge valves.
 - Install an on-site communications system and integrate the existing LS to SCADA.

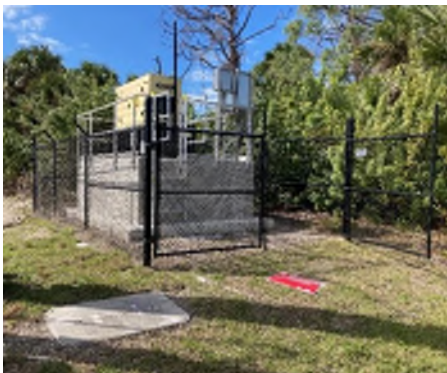
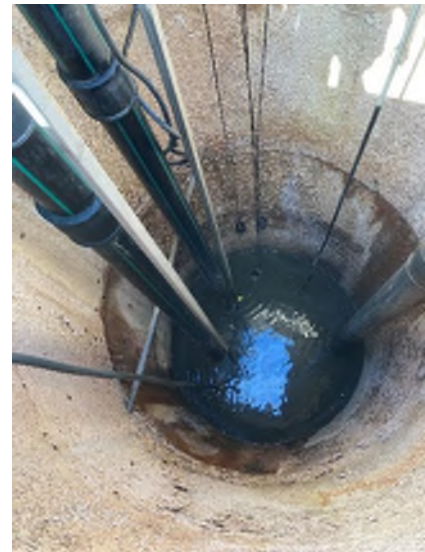
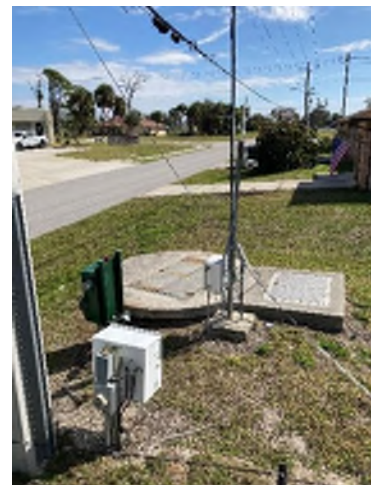
5.2.5.15 LS-821 Rebel Court

- Missing seal-offs from the control panel conduit.
- Erosion around wetwell lid.
- Signs of I/I into the wetwell due to gaps between wetwell section rings. The wetwell is showing signs of degradation due to lack of liner.
- Corrosion of valves in valve vault.
- Corrosion of wetwell hatch.
- Corrosion of discharge bypass camlock connection.
- Outdated SPD.
- Missing dedicated site lighting.

- Install seal-offs on any electrical equipment within 10 feet of the wetwell and perform a detailed electrical code review to return to conformance with current electrical codes.
- Re-establish grade around the wetwell lid.
- Evaluate the significance of the degradation of wetwell and relining of wetwell.
- Evaluate the significance of corrosion on the valves in valve vault.
- Evaluate the integrity of the wetwell hatch.
- Rehabilitate or replace camlock connection.

- Install new and/or up-to-date SPDs to protect the pumps and SCADA system.
- Evaluate incorporating dedicated lift station lighting.

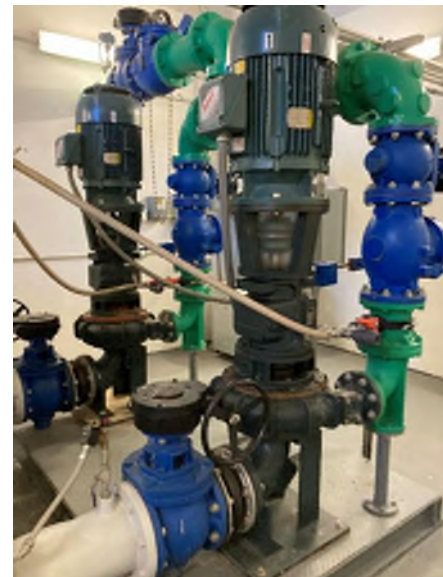
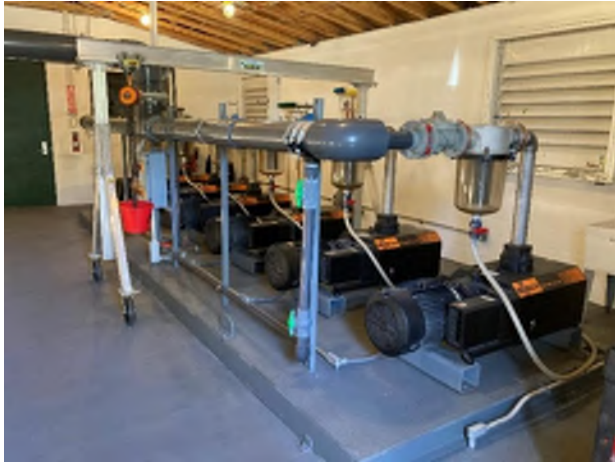
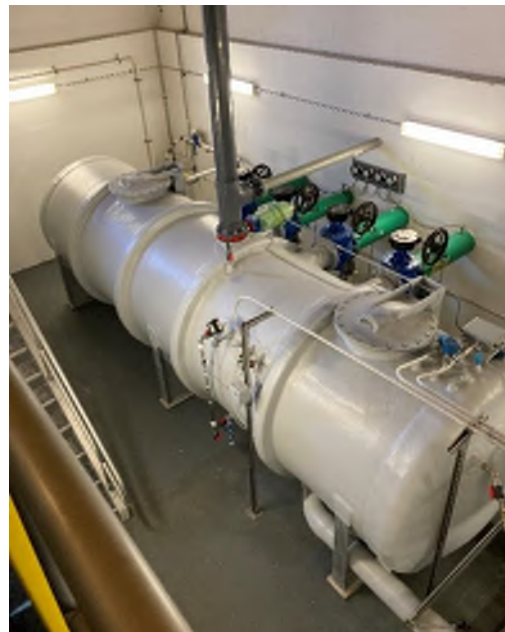
- The crane pump on site is not aligned with the valves. Some of the valves are below the common discharge line and meter, making them difficult to access with the crane.
- The access for tank maintenance is at the top of the tank without a dedicated access point.
- Plastic covers for the effluent pump motor components are missing or broken.
- Mulch bed deficiencies include:
 - Strong odor from the mulch bed.
 - Overall color of mulch appeared faded, suggesting mulch is near end of useful life.
 - Well casing PVC is melted.
 - Open exposure of odor piping in the mulch bed allowing odor to dissipate directly into open atmosphere.
 - 4-inch Dezurik check valves are corroding.
- Poor interior lighting due to repairs from Hurricane Ian.
- Poor drainage in the vacuum tank pit.
- Missing discharge flow meter.

- Evaluate modifying the overhead crane for lateral movement.
- Evaluate adding a catwalk for accessing the top of the tank for maintenance.
- Evaluate replacing the check valve with CCU standard check valves.
- Replace the plastic covers for the pump motor components.
- Evaluate a full rehabilitation of the mulch bed odor-control to mitigate deficiencies listed above.
- Evaluate lighting improvements for operators like the lighting at Ackerman, VS-4.
- Evaluate solutions to address poor drainage to achieve better drainage, such as at Harbor, VS-2.
- Evaluate installation of a discharge flow meter.

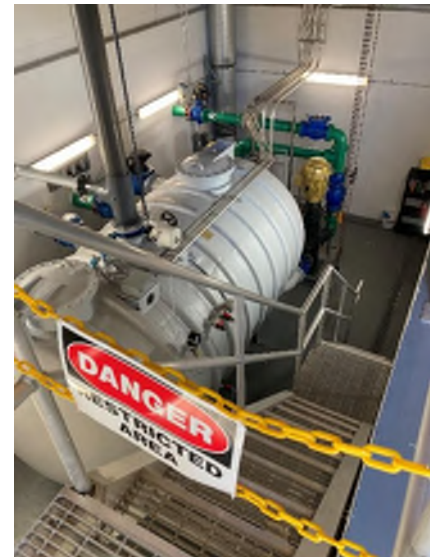
A 5,000-gallon Duratech Vacuum Tank in the lower level of the building has a design pressure of 5 psi. A feasible way to access the equipment on top of the tank to maintain and clean the equipment was not apparent. Access to the lower level is by a stairwell. CCU added a hazard sign near the stairwell to prevent entry by unauthorized personnel. Three 15-HP Busch Mink Model MM 1502 AV vacuum pumps force flows into the vacuum tank; room is available for a fourth pump for future flows. The operators noted that the pumps skids continually rust and routine painting is needed to maintain the appearance. The operators also pointed out that the seals of the moisture separators on the vacuum pumps are beginning to corrode.

- Evaluate modifying the overhead crane for lateral movement.
- Evaluate adding a catwalk for accessing the top of the tank for maintenance.
- Evaluate long-term solutions to pump skid rusting.
- Evaluate replacing corroded seals on moisture separators.
- Evaluate lighting improvements for operators like those at Ackerman VS-4.
- Evaluate security improvements for better monitoring (i.e., cameras, etc.).

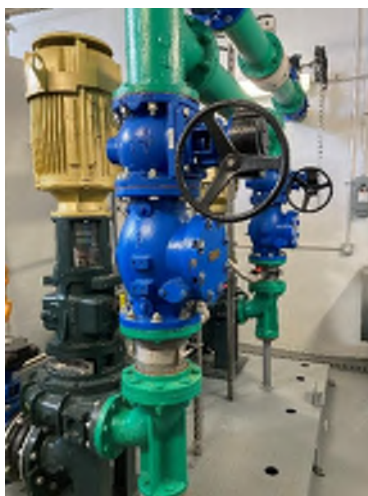
The building contains a dedicated pump crane for removal of pumps and valves from the lower level; however, the crane is not aligned with the pumps or the valves. The discharge isolation valves are overhead and difficult to remove with the dedicated overhead crane in the building.

- The pump crane on site is not aligned with the pump or the valves. Some of the valves are below the common discharge line and meter, making them difficult to access with the crane.
- The tank maintenance access is at the top of the tank without a dedicated access point.
- The pump skid continuously rusts.
- The moisture separator seals are beginning to corrode.
- Poor interior lighting due to repairs from Hurricane Ian.
- Reported issues of unauthorized personnel being near the site.
