Charlotte County Utilities Department

2023 Annual Report

March 2024

Jones Edmunds Project No.: 03405-029-07

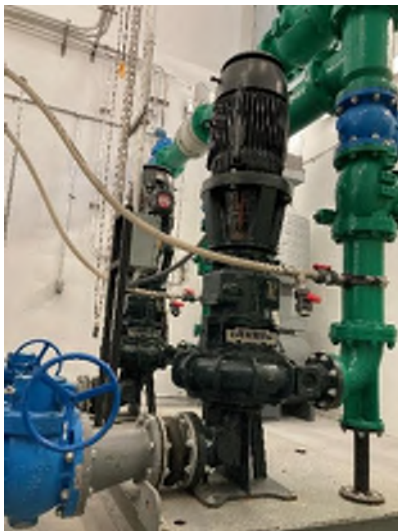
and outdoor site lighting. The operators noted that equipment is frequently cleaned but poor drainage in the vacuum tank pit results in additional labor. This station has a catwalk to make accessing the vacuum tank for maintenance more efficient. Access to the lower level is by a stairwell. CCU added a hazard sign near the stairwell to prevent entry by unauthorized personnel. The power service to the station is 480-volt, three-phase power with a pad-mounted transformer. In case of emergencies, Ackerman can operate on the 352-kW, 440-kVA, 1,500-gallon, diesel tank mounted Cummins generator. The generator is operated every Monday to ensure standby power is fully operational. The station is equipped with Allen Bradley PowerFlex 525 VFDs and a DFS Tac II TCU SCADA system with a telemetry transmitter/receiver unit.

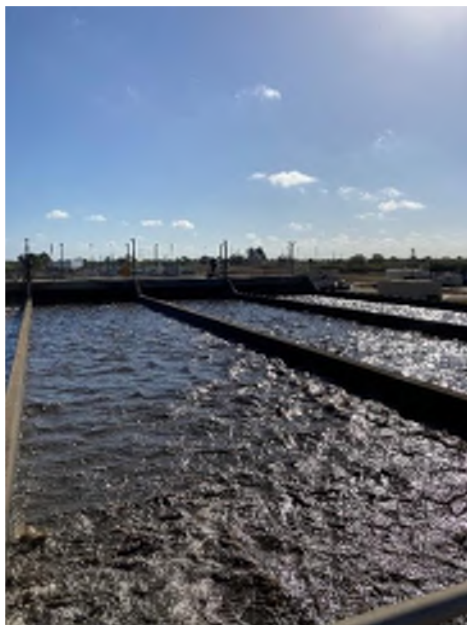
The overall condition and operation of the MLE process are good following the Stage 1 and 2 Improvements in 2016. Four VFD-controlled surface aerators are in operation in the oxidation ditches. The aerator speed is adjusted based on the DO probe at the end of the ditches. The aerators were recently taken down to remove rags and were serviced. Each oxidation ditch has two aerators; one of which runs at a constant set point of 80 percent speed, while the other is running variable speed controlled by VFDs. The DO-control system helps the WRF lower its power consumption and improve the denitrification process by minimizing DO carry-over to the anoxic zone. Six VFD-controlled IR pumps were replaced in the Stage 1 and 2 Improvements. These pumps are controlled by the SCADA based on operators' settings. The IR pumps are well maintained and in good working order. At the time of the site visit on January 31, 2024,

Oxidation Ditch No. 2 anoxic zone was observed to have areas where a significant amount of floatable solids were gathered and forming an island on the water surface. The CCU WRF staff noted that Mixer No. 2 in the anoxic basin will be replaced in the near future. Smaller areas of floatable solids were also observed at Oxidation Ditch No. 1. If this issue persists, we recommend spraying plant water to coax a better mixing zone and prevent floatable solids from collecting.

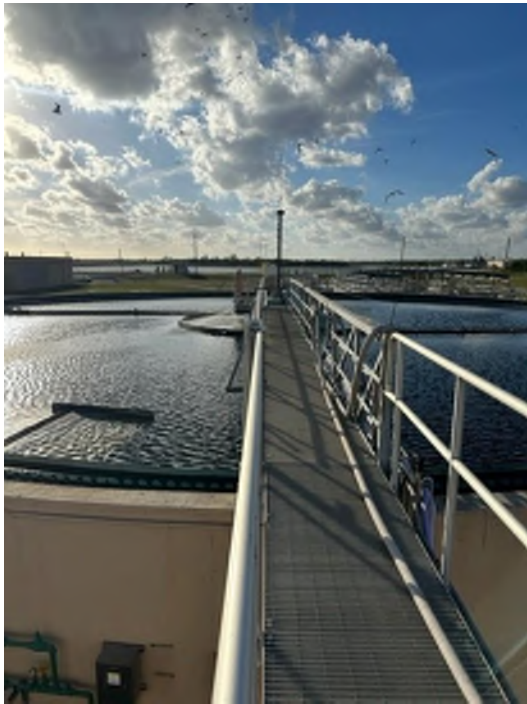
In 2016, the two clarifiers were rehabilitated as part of the Stage 1 and 2 upgrades, which included replacing the clarifier scraper mechanisms. The overall condition of the sedimentation process is well maintained and clean, and the clarifiers are producing a high-quality effluent. The light pole on the walkway between the two clarifiers was blown off at the base by Hurricane Ian and needs to be replaced. The five RAS pumps are VFD-controlled. The operator noted that RAS Pump No. 4 was replaced in FY 2023, and the motor for RAS Pump No. 3 was replaced in FY 2023. The two WAS pumps are controlled by operators' settings in the SCADA system. Both pumping systems are well maintained and in good working order.

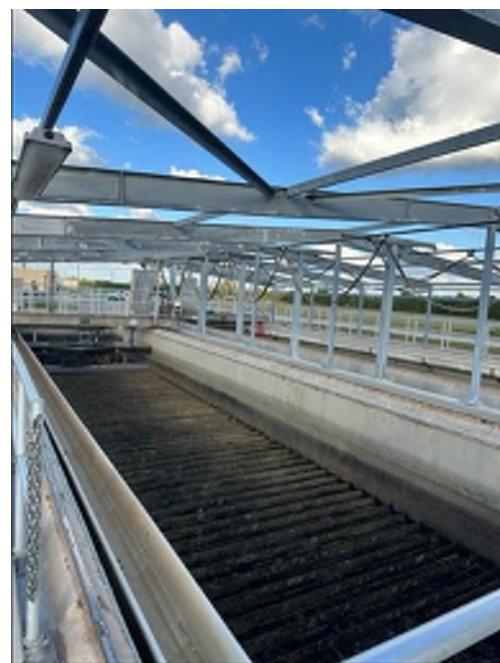
The overall condition of the effluent filtration system is good with a few damages from Hurricane Ian. The emergency alarm does not work, and its associated conduit and support structure is damaged. The filters were rehabilitated as part of the Stage 1 and 2 Improvements. At the time of the site visit, Filter No. 1 was out of service due to a failed gearbox on the trolley, and new media and rails were being installed.

Filter No. 2 was also down for general rehabilitation work. The plant was executing rejecting mode 2 from the operation protocol, bypassing the filters, and sending clarified effluent through CCC No. 2 to the reject pond while the filters are being serviced and rehabilitated. A galvanized metal frame was installed over the filters in the Stage 1 and 2 Improvements to support a fabric roof constructed of UV shade cloth. However, the cloth was missing at the time of the site visit. The cloth will be replaced with roof panels bolted to the galvanized frame as part of the 9.0-MGD plant expansion that is under construction.

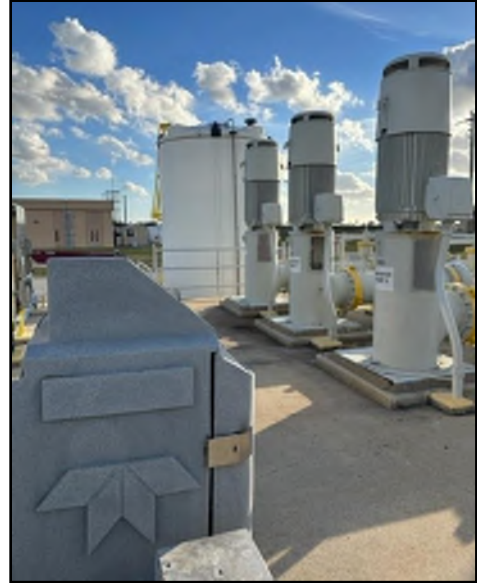
The reclaimed water HSPS No. 2 has five VFD-controlled pumps, can pump 9.0 MGD at 108 psi, and was completed in 2019 as part of the Stage 5 Improvements. Due to heavy winds by Hurricane Ian, paint on the pumps and their associated piping was lost. The system includes four 120-micron self-cleaning filters manufactured by ORIVAL and was submitted as a value-engineering substitution. The units are currently bypassed due to fouling issues. The bypass around these filters is not impacting reclaimed water quality to end users.

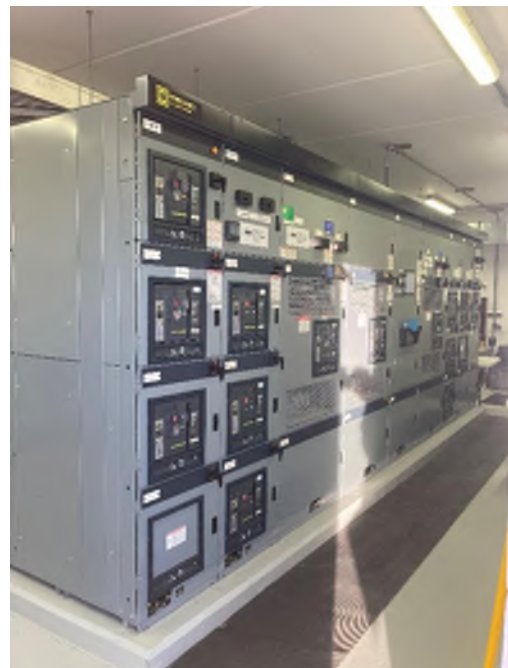
The incoming service and distribution transformers at the Administration building are relatively new and in excellent condition with no obvious signs of concern. The standby generator functions properly and is in good condition. Since it was relocated from another location, it does show signs of wear and deterioration but with no major issues to interfere with its function. The distribution switchgear of the Administration building was in excellent condition with minor issues (see below). Overall, the electrical equipment is in good functioning condition based on information from Operations staff.

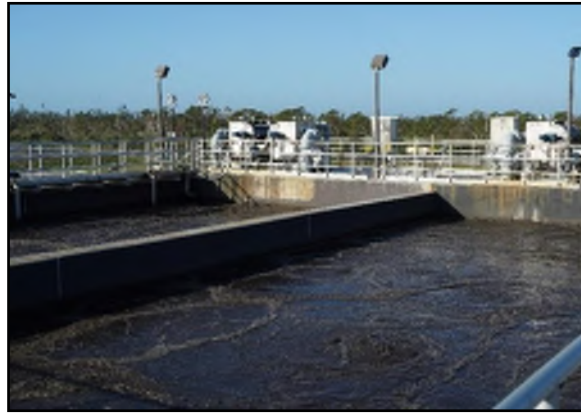
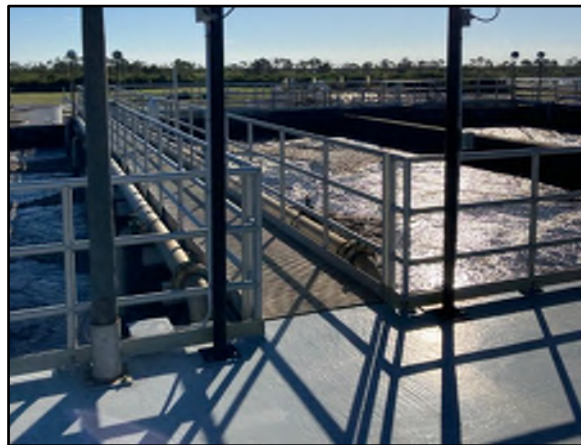
The overall condition of the activated-sludge facilities is good. The mixed liquor suspended solids (MLSS) are sampled every morning by the Operations staff. The WRF has four aeration basins – all basins were in service at the time of the site review. New fine-bubble diffusers were installed in all basins in 2013 and 2014. This has had a positive effect on the treatment process by providing a more even air flow distribution. However, the lack of grit removal continues to present a maintenance challenge since deposited grit levels rise to block the diffusers. Basin No. 3 was cleaned of grit, and damaged aerators were repaired in FY 2016. At the time of the site visit, Basin No. 4 was offline for cleaning. Overall, wastewater in the aeration basins was well-mixed with some foam accumulation at the surface.

All three blowers were operating properly. Usually, one blower is operated at a time to meet aeration requirements. The operators cycle the blowers weekly. The plant typically operates between a pH of 6.6 and 6.7 but adjusts seasonally by running an additional blower. A timer is used to turn the blower on and off throughout the day. Using pH for operational control is not the most practical method for treating wastewater; an alternate control method including DO and oxygen-reduction potential (ORP) should be evaluated. The outlet weirs of the aeration tanks require manual cleaning when debris catches on the weirs. The steel supports of the walkway over the aeration tank effluent splitter box were touched up with paint in FY 2017, and the aeration tanks were repainted in 2018.

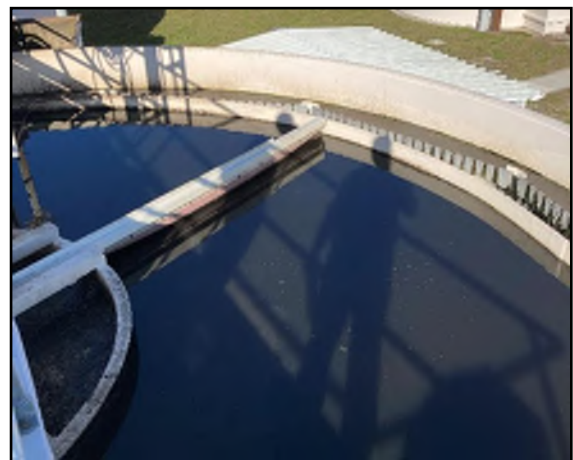
Plant Operations staff follow a routine schedule of clarifier inspection, repair, and painting. The stairways leading to the bridges of the aboveground clarifiers were painted in 2020. The fiberglass grating and steps show signs of moderate fraying and wear.

The sludge-return chambers on the side of each clarifier have telescoping valves used to adjust sludge withdrawal from the bottom of the clarifier. The sludge is then conveyed to the four RAS/WAS pumps that are housed under a sheet-metal roof. Floatables accumulate in the sludge chambers and are periodically removed by manually skimming the 5-foot-by-5-foot boxes from the clarifier bridge when the chambers are full. The telescopic valves were operating properly, and the RAS/WAS pumps are in good operating condition. The pumps were painted in 2017.

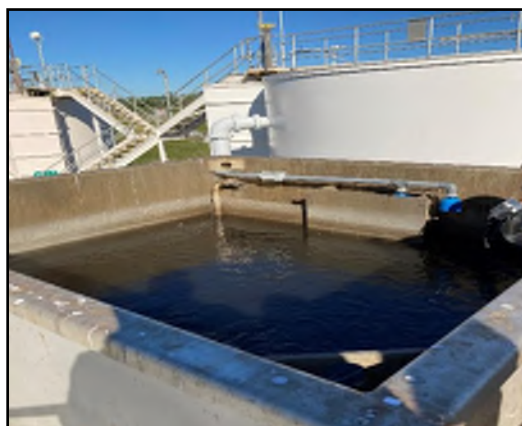
The filters are in good condition. The tanks are cleaned every month with 5 gallons of bleach. A UV cover was put on the filter tanks and then removed because access to the filters during maintenance activities was blocked. Also, using the UV cover requires weekly cleaning due to increased bug life beneath the UV cover. The filter water surface, exposed interior equipment, and interior tank walls are sprayed with a bleach solution once or twice a week by Operations staff to prevent algae growth. Regular bleach spraying mitigates algae growth but may cause long-term issues in with exposed components such as motors. The filter will likely be replaced as part of the future expansion.

The filters are constructed of Type 304 stainless steel, but the fiberglass grating platform between the filters is supported by carbon steel angles. The paint is in good condition with some staining and rust on some exposed components that are not stainless

steel such as the motors, which were replaced in 2021. The motor chains were in good condition and appeared to be functioning properly in the operational filters.

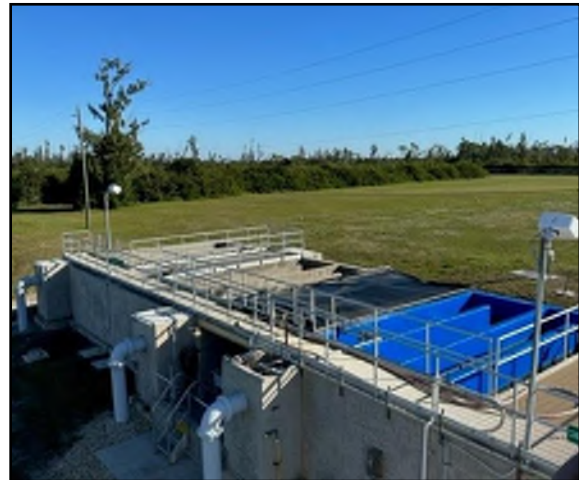
The overall condition of the chlorination system is excellent with the exception of the permanent roof structure. The roof was blown off due to wind damage when Hurricane Ian made landfall in September 2022. This roof and others that were damaged are expected to be replaced or repaired in FY 2024. Only CCC No. 1 was in service at the time of the site visit. CCC No. 2 was reported to be in good working condition. Each CCC has two trains. Good turbulent flow in the inlet boxes to the CCCs creates effective mixing. The pH and chlorine analyzers are in good working order. Plant operators clean the analyzer assemblies at regular intervals to remove any algae buildup. They also periodically alternate the CCCs to clean them.

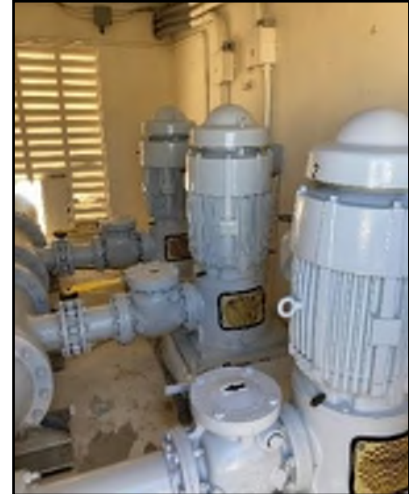
Effluent that does not meet public-access reclaimed water standards is conveyed to a clearwell for disposal via a deep injection well. Three new deep-well pumps are used to convey effluent through a 16-inch manifold pipe into the deep well. All compliance monitoring equipment and pumps were fully functioning and in good condition at the time of the inspection. The building housing the pumps suffered wind damage when Hurricane Ian made landfall in September 2022.

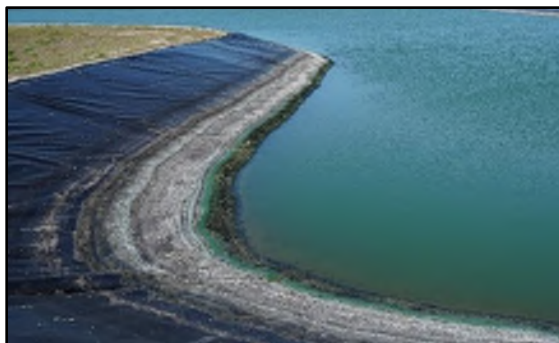
The on-site reclaimed water ponds provide up to 20 MG for wet-weather storage of reclaimed water. At the time of the site visit, the pond linings appeared to be in good condition. The ponds had some algae growth at the time of inspection. The Chief Operator reported in the last Annual Report update that they plan to add some fine-bubble diffusers to the pond in the future.

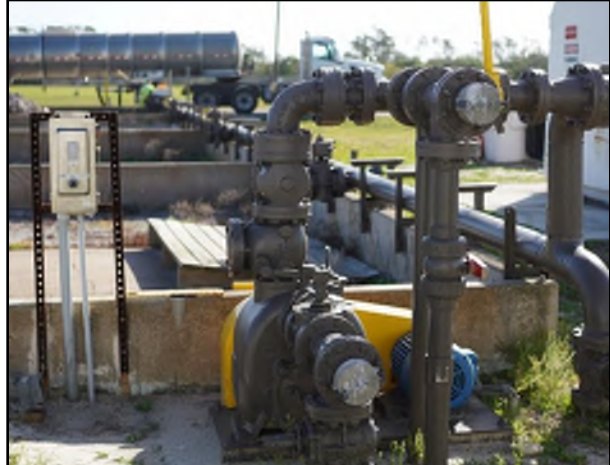
The sludge produced as a byproduct of treatment is pumped to aerobic sludge-holding tanks and then gravity thickened at the West Port WRF before being truck hauled in liquid form to the East Port WRF for sludge dewatering and final disposal at the compost facility. The overall condition of the sludge-holding tanks is good; however, the aerobic sludge-holding tank volume is too small and prevents proper decant thickening, resulting in a decant-thickened sludge of 1-percent solids or less. Additional sludge-holding tank volume and decant-thickening capabilities should be provided to allow a thickened sludge of 1.5- to 2.0-percent total solids, which will reduce the sludge-hauling volume by 50 to 100 percent and hauling costs. CCU is evaluating the feasibility of adding more biosolids-handling capacity at the West Port WRF to handle biosolids generated at the West Port and Rotonda WRFs.

The Chief Operator indicated that the plant is experiencing limited hauling issues with sludge hauling services, and excess sludge stored in the biosolids-handling facilities has not exceeded system capacity. The situation is being closely monitored by Operations staff. The expansion of the storage and dewatering at the biosolids handling facilities at East Port WRF is currently part of the ongoing 9.0-MGD expansion project to increase the receiving capacity from West Port WRF.

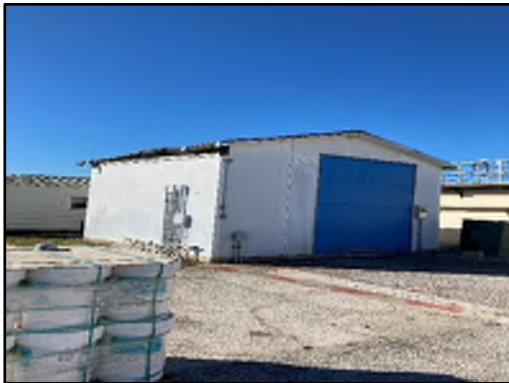
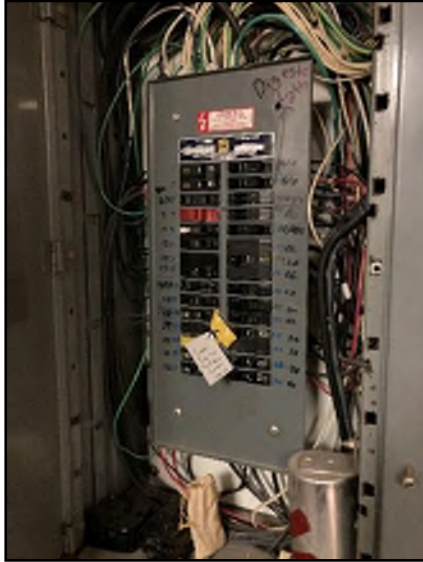
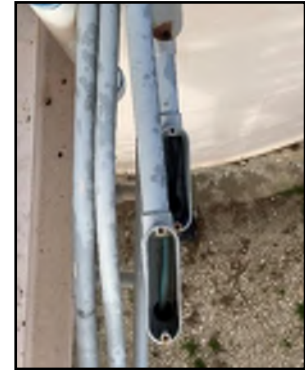
The incoming switchgear and distribution transformer appear in good condition with no obvious signs of significant concern. The incoming power via overhead aerial was installed a few years ago. The WRF is served from two 400-kVA generators connected in parallel that are fed from a subbase tank and an auxiliary tank adjacent to them. A 6,000-gallon fuel tank and pad for the generators was installed in 2020; however, the Chief Operator reported issues with the tank's functionality and expects the tank to be removed and/or replaced in the future. Overall, the electrical equipment is in good functioning condition based on information from the Operations staff, except for the generator MCC building's roof and side panels due to wind damage when Hurricane Ian made landfall in September 2022. Additionally, the hurricane caused some water damage to computer equipment. Generators were used during the entirety of the storm; however, Generator Set No. 2 was damaged and is pending repairs. The repairs to the building and any outstanding equipment will take place in FY 2024.

- Generator Set No. 2 was out of service due to Hurricane Ian. The generator vendor states a new generator is required.
- Staff indicated issues with incoming power where imbalance occurs and trips the blower breakers; staff indicated they plan to monitor and record power to verify this.
- The lighting panel in MCC No. 1 is missing a cover.
- The electrical room adjacent to the generator set was damaged due to Hurricane Ian; the facility is missing the roof, and CCU has installed a temporary cover.
- Sludge bed sump pump conduit broken.
- Blower MCC building outside conduit cover is open.
- MCC Building No. 2 outside

conduit cover is open.

- Digester No. 2 area light conduit support is missing.
- Clarifier No. 1, 2, 3, and 4 are missing conduit clamps on area lights.
- Clarifier No. 1 and 2 have broken conduit and are missing a line-box-style fitting cover.
- The conduit supports on the north wall of the headworks/aeration basin have broken, leaving the conduit unsupported.

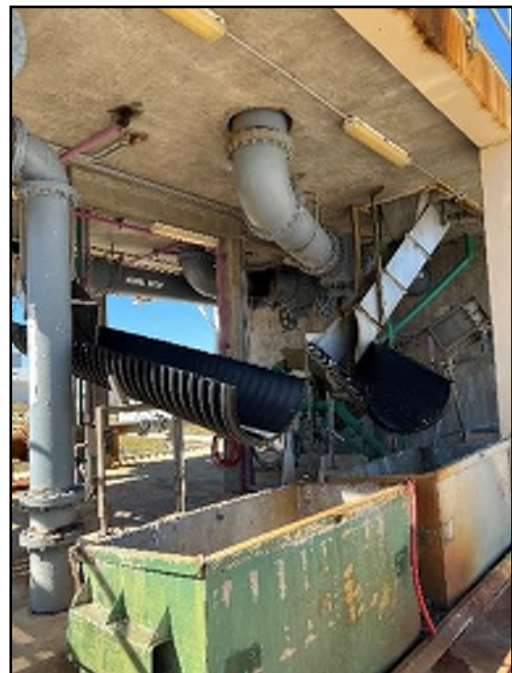
The overall condition of the headworks is fair to poor. The headworks is undergoing an improvement and rehabilitation/replacement project that will include new piping and fine screens as well other improvements to the headworks.

At the time of the site visit, both screens were operational. These screens are critical process units. Each screen rotates on four drum rollers that support the stainless-steel perforated screen as it rotates. The worn rollers were last replaced in 2016. The rate of rotation has been slowed to extend the life of mechanical components. In 2017, the drums were welded, and the roller wheels, chains, and drive gears were replaced. A wash water spray was added to the screening compactors, which improved operation and lengthened the life of the lower

In 2020, the screening handlers (conveyors, compactors, etc.) were replaced with stainless steel and half-pipe corrugated HDPE chutes. The replacement system is operating as intended. The grit removal process operates as intended. The organic wastewater component of the pumped mixture is returned to the wetwells. Separated grit slurry is pumped to two cyclone units where the grit is further concentrated. The separated grit passes to a grit "snail" washer before being deposited into a dumpster. The grit "snail" washer includes a conveyor system that allows the grit to shed water as it proceeds to the dumpster. In FY 2017, Grit Pump No. 2 was replaced, and the cyclones are scheduled for replacement in FY 2024 as part of the Headworks Improvement project.

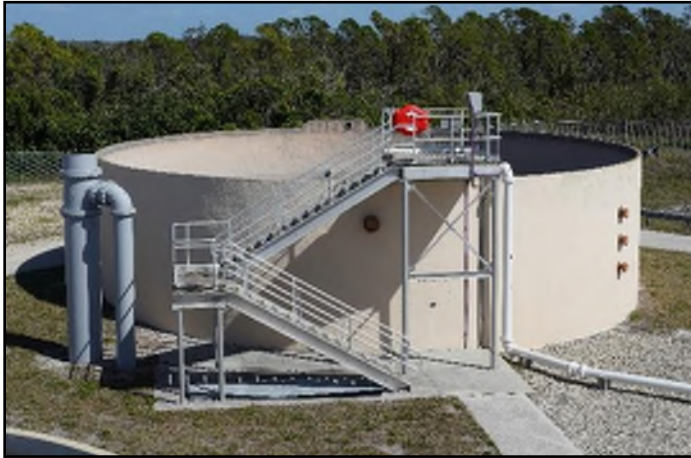
The overall condition of the 0.3-MG EQ tank is good. The EQ tank, which attenuates high hourly flows, is filled through a gravity system initiated by an overflow weir at the headworks structure. The EQ tank contents are returned to the headworks for treatment at a steady flow over 24 hours using VFD pumps. This has proven to be a valuable asset to the operation of the facility. In the FY 2022 review, the Chief Operator noted that MLS 801 sends 1,500 gpm to the

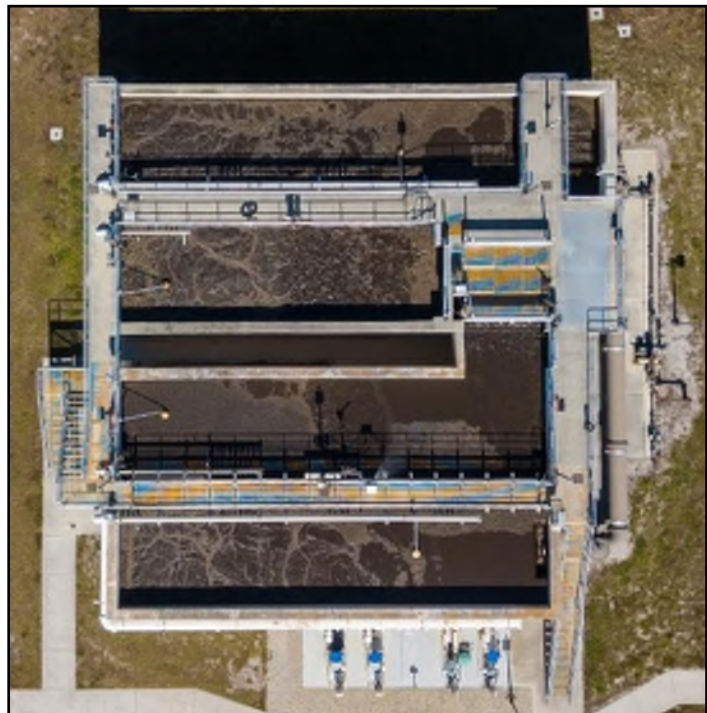
The overall condition of the activated sludge facilities is good. The aeration tanks operate in a plug flow regime with anoxic, aerobic, and swing zones. The anoxic zones and the use of automatic DO probes to control blower speeds have contributed to the high level of treatment while conserving energy use. The aeration tanks are run at an MLSS concentration of 4,500 to 5,000 mg/L. The aeration tanks were last drained for inspection in FY 2012. The aeration basins were pressure-cleaned and painted in FY 2017. A layer of foam was on the water surface in the anoxic zone at the time of inspection. The Chief Operator commented that additional tank volume is needed to increase denitrification capabilities. We recommended additional mixers in the first anoxic zones.

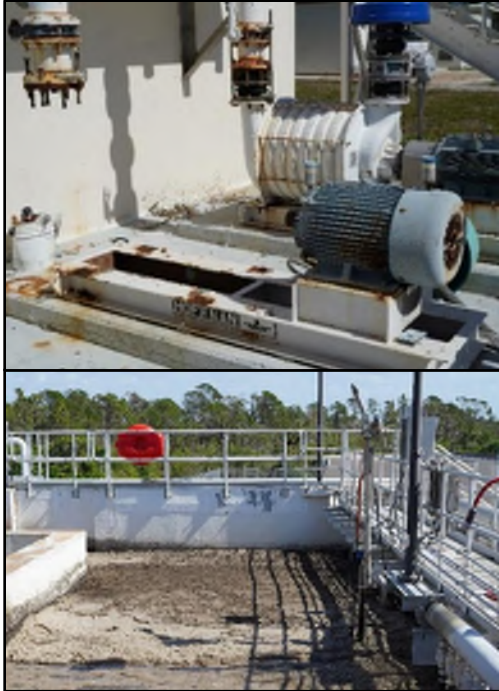
The aeration system continues to supply air to the aeration tanks. The facility has four multi-stage centrifugal Hoffman blowers to serve the aeration trains with room for an additional blower. Generally, one blower meets air requirements. Additional units are brought online during higher demands. Blower No. 2 has been repaired multiple times including a new motor in FY 2014 and new bearings in FY 2016; however, the blower motor was again repaired in FY 2017. During the site visit, we observed that Blower No. 2 was removed from service; staff reported replacement of Blower No. 2 hardware is ongoing and is expected to occur in FY 2024. Blower Nos. 1 and 4 were replaced in FY 2020 and FY 2019, respectfully. The installed blower and motors were in good condition. The Chief Operator commented that they would prefer three large blowers and two small blowers for better flexibility.

One of the DO probes in the aeration basin was replaced in FY 2017. The Chief Operator commented that one of the DO probes needs the sensors replaced. The other three probes are functioning properly. One DO probe controller screen was severely faded and degraded by UV from the sunlight, and other screens showed similar signs of UV damage. The controller with the damaged screen likely transmits data to plant operations staff via SCADA; however, the damaged controllers should be replaced for field operational purposes. Sun shields were observed on the front of three of the six controller three-sided enclosures; we recommend installing sun shields on the remaining three enclosures to extend the life of the existing equipment.

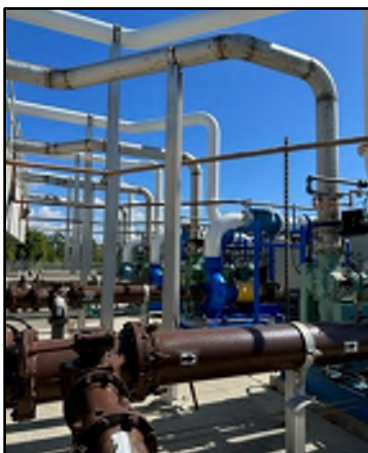
6.4.4.5 Filtration: Membrane Bioreactor

The MBR system continues to produce a high-quality effluent. The system contains four trains with three membrane cassettes each. The MBRs are cleaned once every other day with a weak solution of bleach to maintain their treatment efficiency and remove organics. The cassettes are periodically cleaned in place with concentrated chlorine bleach twice a year and are removed once a year for citrus cleaning to remove inorganics.

- The membranes are in good condition except for some cracked potting headers.
- Check and adjust the slack within the next few months.
- Purchase a few module blanks for top and bottom headers and wait to observe membrane effluent turbidity spikes, which would indicate that one of the cracked potting headers has breached the membrane integrity. Remove the compromised membrane module and install module blanks in its place until the new purchased membrane module is received. Once the new membrane module is received, install the new membrane in the middle of the cassette and move an existing module where the compromised module was. This could prolong the new membrane module potting header life.

- A year before scheduled replacement (currently estimated as FY 2024 for Trains No. 1 and No. 3), order membrane modules. Install new membranes modules in Train No. 3. Do not install new membrane modules with existing membrane modules in the same train. Move the existing membrane modules from Train No. 3 to Train No. 4. Train No. 4 will then have six membrane cassettes, which will extend the life of the membranes. The same procedure was recommended for Trains No. 1 and No. 4. Train No. 4 will receive the existing modules, and Train No. 1 will receive the new modules.

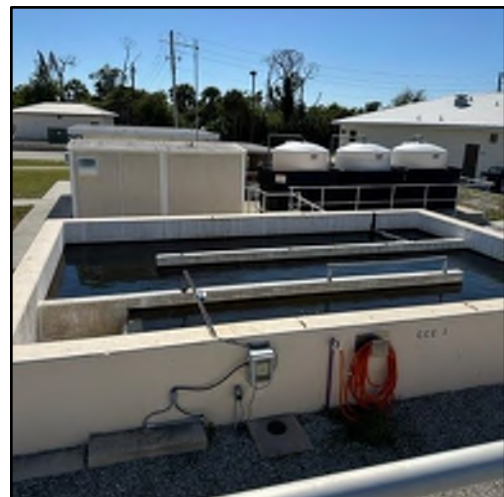
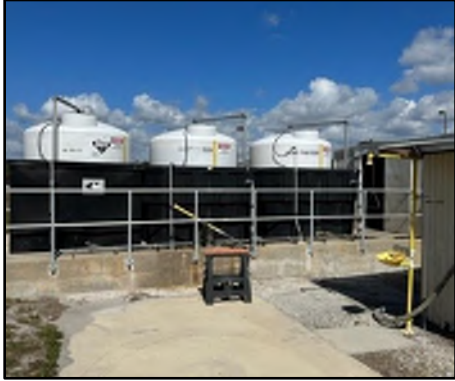
6.4.4.6 Disinfection and Effluent Sampling

The overall condition of the chlorination system is good. The two concrete CCCs are in good condition. The CCCs are used alternately, but only one is required to meet the required contact time under current flows. Wind from Hurricane Ian in September 2022 caused the UV filter cloth and metal roof to be blown off the CCC, and it was still missing at the time of our site visit. During the site visit, neither CCC had a UV filter cloth.

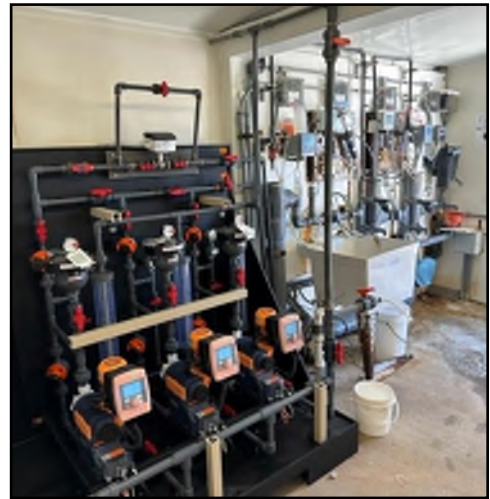
Replacement of Chlorine Storage Tank No. 3 began in FY 2017 and finished in FY 2018. Two new storage tanks with secondary containment were installed in FY 2021. All storage tanks feature polyethylene open-top tank secondary containment. Small-diameter corrugated HDPE drain piping coming from the secondary containments appeared to be in fair condition, and the in-line valves were open during the site visit. The tank piping to the feed pumps is exposed to the sunlight and did not appear to have secondary containment piping. A break to one of these pipes could result in the tank fully draining and

Prominent Feed Pump No. 3 was replaced in FY 2018. Prominent Feed Pump No. 2 was replaced in FY 2019. Prominent Feed Pump No. 1 was replaced in FY 2021. The two total chlorine analyzers were replaced in FY 2019. The metal backplates for the chlorine analyzers have experienced substantial corrosion and staining and should be replaced. The chlorine feed line from the in-plant road was replaced in FY 2018.

spilling on the ground, creating environmental concerns. We recommend that CCU review the drain piping to ensure that Operations staff follow applicable regulations or add secondary containment piping (double-walled piping). The canopy that covered the storage tanks was blown off by Hurricane Ian. We recommend reinstalling this canopy with side walls to help protect the area from UV degradation and rainwater from filling the secondary containment bins that the tanks are set in.

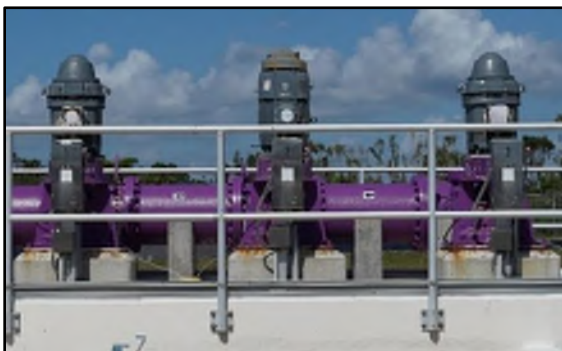
Reuse Facilities

Reclaimed water meeting public-access water quality is sent to the MRS using the HSPs at HSPS No. 1 and HSPS No. 2. HSPS No. 1 uses three vertical turbine pumps with VFDs to provide reclaimed water to golf course storage ponds north of the Rotonda WRF. The golf course's high-pressure pumps then increase pressure for irrigation system use. The motors for Pumps No. 1 and No. 3 failed and were replaced in FY 2022. These motors are only for temporary

use since they are not rated for outdoor use. These indoor motors will continue to be used until outdoor motors can be acquired.

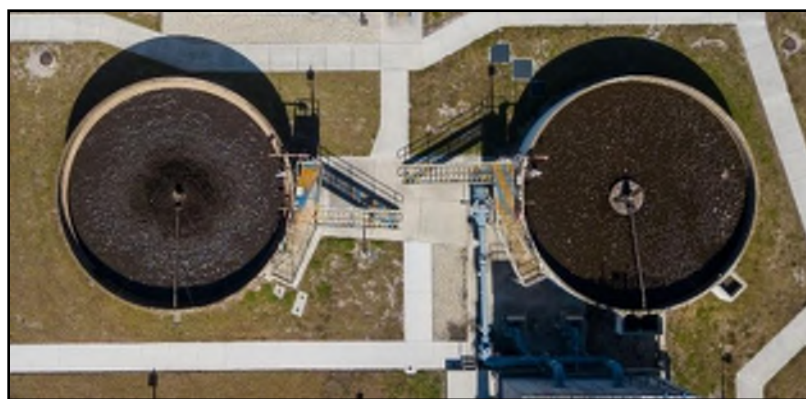
6.4.4.8 Biosolids Handling Facilities

The overall condition of the solids-handling facilities is good. The decant mechanism for the sludge-holding tanks was designed as telescoping valves, but the telescoping valves can only be lowered to one-half the depth of the tank. Currently, decanting is done daily for 10 to 12 hours per day to attempt to maintain the

holding tank capacity. The operators have replaced the designed method of decanting by using bottom-feed submersible pumps and a small winch on each pump to control the pump level.

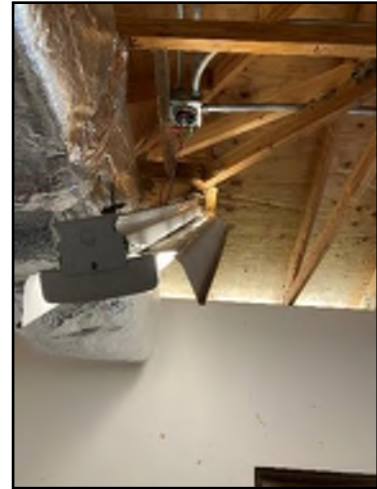
- MCC Building No. 3 sustained Hurricane Ian damage such that interior lighting fixtures are hanging from wires – representing a significant hazard to staff (see photo above). This deficiency is a repeat listing from previous years.

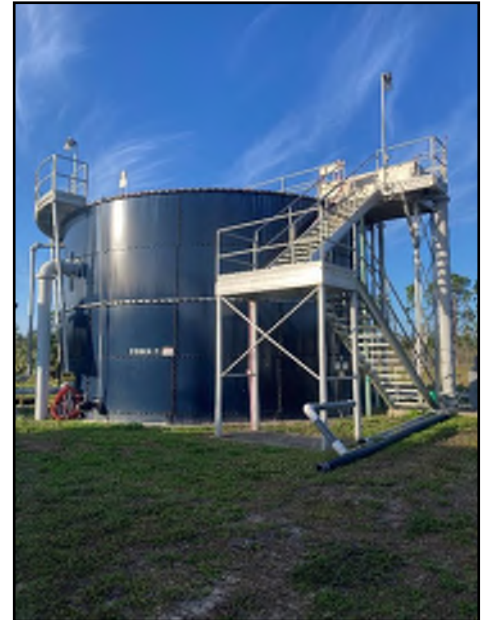
6.5.4.3 Flow Equalization

The Aquastore EQ tank is in poor condition. The EQ tank has signs of rust around the upper steel rim, which likely originates from the RO WTP waste line. Internal piping is in poor condition with leaks at flanged fittings, and one of the drop diffusers inside the EQ tank has been damaged and is no longer secure. Since no grit-removal facilities are provided, grit accumulation occurs in the EQ tank and reduces treatment capacity. The grit accumulation is currently being managed by having a vendor periodically pump out the grit in the EQ tank while in operation.

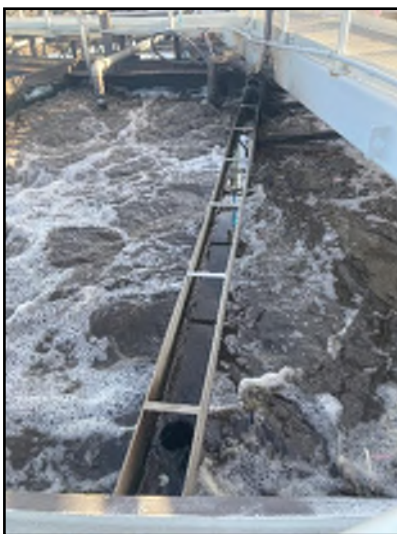
6.5.4.4 Biological Treatment

The activated-sludge facilities are steel-ring package plants consisting of two aeration tanks and two clarifiers. At the time of the site visit, the aeration basins appeared to have adequate and even air distribution throughout the tank. All blowers were rebuilt in 2017, and new VFDs were provided for two of the blowers in 2022. Motor repairs for Blower No. 1 were completed in 2023. The Chief Operator noted that the blowers are undersized for the volume of wastewater that the plant has been experiencing recently. Additionally, the pressure gauges for the blowers were not working at the time of the site visit. The operation of the blowers is based on timers, but no DO sensors are provided to adjust blower operation. The hinged sluice gates separating the two aeration tanks are not functioning as intended, allowing wastewater to flow to the adjacent tank during maintenance. The tanks have minimum

free-board (<1 foot), creating concerns of overflowing during high-flow conditions or if a downstream flow obstruction occurs. CCU staff reported that the tank has since been successfully repaired by staff with assistance from a certified diver. The repairs included installing steel cables to adjust the sluice gates.

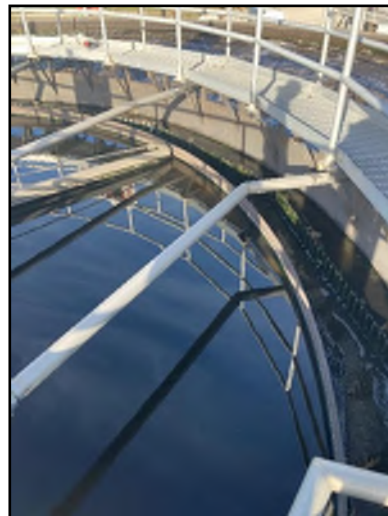
6.5.4.5 Clarification

The clarifier portions of the tanks appear to be functioning, although solids were observed near the surface; Clarifier No. 1 appeared to be performing less adequately than Clarifier No. 2 based on water flow and additional solids observed at the surface. The scum troughs were observed to be worn down and need replacing. The Chief Operator noted that Clarifier No. 2 typically treats approximately 60 percent of the plant flow. Notable algae growth was observed on the weirs. A significant amount of floatables passes through the headworks and collects in the clarifiers. The floatables are returned to the headworks and accumulate in the WRF until they are manually removed. The two RAS/WAS pumps that draw solids from the bottom of the tanks are in poor condition and operating at their end of lifetime. RAS Pump No. 1 was replaced in 2023. The pipe pumping design makes it difficult for operators to de-rag the pumps. The Chief Operator noted that some electrical repairs would be needed due to lights and outlets not working. The County continues to maintain and repair these systems until the WRF expansion is completed.

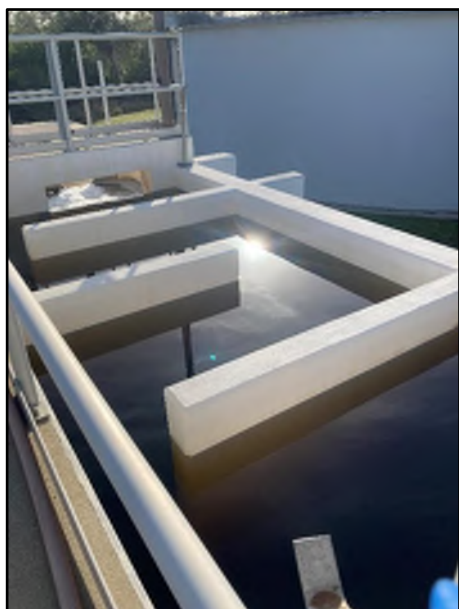
Reuse Facilities

The Burnt Store WRF reuse facilities include a reclaimed water pump station and clearwell, which are in overall good condition. The reclaimed water pump station is above the clearwell following the CCCs. Two HSPs and two booster pumps are used to convey up to 0.5 MGD AADF of reclaimed water to customers. The booster pumps are currently used to satisfy demand in the reuse system, but the two large HSPs are working properly and are tested regularly. The reclaimed water HSPs and jockey pumps are well maintained and show no signs of deterioration. Flow to the reclaimed water pump station is monitored by an ultrasonic flow meter and primary weir device, which became obsolete when the WRF began transferring flow to the deep injection well system. A new flow meter is needed to monitor the pump discharge line and measure reclaimed water flow. In addition, no on-site reclaimed water storage is available, which will require future major reclaimed

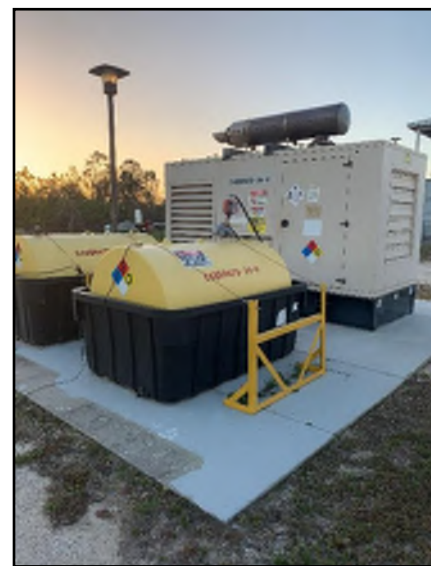
The incoming switchgear and distribution transformer appear in fair-to-good condition. The incoming power company service transformer exhibits an extensive amount of surface rust, which may soon be impacting the transformer function. The existing primary distribution switchboard outside the MCC room is also exhibiting signs of degradation from the weather. The plant is served from a single generator of an undetermined size, and its water pump was replaced in FY 2022. The generator was in good condition but exhibited signs of residual diesel fuel on top of the diesel fuel tank. This may be indicative of additional issues. Overall, the electrical equipment in Building MCC-1 is in good functioning condition based on information from the Operations staff, except for the deficiencies listed below.

- The switchgear contains warning labels identifying parts and components as being energized. However, none of the equipment includes the appropriate arc-flash labeling required by NFPA 70E.
- The fiberglass MCC building should be replaced with a concrete structure.
- The main breaker trips when two blowers are started simultaneously.
- The generator is undersized and is not capable of supporting all blowers at one time.

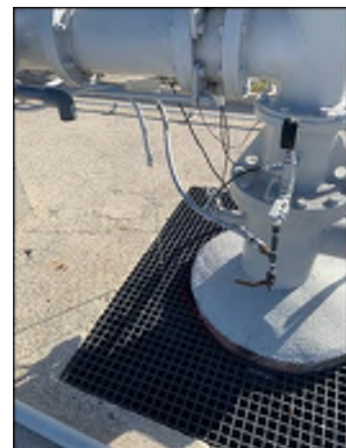
- D) Effluent Disposal: The LTF effluent is conveyed from the effluent storage tank to a deep injection well and disposed of in a confined saltwater aquifer at an approximate depth of 2,700 feet below ground surface. The effluent sample point at the deep injection well may be seen in the photo provided.

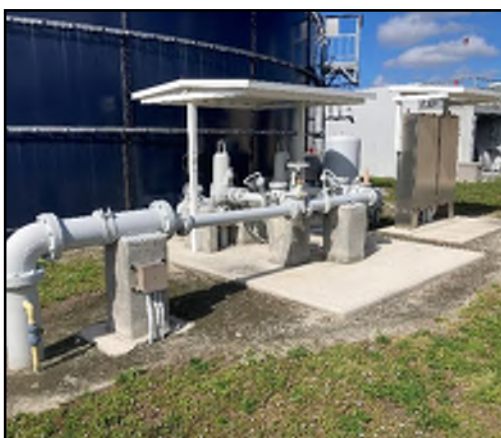
6.7.4.5 Effluent Storage and Disposal

The effluent storage and disposal systems are in fair condition and are properly maintained to meet the facility needs. The facilities were recently painted. The existing 12-HP pumps were installed by CCU personnel in 2015. The pumps are submersible type and are operating satisfactorily under their typical operating period of approximately 7 hours per day. However,

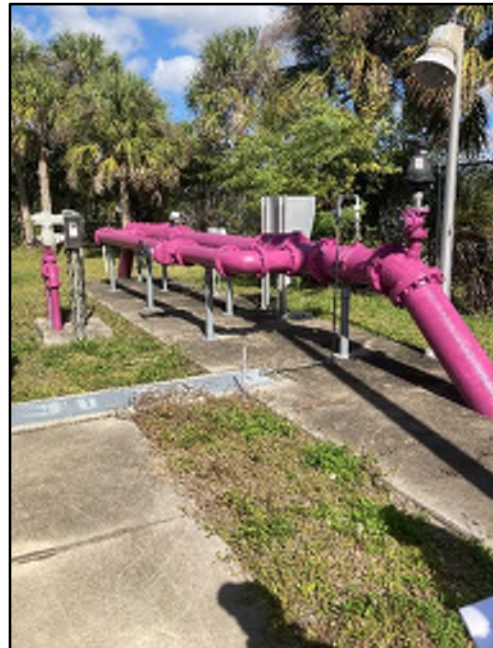
7.1.1.1 Eagle Street – RWBS

Jones Edmunds completed an on-site review of the plant on January 25, 2024; the information gathered at that time was used to update this section in accordance with the project scope. In general, the electrical room equipment, pump room equipment, and tank were found in good condition. However, the screens on the pressure transducers have been damaged by sunlight exposure and need replacing. Additionally, the piping needs proper coating and repainting.

- The pipes were not painted properly and need new coating and repainting.
- The pressure transducer screens are worn out from sun damage and need replacing.
- The anchor system on the sodium hypochlorite tank is rusted and needs replacing.

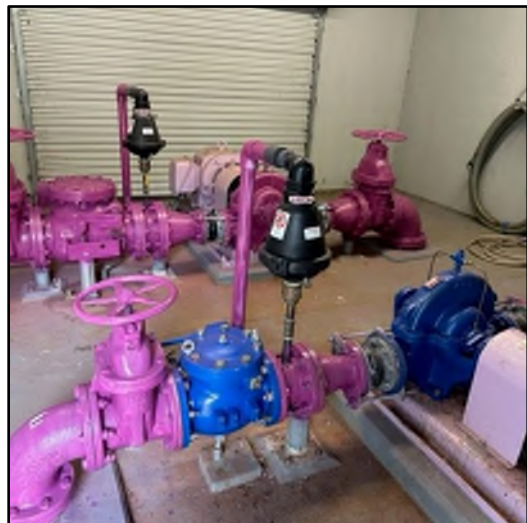
7.1.1.2 Walenda RWBS

The access roads outside the facility are aging and need to be repaved but are in fair condition inside the property. The site fences are damaged and need to be repaired or replaced. Fallen trees are around the site with one leaning against the aboveground storage tank that will require complete removal. The roof over the chemical storage tanks has missing shingles from hurricane winds that need to be replaced. The bypass actuator is currently held on by a strap and needs to be properly secured. The GST level indicator is broken and needs to be replaced. Additionally, pressure transducer screens are damaged from sunlight exposure and need replacing. The HSPs are well maintained and functioning properly.

The electrical room equipment, pump room equipment, and storage tank are in good condition. The piping was painted purple but needs repainting. The grounds are well maintained.

- The access roads outside the facility are washed out and need to be repaved.
- The site fences are damaged and need to be repaired or replaced.
- The site has fallen trees with one leaning against the aboveground storage tank.
- The roof over the chemical storage tanks has missing shingles.
- The bypass actuator is held on by a strap and needs to be properly secured.
- The GST level indicator is broken and needs to be replaced.
- Pressure transducer screens are damaged from sunlight exposure and need replacing.

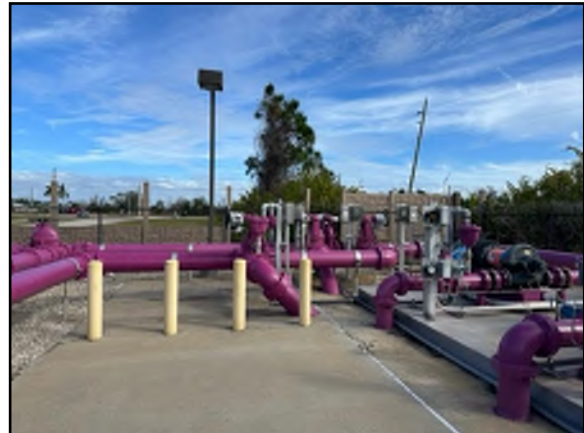
7.1.1.4 Rotonda Blvd East RWBS

The station was in good condition overall. However, some minor issues exist that need attention.

- The external wall panels are damaged and still need replacing.
- Pressure transducer and gauge screens have been damaged from sunlight exposure and need replacing.
- Pipes need to be coated and repainted.
- Some flexible conduits are worn down and need replacing.
- Equipment should be recalibrated.
