CHARLOTTE COUNTY RAILROAD TRESTLES / FISHING PIERS: HISTORICAL BACKGROUND AND CONDITION UPDATE

OBSERVATIONS

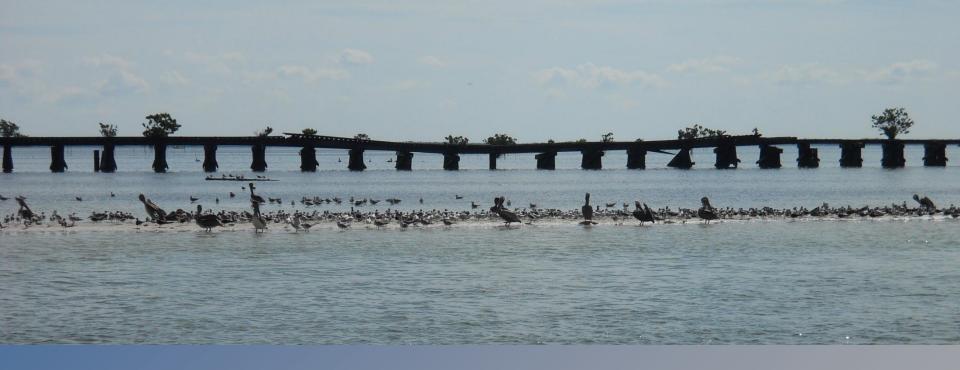
- A site visit to the Boca Grande Causeway railroad trestle was conducted on Friday October 14th by WCIND's Chuck Listowski, Charlotte County Parks and Natural Resources Manager, Andy Stevens, and Mark Kincaid from Coastal Engineering Consultants.
- The causeway was accessed by boat and its overall condition was examined from the north end at the Placida Fishing Pier to the Boca Grande Fishing Pier to the south.
- The purpose of this trip was to develop a plan for addressing the deteriorated conditions of the trestle structures in regards to public safety, historical preservation, public fishing access and environmental concerns.

- From this cursory inspection, it was apparent the structure was in disrepair.
- Public safety being the primary concern, not because of the structure's inability to carry the pedestrian loads on the fishing piers, but because of the severely deteriorated timber components found missing or about to break free from the structure.

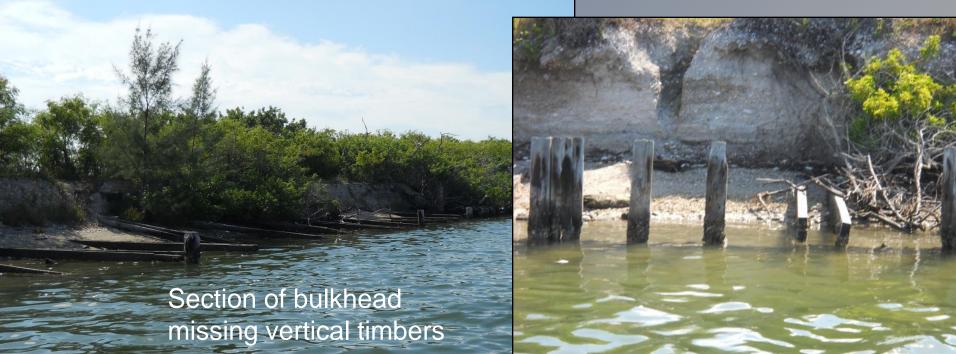
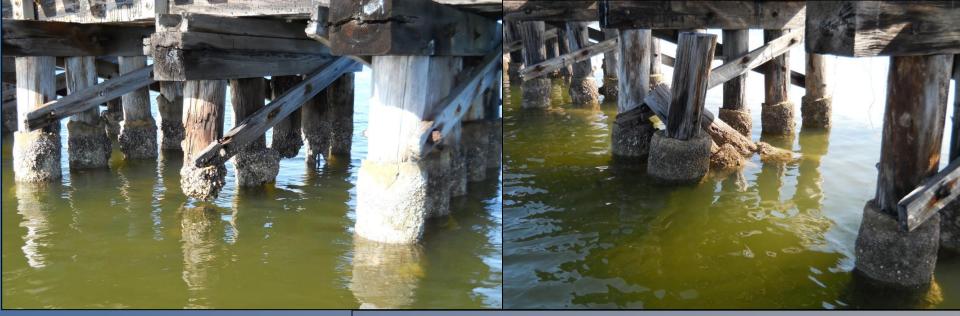
Significant erosion of the soil protecting the trestle along the causeway's spoil island was observed.

Deterioration of the bulkhead was more advanced than the trestle and much of the timber elements have been washed away.

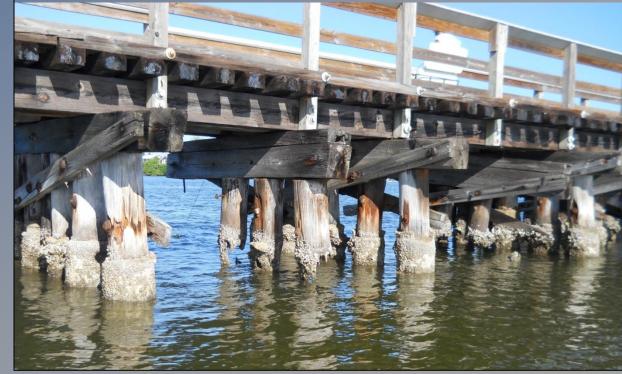
The trestle was designed to carry live loads from railroad cars filled to capacity with phosphate. Pedestrian loads on the structures in the current use as fishing piers may be satisfied, even in its state of advanced deterioration.

- The 100-foot long collapsing section of trestle should be condemned as soon as practical. All materials including pile stubs should be removed from the sound.
- Remove all significantly deteriorated piles and timber members no longer contributing to the stability of the trestle structure.
- Inspect the remaining piles and concrete jackets supporting the fishing piers. Ensure that there are adequate piles (minimum of two) properly spaced to support each pile bent.
- Repair all pile/jacket deficiencies found during inspection to prevent future marine borer infestation. To reduce costs, repairs could concentrate on the minimum number of piles at each bent. For example, each pile bent consists of six piles, but only the two outboard piles are needed for support. The other four piles would not necessarily need to be repaired.
