# Charlotte County Utilities Department

## 2024 Annual Report

### May 2025

Jones Edmunds Project No.: 03405-029-08

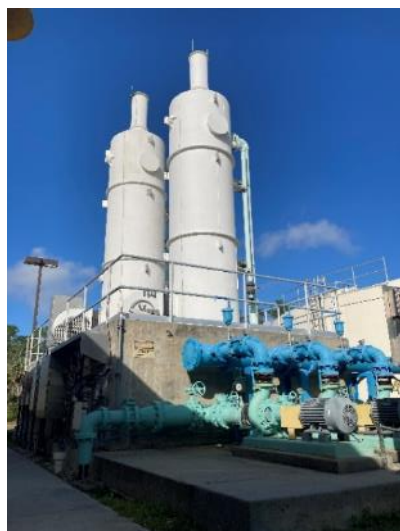
#### Degasification and Clearwell

Hydrogen sulfide is removed from the RO permeate via packed-tower degasification. Three packed-tower degasification units with blowers are on top of the concrete clearwell and can be operated automatically or manually. The degasifier media was replaced in FY 2023. CCU should regularly exercise the isolation valves between the two clearwell tanks.

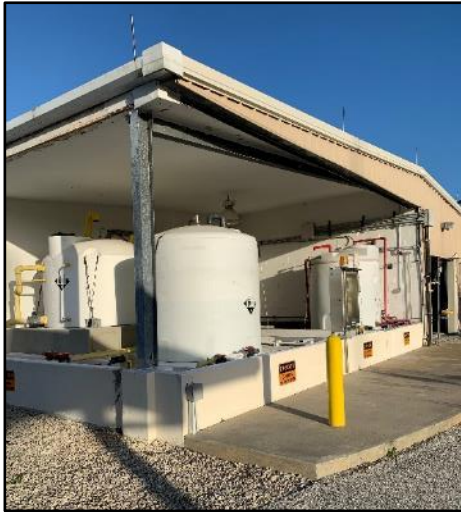
## Sodium Hypochlorite

The sodium hypochlorite system consists of two bulk storage tanks, one 200-gallon day tank, two chemical feed pumps, and two injection points. The two bulk storage tanks are outside the process room and hold 1,400 and 1,100 gallons. Sodium hypochlorite is primarily injected before water enters the storage tanks (pre-disinfection), although operators also have the capability of injecting after the GSTs (post-disinfection) as needed to meet disinfection compliance. Jones Edmunds observed:

- The sodium hypochlorite system appears to be in good operating condition.

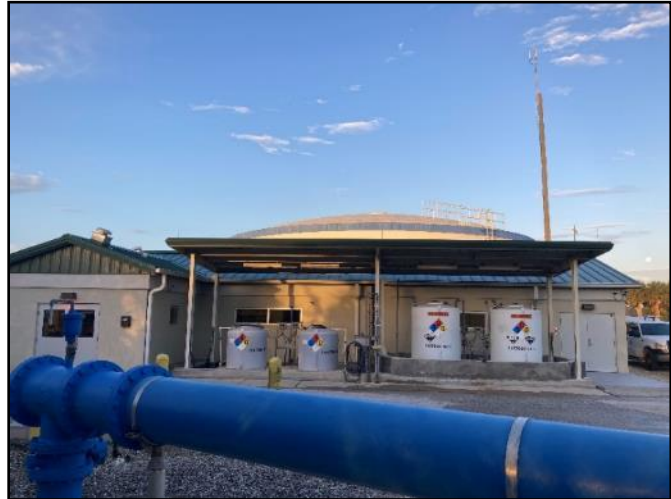
#### 4.1.3.1 Port Charlotte Golf Course – WBS #2

- The sodium hypochlorite dosing line near operations building does not have an outer protective layer.
- The flow meter screens are damaged from sunlight exposure.
- The hazard warning labels on the diesel fuel tank are torn and illegible.
- Lights for the covered storage area are missing vapor covers and are exposed to the environment.
- The VFDs frequently fault-out when maintenance is performed on the generator set.

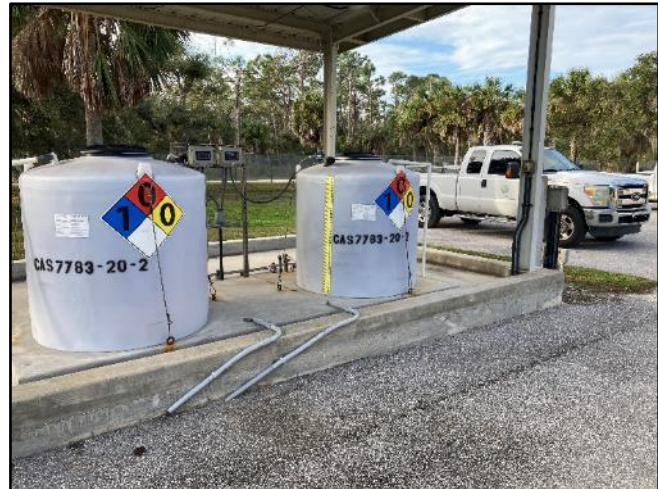
#### 4.1.3.3 Walenda – WBS #4

- The discharge pipe vault for the HSPs needs to be drained of water.

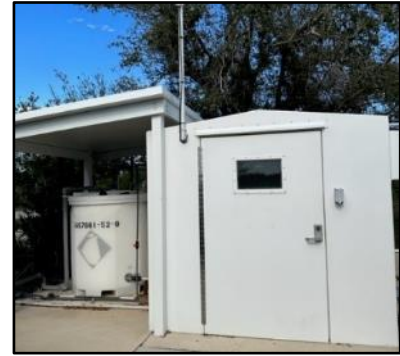
#### 4.1.3.5 Ingraham – WBS #7

The general condition of the station appears to be fair. The buildings are weathered but in operable condition. The landscaping is maintained. The electrical components at the Ingraham Disinfection Station appear to be in good condition with no obvious signs of significant concern. The station does not have access to backup power in the event of power loss.

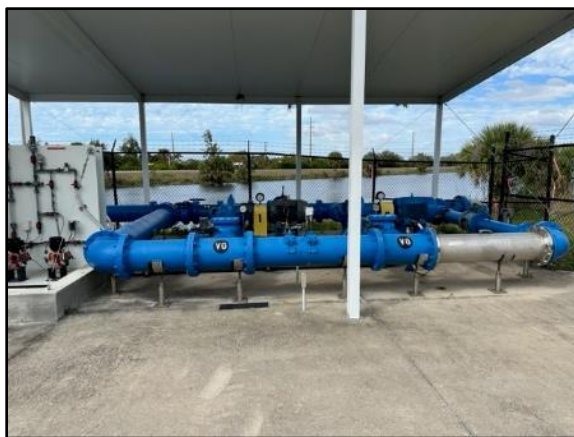
#### 4.1.3.6 Englewood – WBS #8

The Englewood (EWD) WBS is at 6369 Richledge Street, Englewood, Florida 34224. The EWD WBS is primarily used to boost water pressure or transfer water between EWD and CCU during an emergency. It includes two 40-HP booster pumps with a diesel generator for backup power supply. The station was upgraded in FY 2022 to include a chemical disinfection dosing system. However, the station was heavily damaged by Hurricane Ian in September 2023, including damage to electrical equipment and the on-site generator;

the WBS has not been used since the Hurricane while the repairs are pending. Monitoring at the interconnect facility includes total chlorine residual, free ammonia residual, pressure, and flow. By opening or closing valves, the EWD interconnect pumping station can pump water in either direction, i.e., to or from EWD. However, EWD and CCU must both get

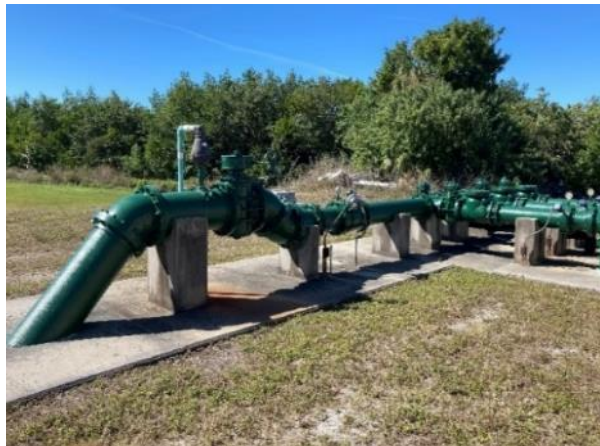
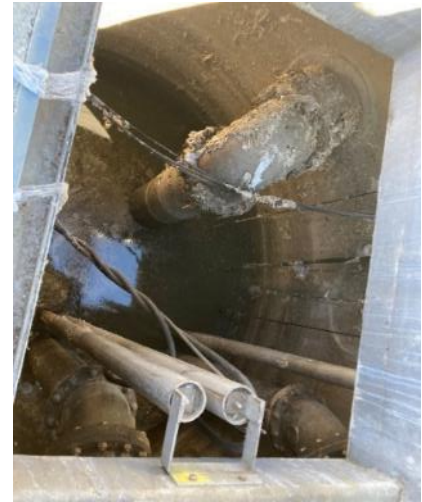
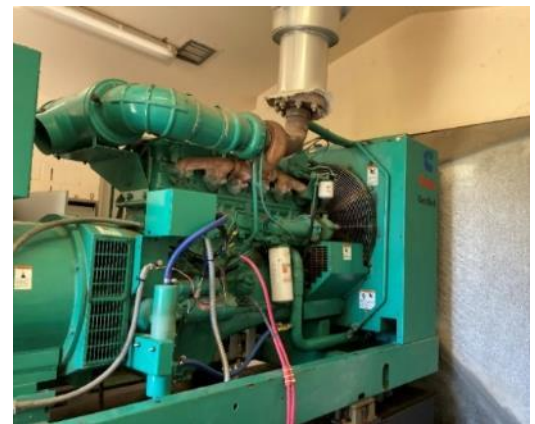
### 5.2.1 MASTER LS-65 SOUTH PORT

- Installed pumps will be running off their performance curve after the RTS and Grand Master Lift Station (GMLS) construction.
- The pressure meter is not functional.
- No fencing or enclosure to protect the valves and piping.
- Generator controls exceed the 6-foot-7-inch limit as required by code.
- The station currently only has two functioning pumps instead of three. Pump 1 is out of service.
- CCU staff noted that the suction piping was clogged.
- ARV is installed on the incorrect side of the valve assembly.
- Wetwell is showing signs of H<sub>2</sub>S corrosion.
- Discharge piping and appurtenances are showing signs of corrosion and sun damage.
- The circuit breaker for Pump 1 does not meet the required service capacity to function properly.

- Evaluate replacing the pumps to a lower head pump selection to avoid future run-out conditions.
- Repair/replace the pressure meter.
- Install a fence the entire site.
- Evaluate generator control elevations to conform to code.
- Cleanout suction pipe of pump 1 to place it back in service.
- Re-install ARV to the correct side of the valve assembly.
- Complete the rebuilding of pump 1 to reinstall it in the wetwell.
- Re-line the wetwell.
- Address the corrosion on the discharge piping and appurtenances and apply a new protective coating system as needed.
- Replace the 200A circuit breaker for pump 1 with a 250A circuit breaker.

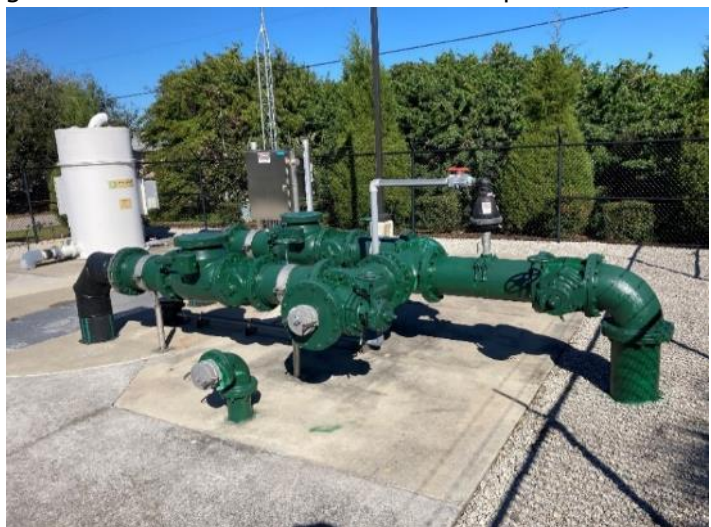
- One of the pumps was out of service and was removed. The other pump was not properly mounted to the railing system.
- CCU staff reports the generator main braker is undersized.
- Water service for the odor control unit is connected through a tube above ground.

- Service and reinstall the out of service pump. Re-mount the other existing pump.
- Replace the generator main breaker with an adequately sized breaker.
- Install an underground line to provide water service to the lift station.

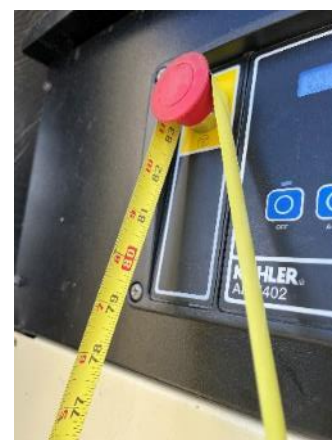
- The standby generator is mounted above a sub-based fuel tank, placing it at a significant height above the ground. The measured mounting height for the emergency stop switch is approximately 83 inches above the ground, making it 3 inches higher than the maximum allowed by the code (80 inches).
- The lift station is missing appropriate ArcFlash labeling on all 480 V equipment, as required by NFPA 70E.

- Lower the mounting of the standby generator so that it is below the required 80 inches.
- Add missing ArcFlash labeling on all 480 V equipment.

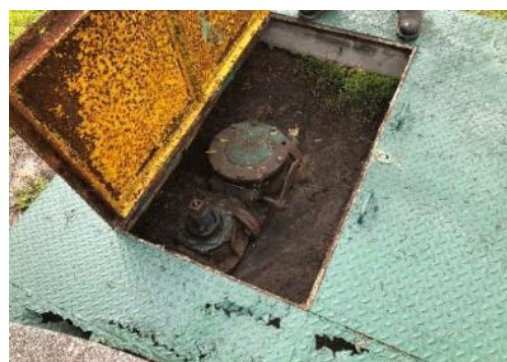
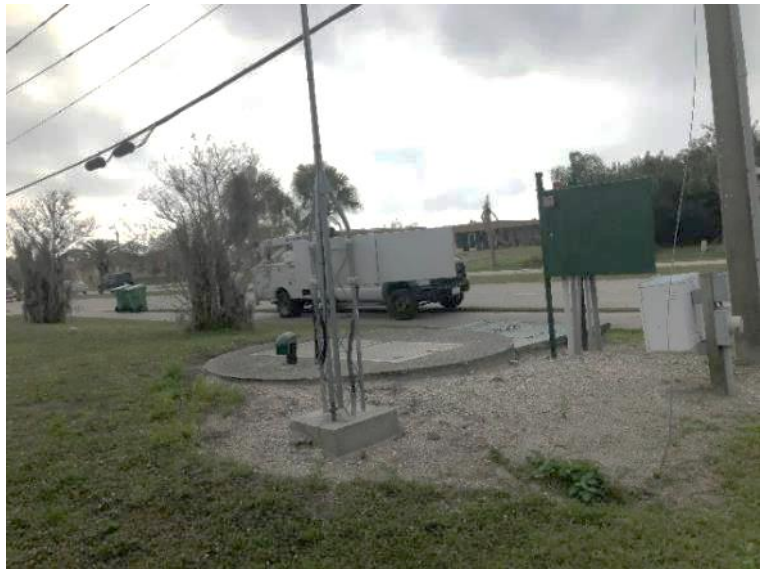
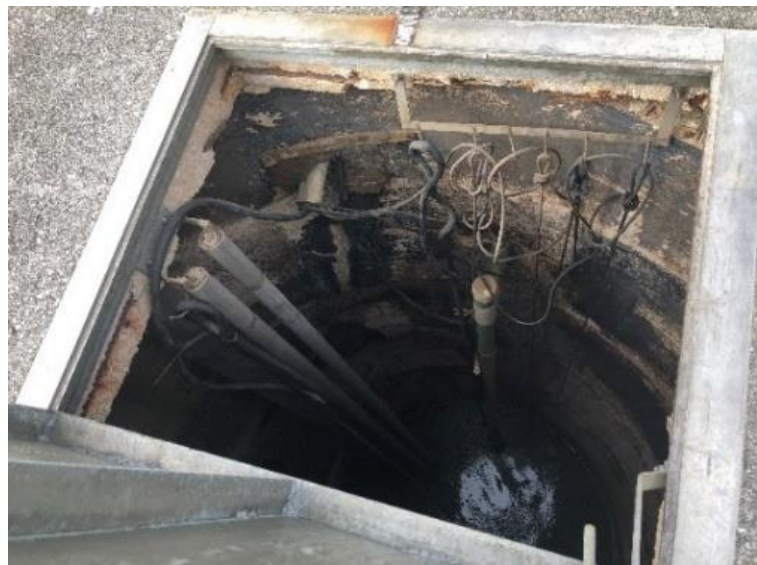
### 5.2.4 MASTER LS-816 ROTONDA BOULEVARD WEST

- Signs of corrosion on the wetwell interior wall likely due to high hydrogen sulfide concentration.
- Interior concrete slab shows wear, exposing structural rebar and wood.
- Significant wear shows on the valve vault, including partial burial of the valves.
- No dedicated suction or discharge bypass piping.
- Missing seal-offs from the control panel conduit. This represents a significant code violation as well as a potential explosion hazard.
- Rusted and worn padlocks on the wetwell hatches.

- Re-line the wetwell.
- Repair or rehabilitate the concrete top slab.
- Replace the valve vault and bring to current standards or evaluate converting the valves to aboveground.
- Install seal-offs on any electrical equipment within 10 feet of the wetwell to return to conformance with code.
- Install dedicated suction or discharge bypass piping.
- Rehabilitate or replace the padlocks on the wetwell hatches.
- Evaluate the adjacent lot for future lift station conversion.

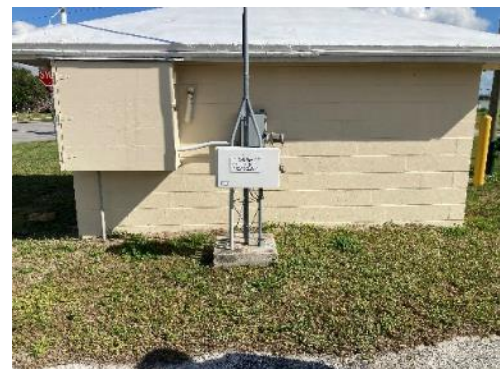
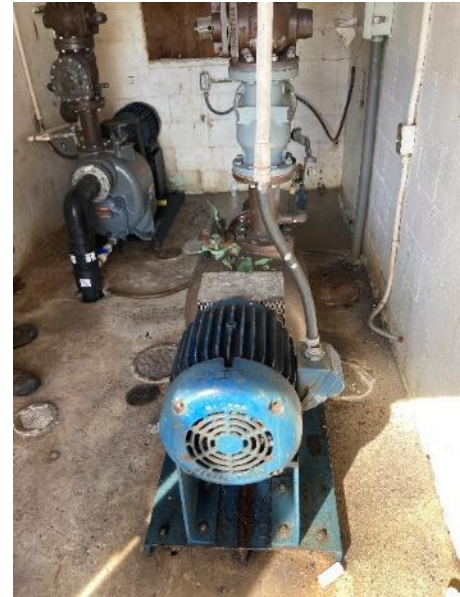
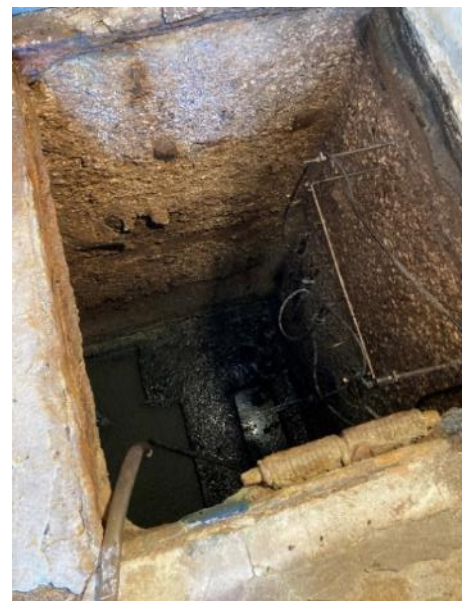
#### 5.2.5.1 LS-1 Community Center

- The concrete building has cracks, including visible daylight through pipe penetrations.
- Signs of corrosion on the wetwell interior wall from hydrogen sulfide.
- The access hatch hinge is separated from the wall.
- Notable wear of paint on pumps and piping.
- Conduit running out of the top of the electric meter is no longer connected and exposed. The metal conduit casing has begun to cut and damage the main electrical feed wiring.

- Seal cracks in building and gaps in pipe penetrations.
  - Evaluate the significance of the corrosion to the wetwell.
  - Anchor the access hatch hinge back to the wall.

- Restore and seal the conduit connection to the electric meter.

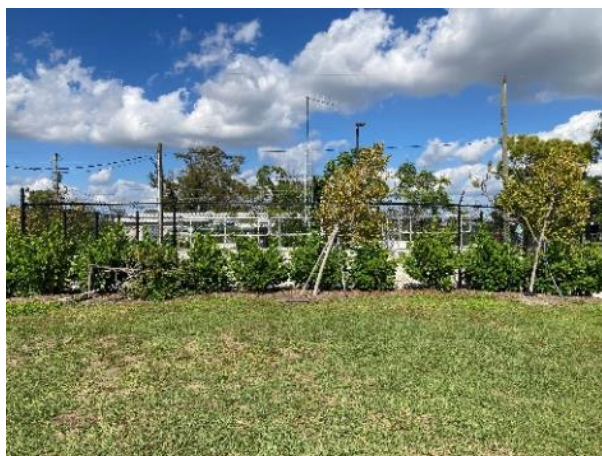
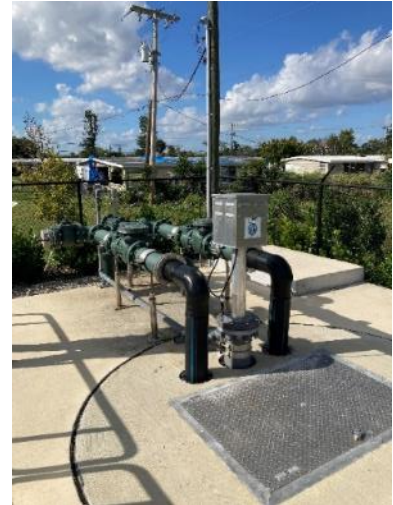
**5.2.5.2 LS-2 Dalton**

- Slight corrosion and paint wear on the discharge piping and appurtenances.
- The front gate is damaged and is temporarily repaired using zip-ties.

- Address the corrosion on the discharge piping and appurtenances and apply a new protective coating system as needed.
- Complete a permanent repair to the front gate.

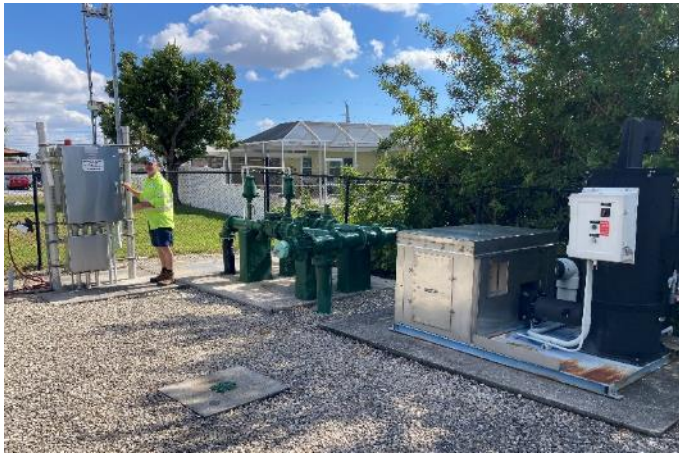
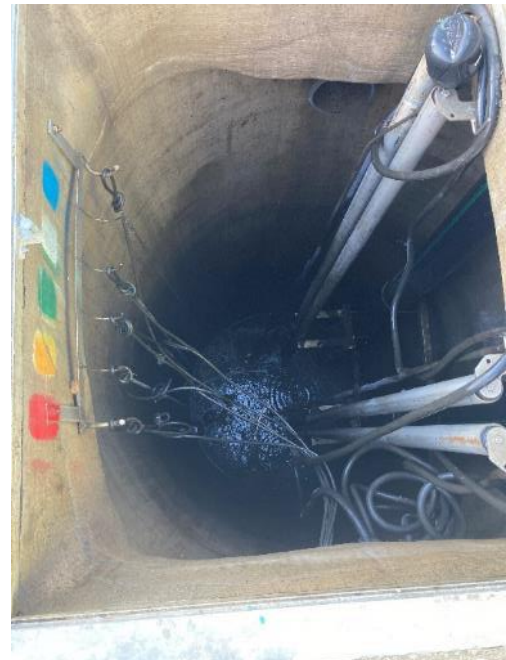
### 5.2.5.3 LS-6 Higgs

- Adequate lighting is not available for evaluating the control panel or wetwell.
- Eroded rock base along southwest fence line has introduced a slip-and-fall hazard. Noticeable gaps are between the grade and the bottom of the fence in various locations.
- Slight corrosion and paint wear on the discharge piping and appurtenances.
- Cracking was observed in the square formwork at the top of the wetwell.
- Odor control system is out of service.
- The surge protector on the main disconnect switch is damaged.
- Float seated atop pump rail and appeared to be damaged.
- Yard waste, debris, and traffic control devices located immediately outside the security fence.
- Geotextile fabric along the station driveway appeared to be overgrown and partially damaged and/or removed.

- Evaluate the installation of additional site lighting for lift station serviceability.
- Reestablish level grade along southwest fence line and along perimeter fence line to eliminate slip-and-fall hazard.
- Address the corrosion on the discharge piping and appurtenances and apply a new protective coating system as needed.
- Evaluate the significance of cracks in concrete formwork at the top of the wetwell.

- Re-establish the float operations in accordance with the intended lift station design.
- Remove yard waste, debris, and traffic control devices immediately outside the security fence.
- Re-establish driveway loading support for CCU vehicle ingress/egress and crane operations.
- Assess the need for an odor control system. If deemed necessary, replace the odor control system.
- Install new SPD to protect the main disconnect switch.

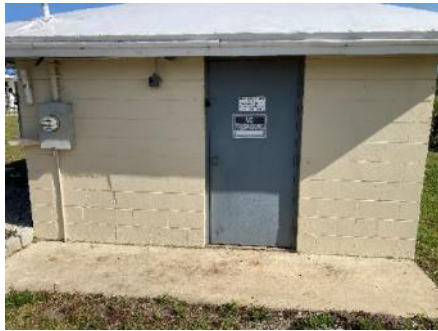
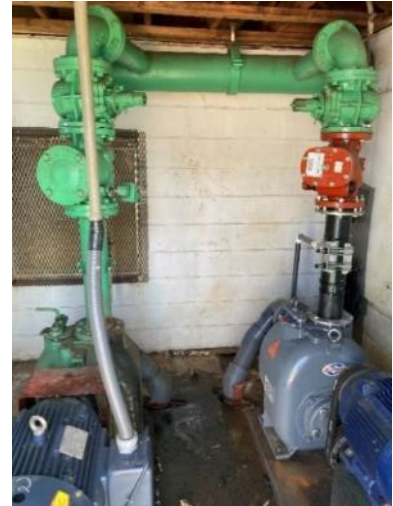
#### 5.2.5.4 LS-7 Pure Oil

- Missing seal-offs from the control panel conduit.
- Obstructed access for a crane truck.
- Corrosion on Gorman-Rupp pump.
- Outdated and lack of surge protection observed.
- Inadequate indoor lighting.
- Float terminal blocks are exposed.

- Address the corrosion on the Gorman-Rupp pump and apply a new protective coating system as needed.
  - Install new and/or up to date SPDs to protect the pumps and SCADA system.

- Install proper indoor lighting.
  - Rehabilitate float terminal blocks to meet NEC codes.

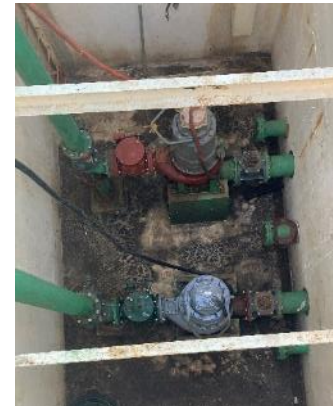
#### 5.2.5.5 LS-9 Church

- Concrete corrosion in the wetwell and concrete separation around the wetwell access hatch.
- Operations staff noted issues with force main flows fighting against each other during heavy rain events.
- Corrosion on seal-offs below the control panel and the portable generator receptacle.
- A small hole was found in the fence in front of the bypass connection.

- Evaluate possible options for converting the station to submersible; otherwise evaluate concrete repair and restoration for the site.
- Evaluate system curve conditions in high rain events to ensure efficient pump selection.
- Install new and/or up to date SPDs to protect the pumps and SCADA system.
- Address the corrosion on the portable generator receptacle and apply a new protective coating system as needed.
- Provide provisions to access the bypass valve while maintaining site security.

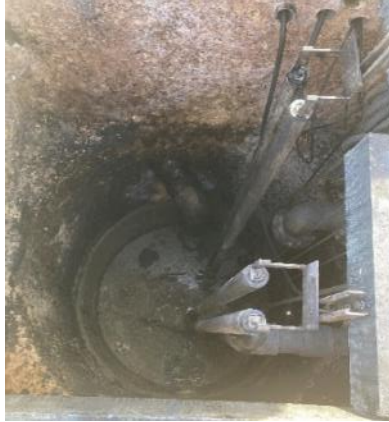
#### 5.2.5.6 LS-24 Charlotte Square

The station is equipped with a 2-inch cylindrical rail-retrieval system. The wetwell is an older design in which the valve vault is not separated by a wall and is instead a shelf built into the side of the wetwell (shown in photograph to the left). This design can be dangerous to operators who need access during high-water levels in addition to confined space issues and sulfide exposure. The site is not fenced in and has a large buildup of debris and trash from surrounding businesses. Table 5-10 provides the details for this lift station.

- Heavy corrosion of the lined concrete wetwell and equipment.
- Flooding events during heavy rainfall in short periods (flash flooding).
- No dedicated station bypass.
- The current discharge piping configuration poses major safety concerns as there is no separation between the discharge piping/valves and the wetwell.
- Missing seal-offs from the control panel conduit.
- Missing dedicated site lighting.
- Valve vault hatch bolt is corroded, and the valve vault cannot be opened properly.

- Evaluate the wetwell for potential structural repair and restoration of wetwell lining.
- Current and buildout flows will be modeled by Jones Edmunds as part of the RTS, Interceptor, and GMLS Update. Based on the model evaluation, improvements will be suggested to address issues with flooding events.
- Construct a separate isolated valve vault for operator safety, including standard dedicated discharge.
- Install seal-offs on any electrical equipment within 10 feet of the wetwell to conform with current codes.
- Evaluate incorporating dedicated lift station lighting.
- Restore valve vault hatch to normal operating conditions.

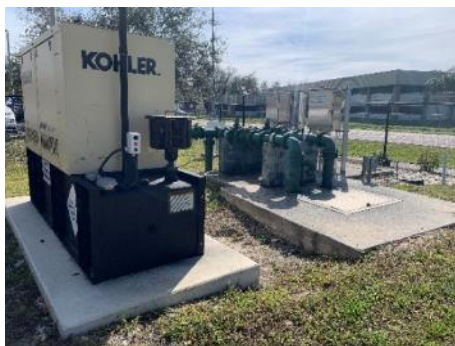
**5.2.5.7 LS-25 Vo-Tech**

The site is fenced with barbed wire but does not have dedicated site lighting, but the operator noted the lighting is generally adequate due to the lift station being near a traffic intersection. Adequate space appeared to be provided for maintenance activities. The operator advised that the site was being evaluated by CCU for a potential sinkhole and advised the Jones Edmunds staff not to walk on or stand near the grade settlement. Subsequent observation of the wetwell indicated a gravity sewer line runs under the

identified area, potentially damaged or crushed by the observed grade settlement.  
Table 5-11 provides the lift station details.

- Lined concrete wetwell is showing early signs of corrosion.
- Grade settlement observed near generator and between discharge piping and generator.
- Potentially crushed invert east of the wetwell.
- Missing ARVs on the discharge piping.
- Antiquated check valves.
- Missing SPD.

- Re-line the wetwell.
- Re-establish grade near the generator and between discharge piping and generator to original condition.
- Evaluate the invert east of the wetwell.
- Replace the removed ARVs on the discharge piping.
- Replace the check valves with those specified in CCU standards.
- Install new and/or up-to-date SPDs to protect the pumps and SCADA system.

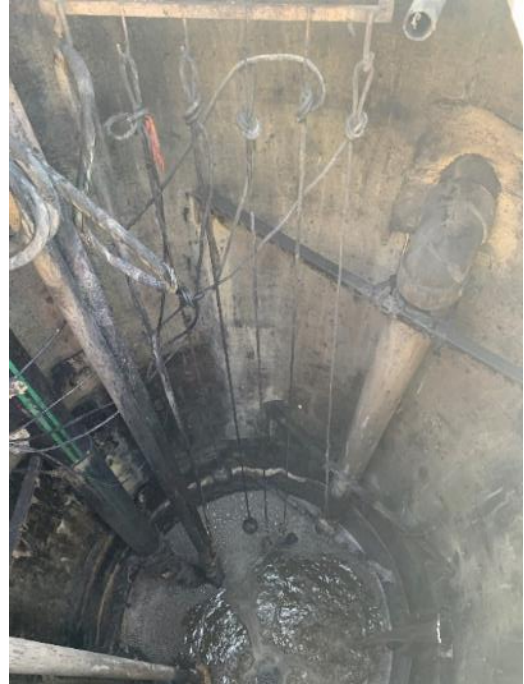
The wetwell is extremely corroded with cracks along the lining of the wall, and lining separation from the wall. The wetwell hatch is in good condition and provides adequate access to remove the pumps along the 2-inch cylindrical rail-retrieval system. The wetwell is vented but a strong odor was present at the time of the site visit. The adjacent lined valve vault includes 4-inch ductile iron discharge piping, Dezurik plug valves, and Mueller check valves with a dedicated discharge. Heavy corrosion is evident within the vault, particularly on the check valves. The hatch of the valve vault is in good condition.

- Evaluate and perform full replacement of wetwell, valve vault, and associated appurtenances to meet CCU standards.
- Address the corrosion on the piping, check, and plug valves in the vault and apply a new protective coating system as needed.
- Evaluate incorporating dedicated access for operations staff.
- Restore corroded fence materials and repair the fence damage. Re-establish the grade between the fence and gravel.
- Re-establish the pump to its original seating to prevent blowback.
- Evaluate the addition of an odor-control system.
- Replace the seal-offs on the control panel due to heavy corrosion and immense sulfide odor.
- Evaluate incorporating dedicated lift station lighting.

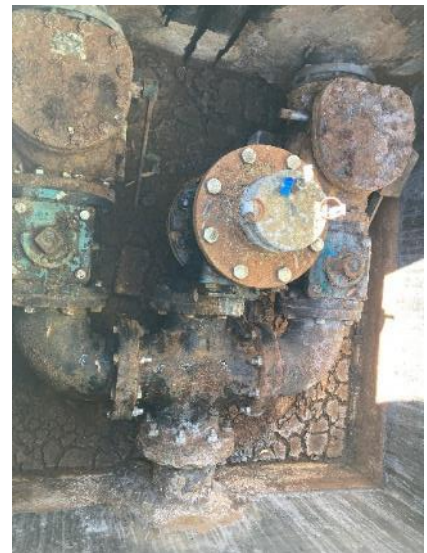
- The wetwell has severe lining peeling and corrosion.
- Piping, check, and plug valves in the vault are heavily corroded.
- Being next to the school makes access difficult during peak school traffic.
- The fence is corroding at the brackets and hinges, has barbed wire damage, and has gaps between grade and fence line.
- Blowbacks from the pump.
- Strong hydrogen sulfide odor from the wetwell.
- Seal-offs are corroded.
- Missing dedicated site lighting.

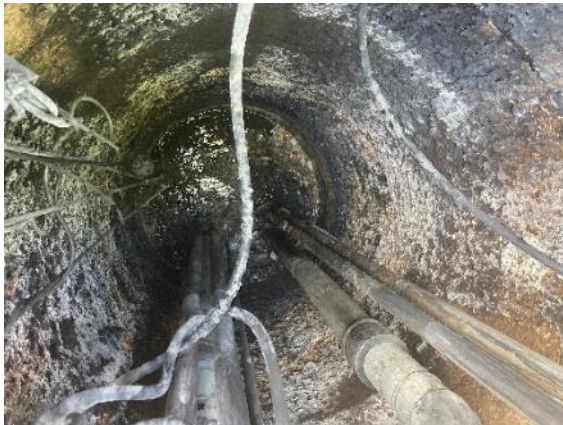
### 5.2.5.9 LS-45 Woodbury

- Missing seal-offs from the control panel conduit.
- Strong hydrogen sulfide odor from wetwell.
- Broken invert between the LS and manhole to the immediate east (on Woodbury Drive). The operator reported repairs to the invert and/or manhole are pending through CCU.
- The fence and barbed wire are showing signs of corrosion and have some damage.
- Piping, check, and plug valves in the vault are heavily corroded.
- Missing or damaged swing mechanism for the check valve.
- Wetwell is showing signs of corrosion.
- Outdated SPD.
- Missing dedicated site lighting.
- The concrete support for the control panel, power feed, and main disconnect is damaged.

- Install seal-offs on any electrical equipment within 10 feet of the wetwell to return to conformance with current electrical codes.
- Install an odor-control system.
- Evaluate and complete rehabilitation of the invert and/or manhole to immediate east to restore normal operating conditions.
- Address the corrosion on the piping, check, and plug valves in the vault and apply a new protective coating system as needed.
- Replace corroded fence materials. Repair fence and barbed wire damage.
- Rehabilitate or replace check valve.
- Re-line the wetwell.
- Install new and/or up-to-date surge-protection device (SPDs) to protect the pumps and SCADA system.
- Evaluate incorporating dedicated lift station lighting.
- Repair or replace the damaged concrete electrical support.

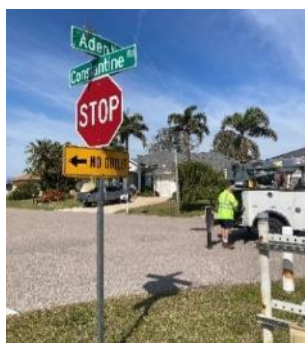
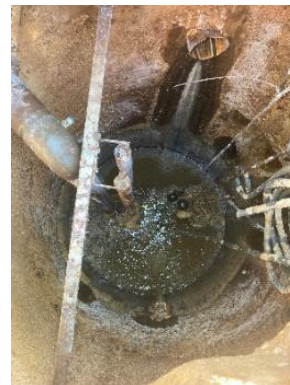
#### 5.2.5.10 LS-303 Constantine

The wetwell is in the center of the road intersection, which requires Operations staff to manage traffic during routine maintenance and any pump removal. The design to move the lift station into the lot and convert the existing wetwell to a master manhole has been completed. The new design includes isolation valves and bypass piping, which currently do not exist at this simplex station. Table 5-13 provides the lift station details.

- No interlock between the generator breaker and the main breaker.
- Missing seal-offs from the control panel conduit.
- Difficult-to-access wetwell.
- No isolation valves.

- Install an interlock on the electrical equipment and perform a detailed electrical code review to return to conformance with code.
- Install seal-offs on any electrical equipment within 10 feet of the wetwell to conform with current codes.
- Perform thorough rehabilitation on the wetwell and prepare for construction of the improved design to allow safe access.
- Prepare for construction of the improved design to allow safe access, inclusion of appropriate valves, and inclusion of bypass piping.

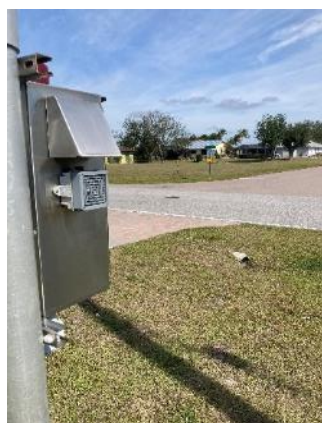
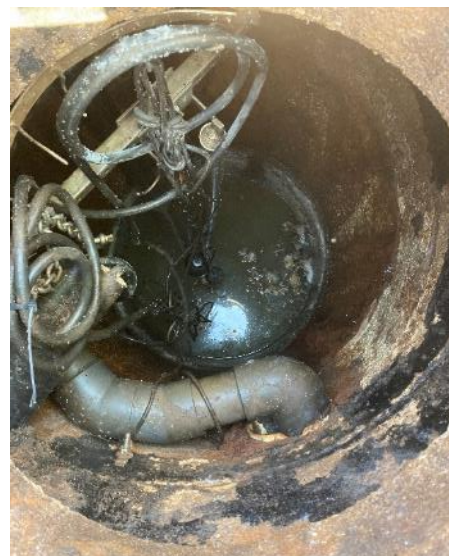
### 5.2.5.11 LS-305 Bremen

The lift station requires Operations staff to manage traffic during routine maintenance and any pump removal. The lift station is planned to move into a nearby lot and for the existing wetwell to be converted to a master manhole. Table 5-14 provides the lift station details.

- No interlock between the generator breaker and the main breaker.
- Missing seal-offs from the control panel conduit.
- Difficult-to-access wetwell.
- No isolation valves.

- Install an interlock on the electrical equipment and perform a detailed electrical code review to return to conformance with code.
- Install seal-offs on any electrical equipment within 10 feet of the wetwell to conform with current codes.
- Perform thorough rehabilitation on the wetwell and prepare for construction of the improved design to allow safe access.
- Prepare for construction of the improved design to allow safe access, inclusion of appropriate valves, and inclusion of bypass piping.

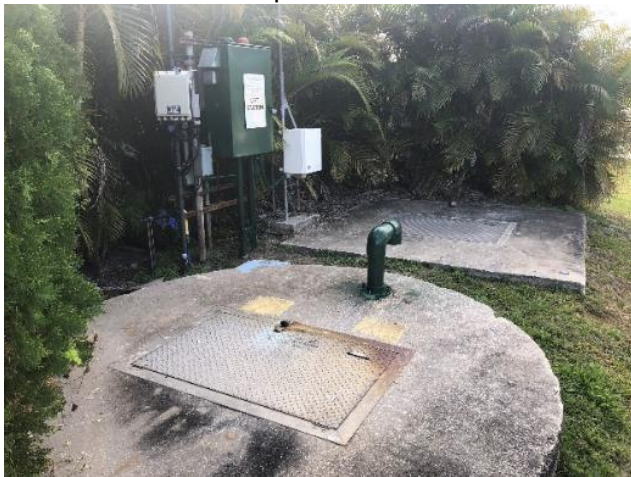
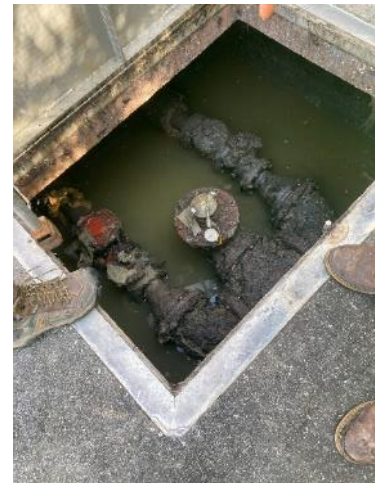
#### 5.2.5.12 LS-323 Aysen

- Signs of corrosion on the wetwell and valve vault interior likely due to hydrogen sulfide concentrations.
- No interlock between the generator breaker and the main breaker.
- Missing seal-offs from the control panel conduit.
- Nearby vegetation is impeding access to the control panel.

- Coat the wetwell and valve vault and repair the valve vault appurtenances.
- Install seal-offs on any electrical equipment within 10 feet of the wetwell to conform with current codes.
- Proceed with lift station conversion.
- Remove nearby vegetation around the control panel.

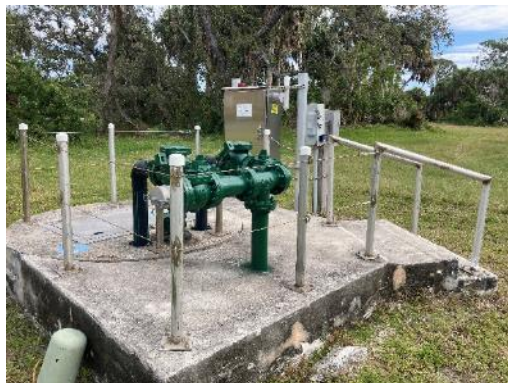
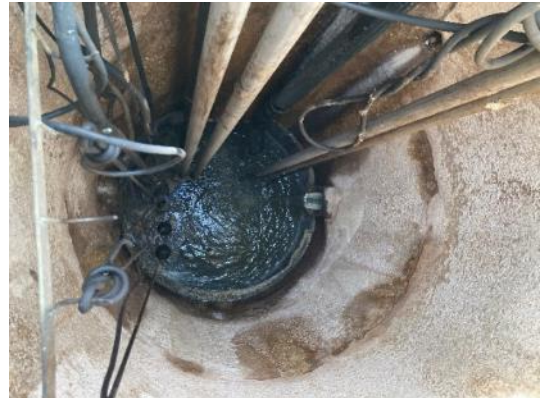
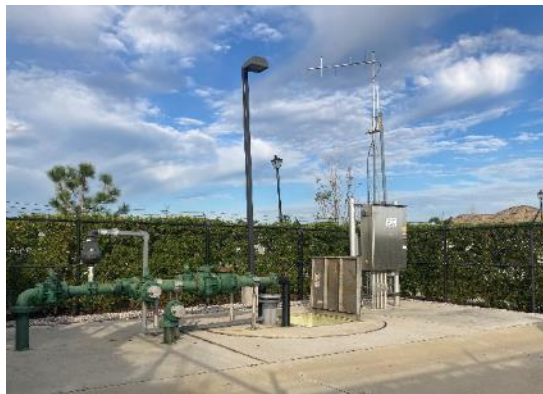
#### 5.2.5.13 LS-812 Annapolis

- Missing seal-offs from the control panel conduit. This represents a significant code violation as well as a potential explosion hazard.
- No dedicated drive access. Difficult to access during wet weather.
- Missing potable water service near the station.
- Missing SCADA system.
- Wetwell is cracking and leaking.
- Wetwell is showing signs of corrosion.
- Missing dedicated site lighting.

- Install seal-offs on any electrical equipment within 10 feet of the wetwell to return to conformance with current electrical codes.
- Construct dedicated access pathway for the Operations staff.
- Connect to water service near the station.
- Install a SCADA system.
- Seal cracks and leaks in wetwell.
- Re-line the wetwell.
- Build dedicated lift station lighting.

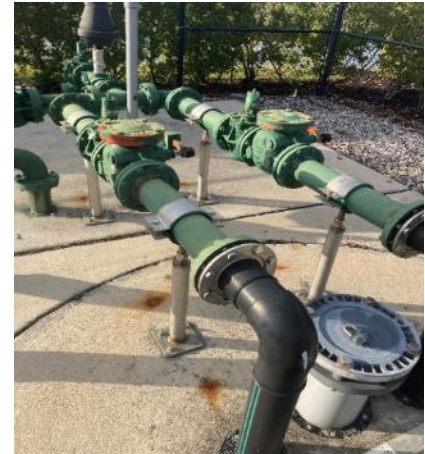
- Paint chipping and slight corrosion on the discharge piping and appurtenances.

- Address the corrosion on the discharge piping and appurtenances and apply a new protective coating system as needed.

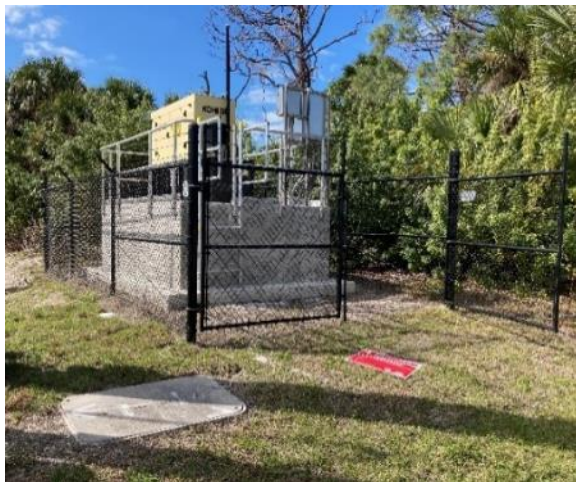
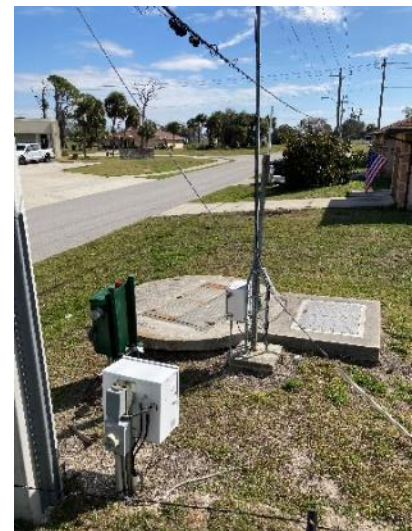
#### 5.2.5.15 LS-821 Rebel Court

The station is equipped with a T-shaped rail-retrieval system. A dedicated discharge is on site but is buried, showing signs of corrosion, and not easily accessible in case of an emergency.

- Missing seal-offs from the control panel conduit.
- Erosion around the wetwell lid.
- Signs of I/I into the wetwell due to gaps between wetwell section rings. The wetwell is showing signs of degradation due to lack of liner.
- Corrosion of valves in the valve vault.
- Corrosion of wetwell hatch.
- Corrosion of discharge bypass camlock connection.
- Outdated SPD.
- Missing dedicated site lighting.

- Install seal-offs on any electrical equipment within 10 feet of the wetwell and perform a detailed electrical code review to return to conformance with current electrical codes.
- Re-establish grade around the wetwell lid.
- Re-line the wetwell
- Address the corrosion on the discharge piping and appurtenances and apply a new protective coating system as needed.
- Rehabilitate or replace the wetwell hatch.
- Rehabilitate or replace camlock connection.
- Install new and/or up-to-date SPDs to protect the pumps and SCADA system.
- Build dedicated lift station lighting.

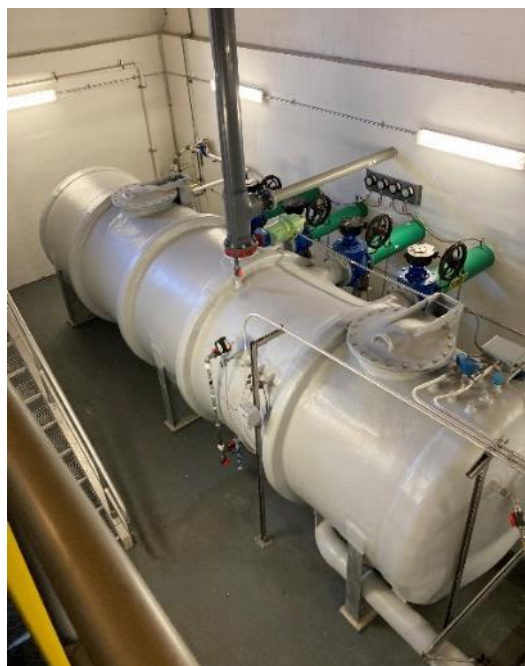
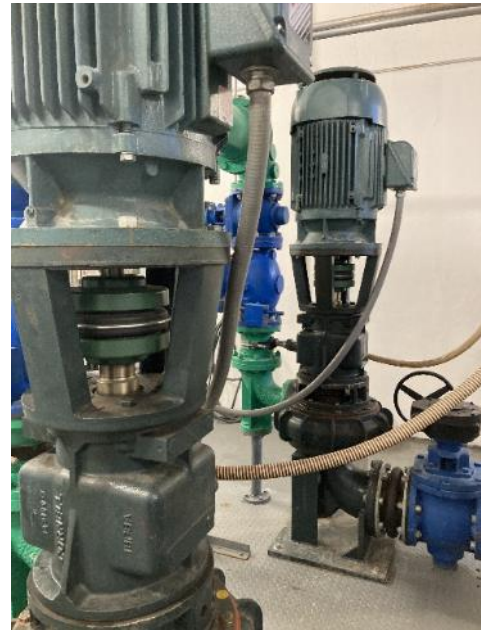
The Skylark Vacuum Station (VS-1) is at 598 Skylark Lane NW, southwest of the intersection of Azalea Avenue NW and Skylark Lane NW. This vacuum lift station receives flow from the vacuum collection system in the surrounding area through two 10-inch and two 8-inch vacuum lines. VS-1 discharges through a 6-inch that manifolds into an 8-inch force main header that conveys flow to the East Port WRF.

The building contains a dedicated pump crane for removing the discharge pumps and valves from the lower level. Additionally, CCU maintains a portable hoist system for use at any vacuum station. The station is gated and surrounded by a block wall. The roof and ceiling are being repaired from wind damage from Hurricane Ian. The operators noted that equipment is frequently cleaned, but poor drainage in the vacuum tank pit results in additional

The following deficiencies were noted:

- The crane pump on site is not aligned with the valves. Some of the valves are below the common discharge line and meter, making them difficult to access with the crane.
- The access for tank maintenance is at the top of the tank without a dedicated access point.
- Plastic covers for the effluent pump motor components are missing or broken.
- Liner within mulch bed is tearing at the edges. Poor drainage in the vacuum tank pit.
- Check valve for pump 1 was noted by CCU staff to be leaky.
- Missing discharge flow meter.

Proposed improvements to the station include:

- Modify the overhead crane for lateral movement.
- Add a catwalk for accessing the top of the tank for maintenance.
- Rehabilitate or replace the leaky check valve.
- Replace the plastic covers for the pump motor components.
- Evaluate solutions to address poor drainage to achieve better drainage, such as at VS-2 Harbor.
- Rehabilitate the liner for the mulch bed.
- Install a discharge flow meter.

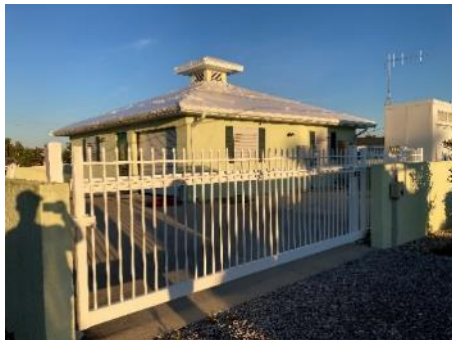
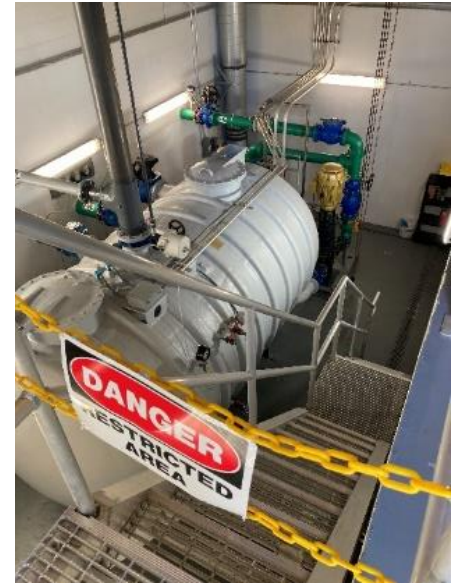
The Harbor Vacuum Station (VS-2) is at 3450 Harbor Boulevard. This vacuum lift station receives flow from two 8-inch vacuum lines, with a third 8-inch influent line for future use. VS-2 collects flow from approximately 200 homes in the surrounding area. VS-2 transmits flow through a 6-inch Siemens flowmeter to the Southport Master Lift Station (LS-65), which flows directly to the East Port WRF. The building contains a dedicated pump crane for removal of pumps and valves from the lower level.

The station is gated and surrounded by a 4-foot block wall. CCU added a hazard sign near the stairwell to prevent entry by unauthorized personnel. The roof and ceiling are being repaired from wind damage from Hurricane Ian. The station has outdoor and indoor site lighting. The generator is operated once a week each Monday to verify standby power capabilities. Table 5-21 provides the vacuum station details.

The following deficiencies were noted:

- The pump crane on site is not aligned with the pump or the valves. Some of the valves are below the common discharge line and meter, making them difficult to access with the crane.
- The tank maintenance access is at the top of the tank without a dedicated access point.
- The pump skid continuously rusts.
- The moisture separator seals are beginning to corrode.
- Poor interior lighting due to repairs from Hurricane Ian.
- Reported issues of unauthorized personnel being near the site.
- Suction and discharge bypass labels are not consistent with other vacuum stations.
- The exhaust fan was reported by CCU staff to be out of service.
- The liner for the mulch bed is tearing at the edges.

Additionally, the Jones Edmunds electrical engineer visited on February 11, 2025, to meet with staff and observe the station. CCU staff reported the exhaust fan at the lower level is inoperable and out of service. A belt has been ordered to replace the current one, if this was caused by mechanical or electrical issues is unknown.

The electrical engineer noted the following deficiencies:

- The interior of the structure is missing a ceiling, which is being replaced.
- Temporary lighting has been strung across the ceiling but provides poor illumination, which might be an issue for staff.
- Unsupported conductors are partially suspended from the ceiling. These are likely from the original lighting and intended to be reused. Extreme care should be taken within the facility due to the potential of shock hazard.
- The exhaust fan is inoperable at the lower levels – a belt replacement was ordered.

- Modify the overhead crane for lateral movement.
- Add a catwalk for accessing the top of the tank for maintenance.
- Evaluate long-term solutions to pump skid rusting.
- Replace corroded seals on moisture separators.
- Evaluate lighting improvements for operators like those at Ackerman VS-4.
- Rehabilitate the liner for the mulch bed.
- Relabel the suction and discharge bypass piping to be consistent with other vacuum stations.
- Evaluate security improvements for better monitoring (i.e., cameras, etc.).

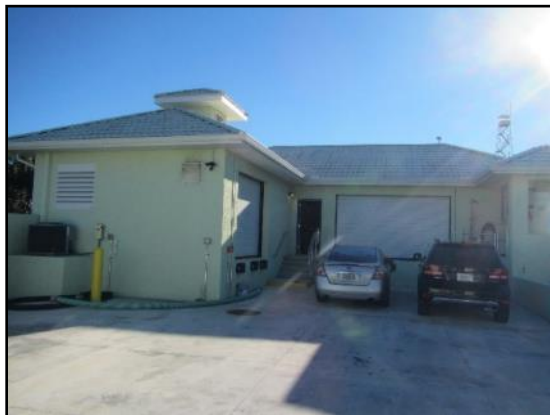
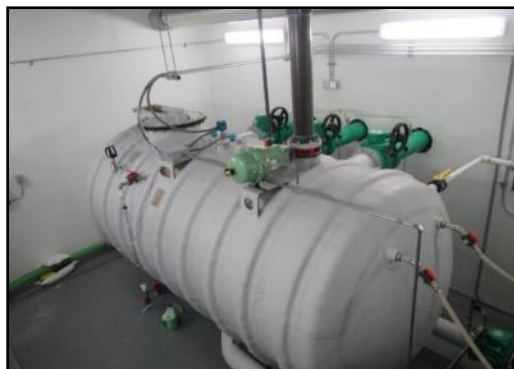
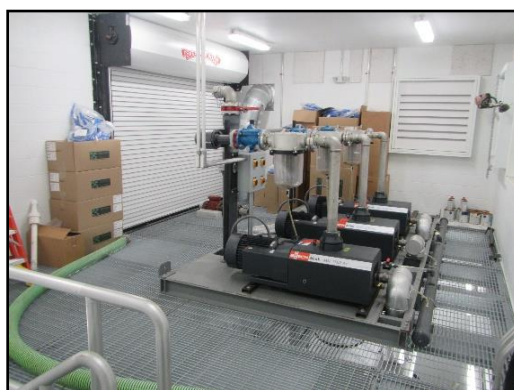
The El Jobean Vacuum Station (VS-3) (LS 99) is at 4070 Railroad Avenue, south of the intersection of Weeksonia Avenue and Railroad Avenue. The vacuum lift station receives flow from the vacuum collection system in the surrounding area, including residential units and three restaurants, through three 8-inch vacuum lines.

The following deficiencies were noted:

- The access for tank maintenance is at the top of the tank without a dedicated access point.
- The overhead door to pull the vacuum pumps is relatively short and has a low ceiling.
- The platform holding the vacuum pumps near pump 2 has a small crack.

Proposed improvements to the station include:

- Install a catwalk or dedicated ladder for accessing the top of the tank for maintenance.
- Verify the vacuum station site is in accordance with OSHA and County safety and confined-space requirements.
- Install a portable hoist or dedicated overhead crane for easier access to the vacuum pumps.
- Evaluate fall protection needs while removing pumps for maintenance and repair.
- Rehabilitate or repair the platform holding up the vacuum pumps.

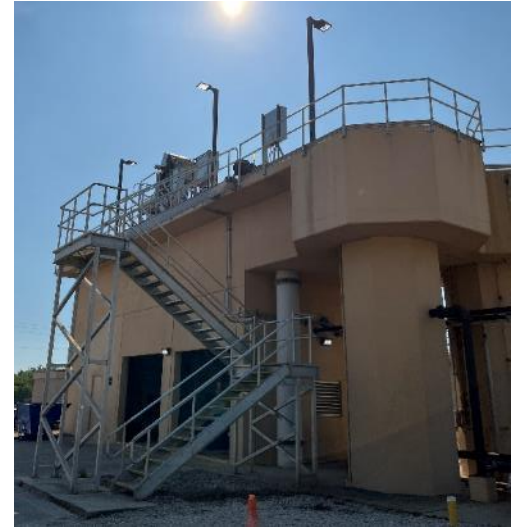
The overall condition of the headworks is fair, but various components have experienced corrosion and are in poor condition. The CCU WRF team have kept the equipment functioning. The CCU WRF staff have installed a number of bird deterrents on the lower level on pipes and ledges, but a few areas remain where birds still land and create waste on the floor.

- The rake/teeth used to clear the screens of captured debris have broken off or deteriorated along with other components. CCU is working to replace the headwork screens, but an overall replacement with an upgraded headworks is recommended in the next 1 to 2 years.
- The grit classifiers show signs of corrosion.
- The aluminum grating at the influent channel was not installed or missing at the time of the visit and should be to be reinstalled or replaced.
- The floor is clean and dry.
- The hose bibb at the top of the headworks was disconnected and no longer in use.

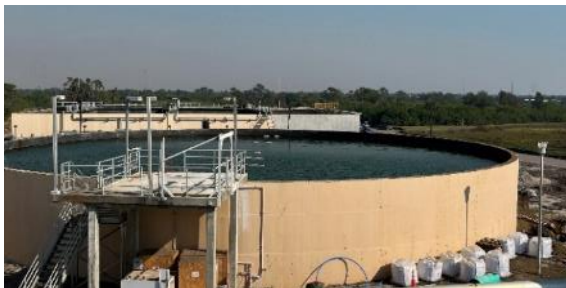
The East Port WRF does not have flow EQ storage for peak-hour influent flows and loads. However, the 1.48-MG cast-in-place concrete tank that previously served as an aerobic digester is being modified and retrofitted to serve as an influent EQ tank as part of the 9.0-MGD expansion under construction.

- The tank is full of water, and the contractor has been working on leak-testing and mitigation.

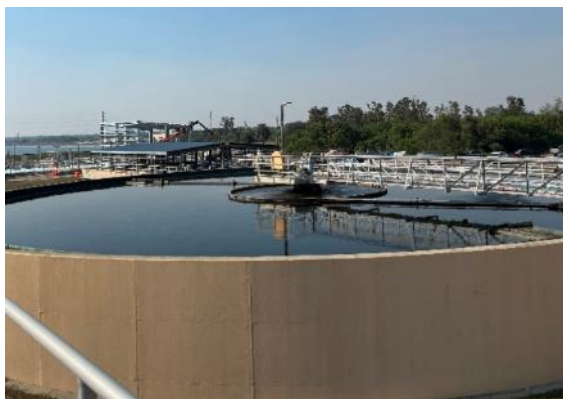
The overall condition of the clarification process is well maintained and clean. The two existing clarifiers were observed to be in good operating condition.

- The light pole on the walkway between the two clarifiers was replaced after being blown off by Hurricane Ian.
- The clarifiers have five well-maintained and functioning VFD-controlled RAS pumps. RAS Pump No. 4 was replaced in FY 2023, and the motor for RAS Pump No. 3 was replaced in FY 2023. Operators set controls through SCADA.
- The RAS flow meter was calibrated in December 2024.
- Two well-maintained and functioning WAS pumps are controlled by operators' settings in the SCADA system.
- The scum ejectors were replaced in FY 2023; however, they will eventually be replaced with a cost-effective scum-pumping system as part of the 9.0-MGD plant expansion that is under construction.
- Two additional clarifiers and a matching RAS and WAS pump stations are under construction as part of the 9.0-MGD plant expansion.

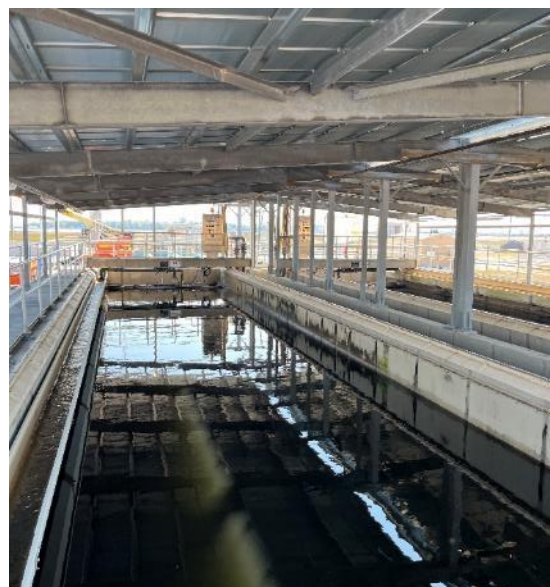
The overall condition of the effluent filtration system is good.

- Both filters were in operation and were rehabilitated in FY 2023/2024.
- New roof panels were installed on the galvanized frame and provide UV protection for the filters as part of the 9.0 MGD expansion.

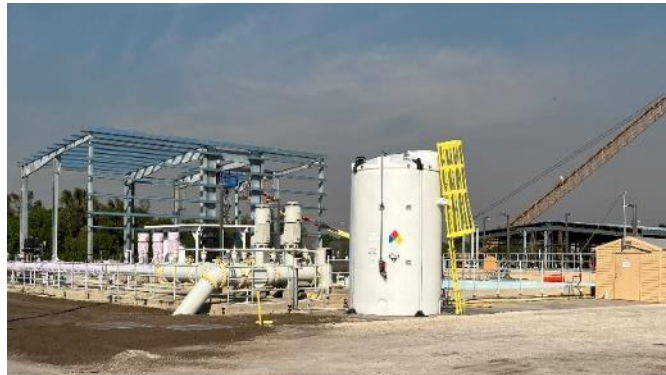
The CCCs and chemical feed systems are in good condition, well maintained, and operated to produce reclaimed water for unrestricted public-access reuse.

- Liquid sodium hypochlorite (12.5 percent) is stored in a 6,000-gallon dual-containment tank.
- The skid-mounted chlorine feed system is encased in a clear plastic enclosure with access doors on the front and top.
- The effluent flow and monitoring locations (EFA-01 and EFA-02) are clearly marked, and the refrigerated effluent composite samplers are in good operating condition.
- The effluent sample pump at CCC No. 1 does not have a proper base and should be provided with a new one.
- A new chemical storage and feed facility are under construction as part of the 9.0-MGD plant expansion.

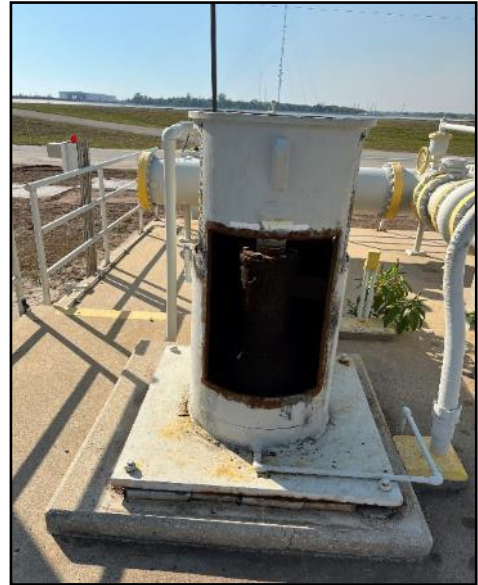
The pond transfer pump station is in the CCC No. 2 clearwell and transfers water to the ponds.

- Pump No. 1 was out of service for repairs and is expected to be returned in FY 2025.
- The other two pumps are well maintained but are showing signs that they need to be repainted.
