# Charlotte County Utilities Department

## 2024 Annual Report

### May 2025

Jones Edmunds Project No.: 03405-029-08

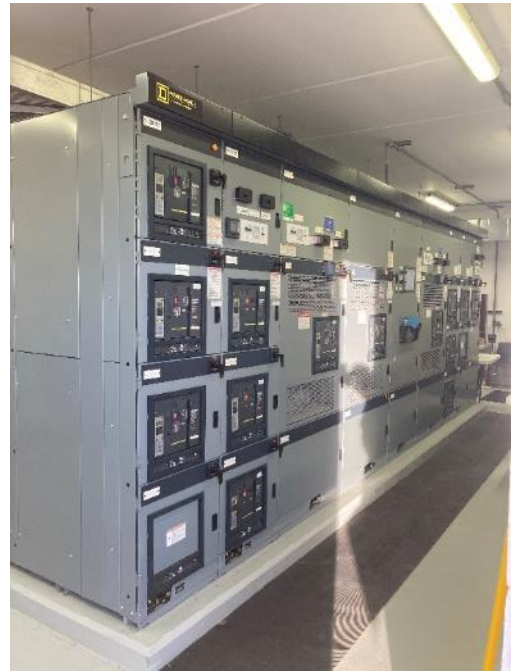
The East Port WRF contains one 1,250-kW generator serving as the primary standby power and an additional 1,500-kW generator. One standby generator serving the Administration Building was relocated from another facility in used condition. The facility has five primary electrical switchgear locations – the Administration Building, the Generator/MCC Building, the new primary Incoming Switchgear Building, the new Electrical Building No. 2, and the Blower Building. The Administration Building has a separate service drop from the power company. The rest of the WRF is served through two new parallel transformers serving the incoming switchgear building recently constructed. The Administration Building, the incoming switchgear building, and Electrical Building No. 2 were all constructed within the last 9 years. The Generator/MCC Building had upgrades and improvements to the existing original equipment and generators. The Blower Building has been in service for several years.

The incoming service and distribution transformers at the Administration Building are in excellent condition with no obvious signs of concern. The standby generator functions properly and is in good condition. Since it was relocated from another location, it does show signs of wear and deterioration but with no major issues to interfere with its function. The distribution switchgear of the Administration Building was in excellent condition with minor issues (see below). Overall, the electrical equipment is in good functioning condition based on information from Operations staff.

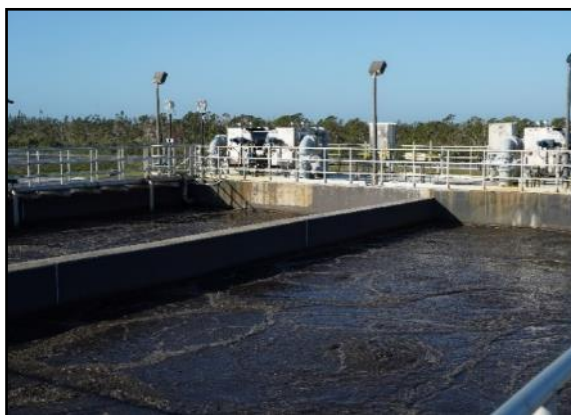
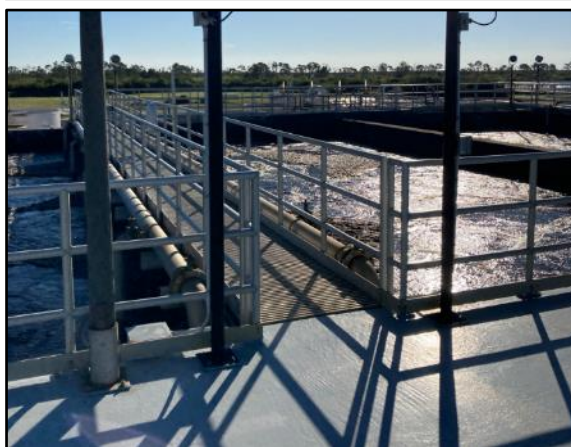
The overall condition of the activated-sludge facilities is good. The mixed liquor suspended solids (MLSS) are sampled every morning by the Operations staff. The WRF has four aeration basins. However, the lack of grit removal continues to present a maintenance challenge since deposited grit levels rise to block the diffusers. At the time of the site visit, Basin No. 4 was offline for cleaning. Overall, wastewater in the aeration basins was well mixed with some foam accumulation at the surface.

All three blowers appeared to be functioning as intended. Blower 2 received a new motor last year. Usually, one blower is operated at a time to meet aeration requirements. The operators cycle the blowers weekly. The plant typically operates between a pH of 6.6 and 6.7 but adjusts seasonally by running an additional blower. A timer is used to turn the blower on and off throughout the day. Using pH for operational control is not the most practical method for treating wastewater; an alternate control method including DO and oxygen-reduction potential (ORP) should be evaluated. The outlet weirs of the aeration tanks require manual cleaning when debris catches on the weirs.

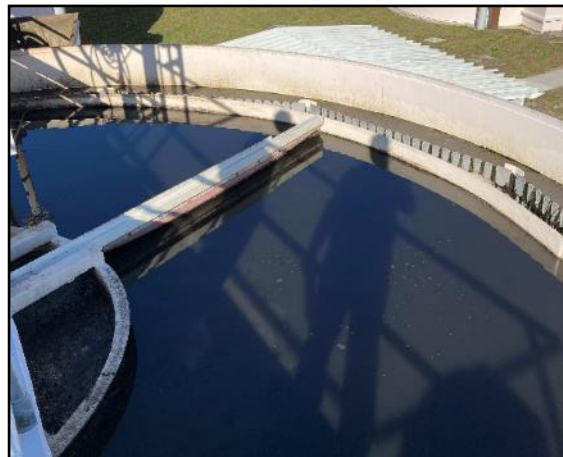
Each of the feed wells had a small hole in the top wall causing a noticeable amount of suspended solids to exit into the main part of the clarifier. Operations staff follow a routine schedule of clarifier inspection, repair, and painting. The stairways leading to the bridges of the aboveground clarifiers were painted in FY 2020. The fiberglass grating and steps show signs of minor fraying and wear.

Overflow weirs are sprayed daily and brushed every 2 weeks to keep them clean. Algae builds up quickly despite the frequent cleanings. The overflow weirs were leveled in FY 2017. New weirs were installed in Clarifier No. 1 and Clarifier No. 2 in FY 2018. Clarifier No. 3 and Clarifier No. 4 received new weirs in FY 2020 and FY 2021, respectively.

The sludge-return chambers on the side of each clarifier have telescoping valves used to adjust sludge withdrawal from the bottom of the clarifier. The sludge is then conveyed to the four RAS/WAS pumps that are housed under a sheet-metal roof. Floatables accumulate in the sludge chambers and are periodically removed by manually skimming the 5-foot-by-5-foot boxes from the clarifier bridge when the chambers are full. The telescopic valves were operating properly, and the RAS/WAS pumps are in good operating condition. The pumps were being painted at the time of the visit.

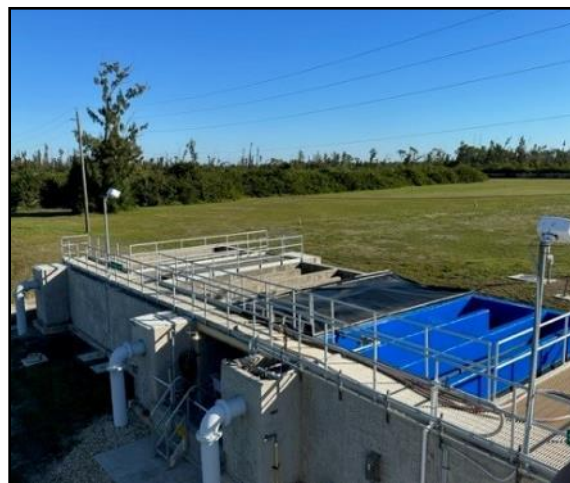
The overall condition of the chlorination system is excellent with the exception of the permanent roof structure. The roof was blown off due to Hurricane Ian but has not been repaired. Only CCC No. 1 was in service at the time of the site visit. CCC No. 2 was reported to be in good working condition. CCC No. 1 was recently painted. Each CCC has two trains. Good turbulent flow in the inlet boxes to the CCCs creates effective mixing. The pH and chlorine analyzers are in good working order. Plant operators clean the analyzer assemblies at regular intervals to remove any algae buildup. They also periodically alternate the CCCs to clean them.

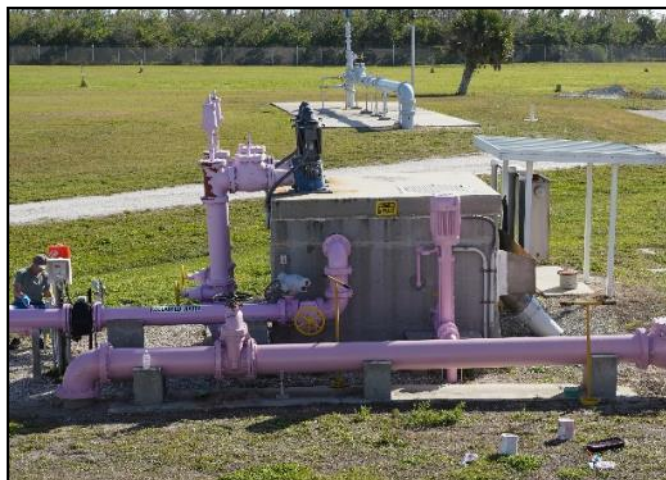
The reclaimed water pump station conveys water into the interconnected MRS. The station contains two reclaimed water HSPs and one jockey pump. The two HSPs were replaced in FY 2021, the HSPs have difficulty pumping against the head conditions in the MRS. The main reclaimed water customer for the West Port WRF is the Coral Creek Golf Club Golf Course, which receives reclaimed water through a 7-mile-long, 10-inch-diameter main along Gasparilla Road.

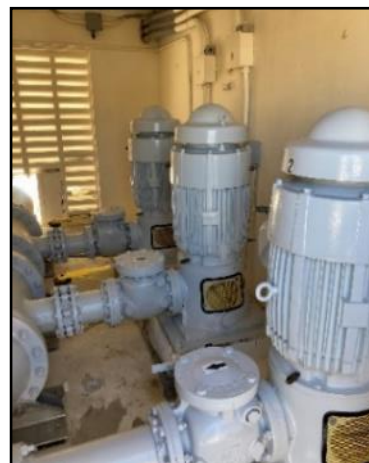
The plant also contains an option for reclaimed water disposal via deep injection well. Three new deep-well pumps are used to convey effluent through a 16-inch manifold pipe into the deep well. The building housing the pumps suffered wind damage from Hurricane Ian but was not yet repaired.

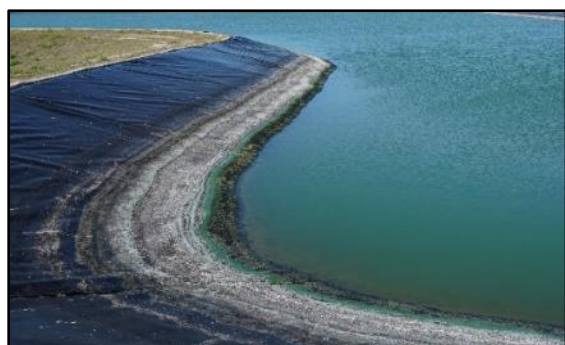
The on-site reclaimed water ponds provide up to 20 MG for wet-weather storage of reclaimed water. At the time of the site visit, the pond linings appeared to be in good condition. The ponds had some algae growth at the time of inspection. CCU is evaluating adding diffusers for the ponds.

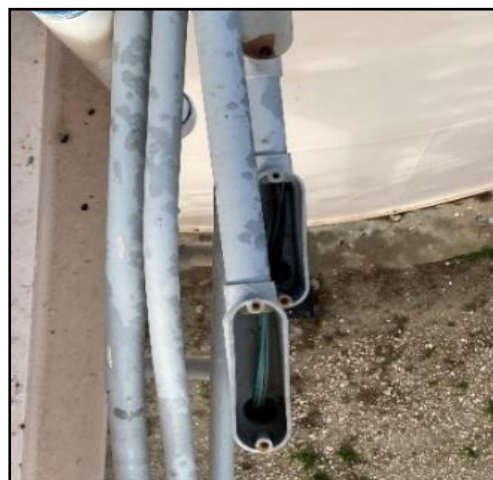
- Clarifiers No. 1, 2, 3, and 4 are missing conduit clamps on area lights.
- Clarifiers No. 1 and 2 have broken conduit and are missing a line-box-style fitting cover.
- The conduit supports on the north wall of the headworks/aeration basin have broken, leaving the conduit unsupported.

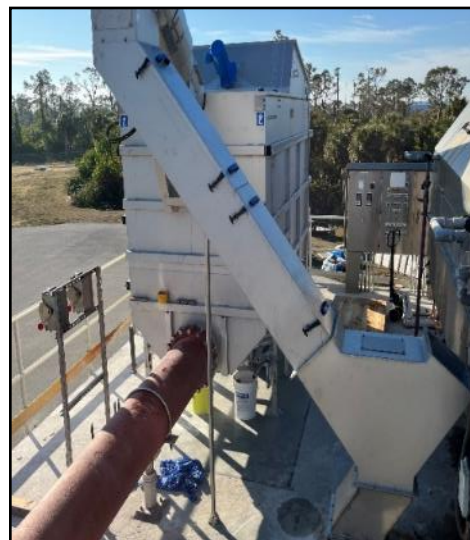
The overall condition of the headworks is fair to poor. Construction of the headworks improvements project was underway at the time of the visit.

- Portions of the new influent piping had been installed.
- One screen had been replaced with a new Huber Rotamat screen. The other screen will be replaced as well.
- The grit removal system is functioning as intended.
- The grit cyclones are scheduled for replacement in FY 2024 and FY 2025 as part of the headworks improvements project.

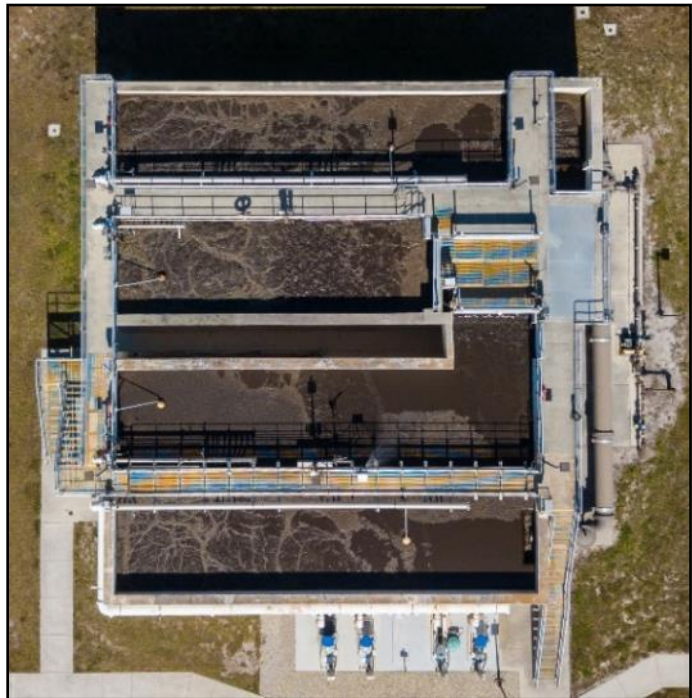
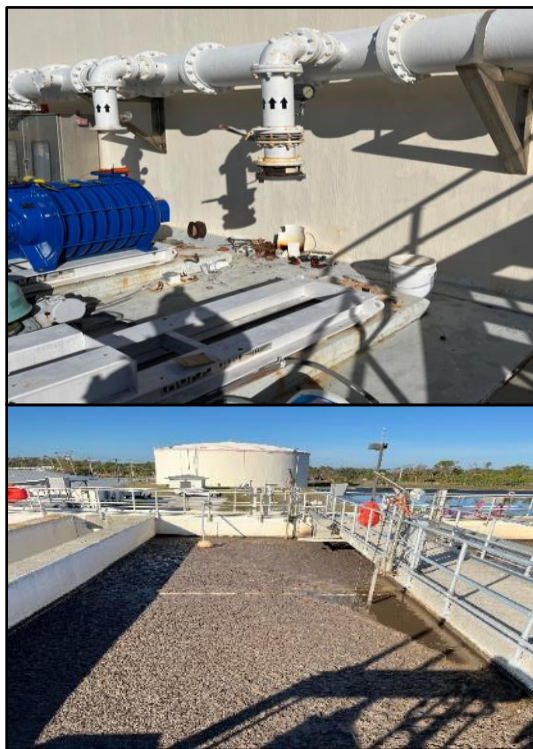
- The anoxic zones and the use of automatic DO probes to control blower speeds have contributed to the high level of treatment performance while conserving power.
- The lead operator noted that the aeration tanks are run at an MLSS concentration of 5,600 to 5,700 mg/L.
- A layer of foam was on the water surface in the anoxic zone at the time of inspection. To increase denitrification, additional tank volume may be needed.
- Additional mixers in the first anoxic zones are recommended.
- The Chief Operator indicated that an inspection of the diffuser in the aeration zones will be completed in summer FY 2025.

- Blowers No. 1 and No. 2 switched locations.
- Blower No. 2 was removed and is scheduled for replacement in FY 2026.
- Blower No. 1 was undergoing repairs at the time of the site visit.
- Blowers No. 4 and No. 5 were in excellent condition.
- The Chief Operator indicated they prefer three large and two small blowers for better flexibility.
- A sensor on one of the DO probes was replaced, and the other three probes are functioning properly.
- All Hach sensors that had been sun-damaged were replaced, and new UV covers were installed.

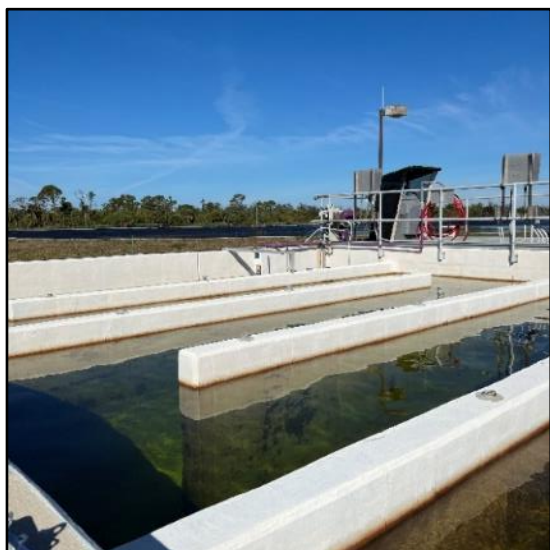
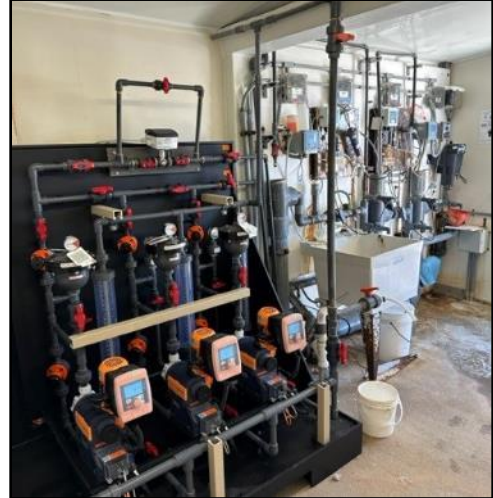
- Wind from Hurricane Ian in September 2022 caused the UV filter cloth and metal roof to be blown off the CCC, and it was still missing at the time of our site visit. During the site visit, neither CCC had a UV filter cloth.
- Operators should monitor the corrosion of the chlorine skids.
- The chlorine storage tanks feature polyethylene single-walled tanks with secondary containment basins. The tanks were replaced in FY 2021.

- Small-diameter corrugated HDPE drain piping coming from the secondary containments appeared to be in fair condition, and the in-line valves were open during the site visit.
- In FY 2024 secondary containment piping was installed from the storage tanks to the feed pumps.
- The canopy that covered the storage tanks was blown away by Hurricane Ian and replaced in FY 2024.
- The metal backplates for the chlorine analyzers have substantial corrosion and staining and should be replaced.

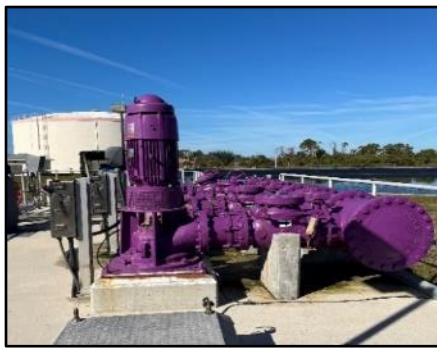
- The HSPS No. 1 motors were replaced with outdoor-rated motors in FY 2024.
- The HSPSs and aboveground piping were repainted in FY 2021.
- Both pump stations appeared to be in good working order during the visit.

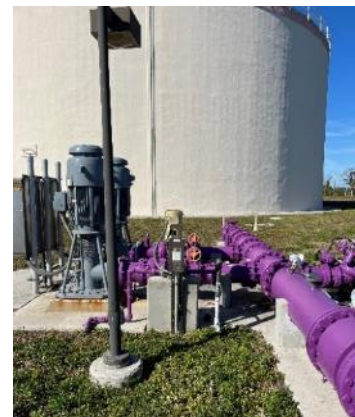
Reclaimed water from the GST can be pumped to pressurized reuse customers using HSPS No. 2. The GST exterior appeared to be in good overall condition.

- The GST was drained and cleaned in FY 2017, and USG Water Solutions completed a detailed condition assessment on the exterior and interior with a report in April 2023.

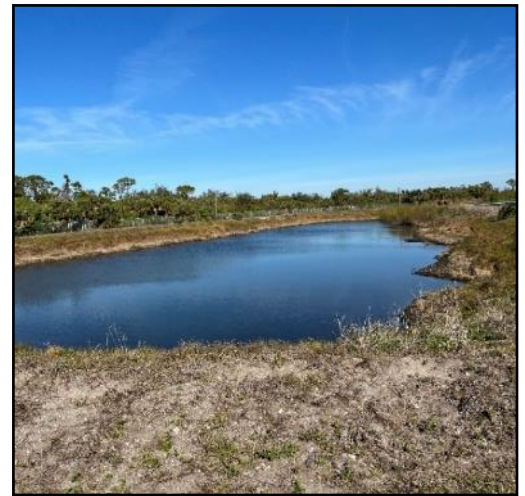
- The unlined reclaimed water storage pond has a reduced capacity due to groundwater percolation into the pond. The brush around the pond had been cleared in FY 2024.
- The Chief Operator expressed that the unlined storage pond is not being used at this time or in the foreseeable future. Jones Edmunds recommends considering removing this pond from the operating permit. Future planning indicates that this pond would be filled with compacted suitable soil and replaced with a 3.0-MG GST. This is expected to be decided as part of the Rotonda WRF Upgrades to AWT project currently in the planning phase.

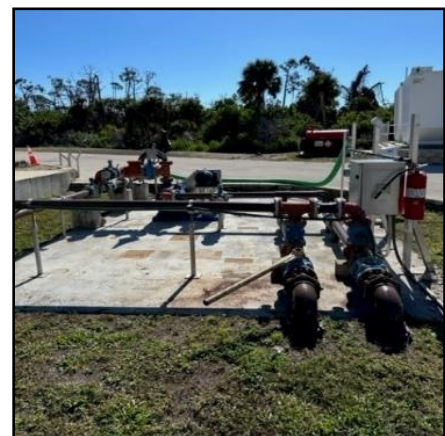
The overall condition of the solids-handling facilities is good. The decant mechanism for the sludge-holding tanks use telescoping valves, but the telescoping valves are limited to being lowered to one-half the depth of the tank. The operators have replaced the designed method of decanting by using bottom-

feed submersible pumps lowered to the desired level with a winch to control the decanting level. Currently, decanting is done daily to attempt to maintain the holding tank capacity.

- No indication of limitations to the sludge-hauling capabilities was observed, as noted in last year's report.
- The pump-out station pumps and piping were replaced in FY 2023 by the CCU staff.
- One tank was half empty at the time of the visit.

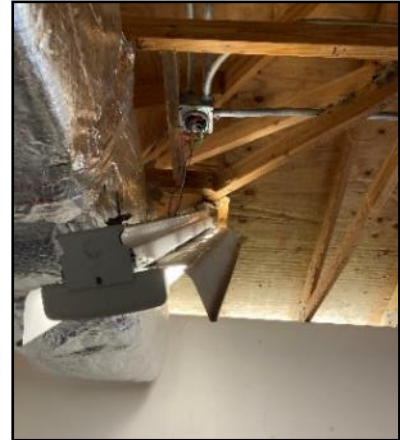
- MCC Building No. 3 sustained Hurricane Ian damage such that interior lighting fixtures are hanging from wires – representing a significant hazard to staff (see photo). This deficiency is a repeat listing from previous years.
- Several control boxes made of fiber-reinforced plastic are showing severe signs of UV damage.

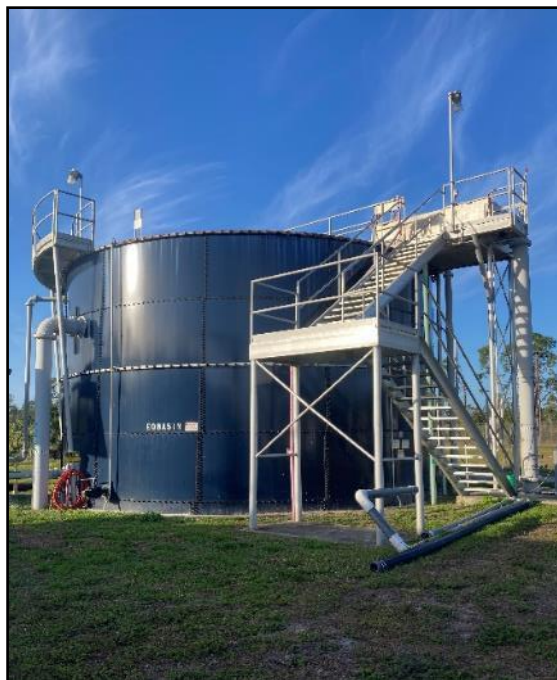
The Aquastore EQ tank is in poor condition. The EQ tank has signs of rust around the upper steel rim, which likely originates from the RO WTP waste line. Internal piping is in poor condition with leaks at flanged fittings, and one of the drop diffusers inside the EQ tank has been damaged and is no longer secure. Since no grit-removal facilities are provided, grit accumulation occurs in the EQ tank and reduces treatment capacity. The grit accumulation is currently being managed by having a vendor periodically pump out the grit in the EQ tank while in operation. The blower and motor for the EQ tank need to be replaced. The air diffusers and piping should be cleaned and/or repaired as necessary the next time the tank is cleaned.

Construction of the Burnt Store WRF expansion, which is projected to be completed by FY 2026, should evaluate the installation of a new headworks. Operations noted the EQ tank is scheduled for cleaning at the next EQ tank inspection.

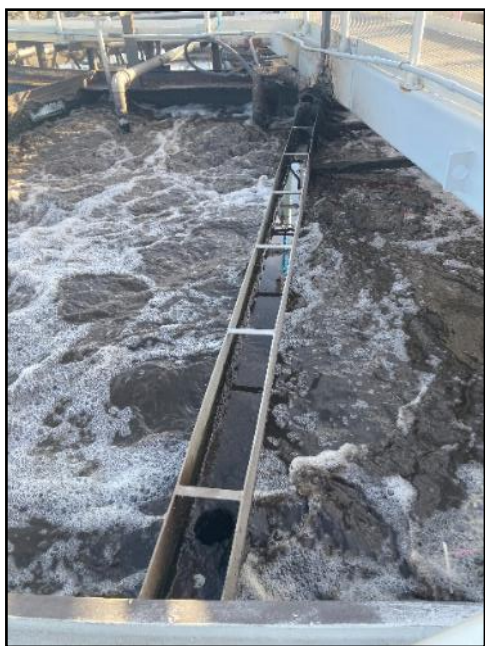
The activated-sludge facilities are steel-ring package plants consisting of two aeration tanks and two clarifiers. At the time of the site visit, the aeration basins appeared to have adequate and even air distribution throughout the tank. All blowers were rebuilt in FY 2017, and new VFDs were provided for two of the blowers in FY 2022. Motor repairs for Blower No. 1 were completed in FY 2023. Blowers 2 and 3 need to be replaced. The Chief Operator noted that the blowers are undersized for the volume of wastewater that the plant has been experiencing recently. Additionally, the pressure gauges for the blowers were not working at the time of the site visit. The operation of the blowers is based on timers, but no DO sensors are provided to adjust blower operation. The hinged sluice gates separating the two aeration tanks are not functioning as intended, allowing wastewater to flow to the adjacent tank during maintenance. The tanks have

minimum free-board (<1 foot), creating concerns of overflowing during high-flow conditions or if a downstream flow obstruction occurs. CCU staff reported that the tank has since been successfully repaired by staff with assistance from a certified diver. The repairs included installing steel cables to adjust the sluice gates.

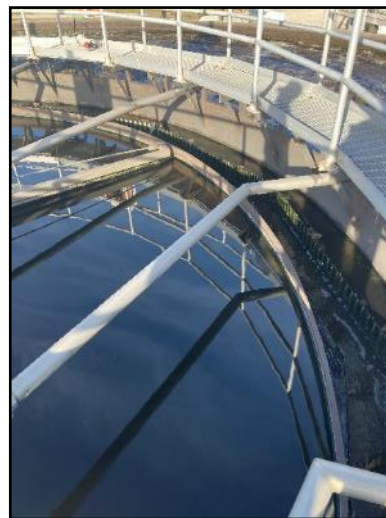
The clarifier portions of the tanks appear to be functioning, although solids were observed near the surface; Clarifier No. 1 appeared to be performing less adequately than Clarifier No. 2 based on water flow and additional solids observed at the surface. The Chief Operator noted that Clarifier No. 2 typically treats approximately 60 percent of the plant flow. Notable algae growth was observed on the weirs. A significant amount of floatables passes through the headworks and collects in the clarifiers. The floatables are returned to the headworks and accumulate in the WRF until they are manually removed. The scum troughs were observed to be worn and need replacing. Operators must manually turn on the solenoid to drain the East tank's scum trough and return floatables to the headworks; this should be replaced to automatically drain the trough. The two RAS/WAS pumps that draw solids from the bottom of the tanks are in poor condition and are operating at their end of lifetime. RAS Pump No. 1 was replaced in FY 2023. The valves of the RAS/WAS station have notable rust and should be considered for replacement. The pipe pumping design makes it difficult for operators to de-rag the pumps. The Chief Operator mentioned that the gear box for the clarifiers needs repair or replacement soon. CCU continues to maintain and repair these systems until the WRF expansion is completed.

Overall, the tanks appear to be in good condition and were recently painted. Additionally, a white rock and shell aggregate was being installed around the tanks, adding to the plant aesthetics.

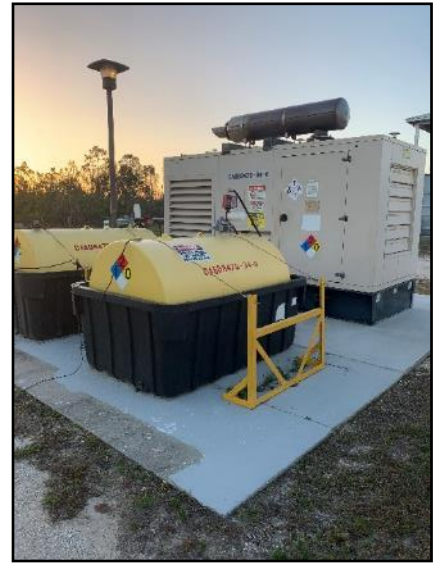
The incoming switchgear and distribution transformer appear in fair-to-good condition. The incoming power company service transformer exhibits an extensive amount of surface rust, which may soon be impacting the transformer function. The existing primary distribution switchboard outside the MCC room is also exhibiting signs of degradation from the weather. The plant is served from a single generator of an undetermined size, and its water pump was replaced in FY 2022. The generator was in good condition but exhibited signs of residual diesel fuel on top of the diesel fuel tank. This may be indicative of additional issues. Overall, the electrical equipment in Building MCC-1 is in good functioning condition based on information from the Operations staff, except for the deficiencies listed below.

- The switchgear contains warning labels identifying parts and components as being energized. However, none of the equipment includes the appropriate arc-flash labeling required by NFPA 70E.
- The fiberglass MCC building should be replaced with a concrete structure.
- The main breaker trips when two blowers are started simultaneously.
- The generator is undersized and is not capable of supporting all blowers at one time.

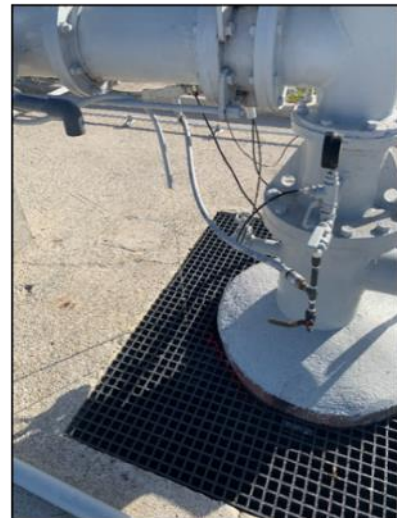
- D) Effluent Disposal: The LTF effluent is conveyed from the effluent storage tank to a deep injection well and disposed of in a confined saltwater aquifer at an approximate depth of 2,700 feet below ground surface. The effluent sample point at the deep injection well may be seen in the photo provided.

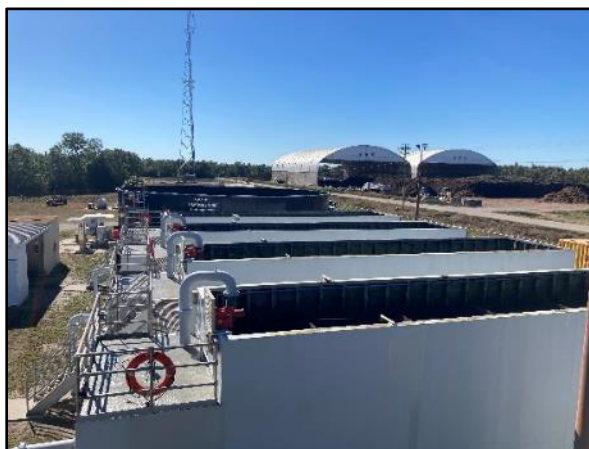
The three PACT units are in decent-to-poor condition. At the time of the visit, signs of leaking were observed due to the rust on the bottom of all treatment tanks, including the decommissioned sludge holding tank. After discussion with Operations, to extend the operation life of the tanks the liner on the inside of the tank can be removed and new tank liner installed. The motor for the third tank blower was replaced, but the polymer feed systems and blower air intakes for the treatment trains should be replaced. Significant rust and corrosion were observed on the decant mounting system of the tanks and should be replaced.

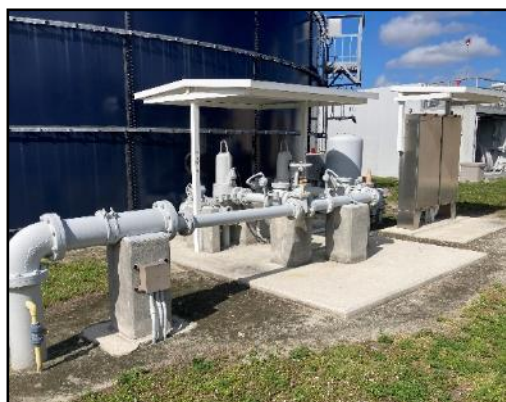
The effluent disposal system contained a storage tank, submersible pumps, and a deep injection well. LTF effluent is stored and equalized in an effluent storage tank so that the injection well down-hole flow does not exceed 320 gpm. LTF effluent is pumped from the effluent storage tank into the injection well by two dry-pit submersible pumps. Effluent is typically disposed of the same day it is treated. Most of the effluent is pumped into the deep injection well, with a small volume used for dust control at the landfill. The deep injection well typically operates

The effluent storage and disposal systems are in fair condition and are properly maintained to meet the facility's needs. The facilities were recently painted. The existing 12-HP pumps were installed by CCU personnel in FY 2015. The pumps are submersible type and are operating satisfactorily under their typical operating period of approximately 7 hours per day. However, the pumps' exposed exteriors generate high heat, creating a risk of skin exposure to operators.

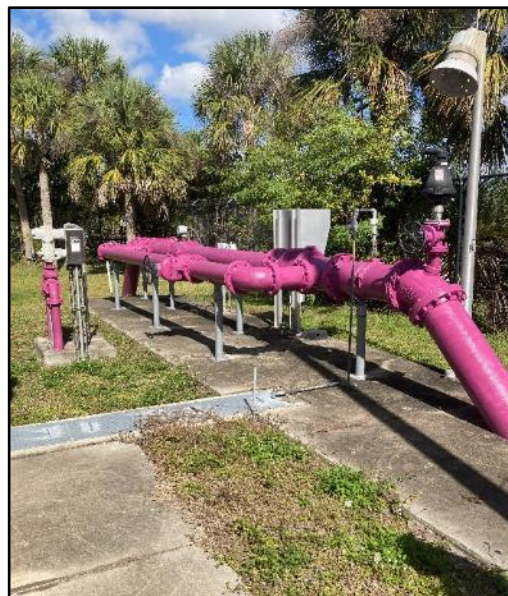
Jones Edmunds completed an on-site review of the plant on January 27, 2025. In general, the electrical room equipment, pump room equipment, and tank appeared to be in good condition. Additionally, a Jones Edmunds electrical engineer conducted an electrical equipment site visit assessment on February 11, 2025, with County staff. The distribution breaker in panel L1 tripped and a faulty receptacle was reported. The MOV that is mounted on the recycle pipe is inoperable, and the reason for faulty operation is unknown. All 480V equipment was missing ArcFlash labels, which are required by NFPA 70E.

- The pipes were not painted properly.
- The pressure transducer screens are worn out from sun damage.
- Faulty receptacle that trips a breaker in panel L1.
- The MOV for the recycle pipe is not operational.
- All 480V equipment was not equipped with ArcFlash labels.

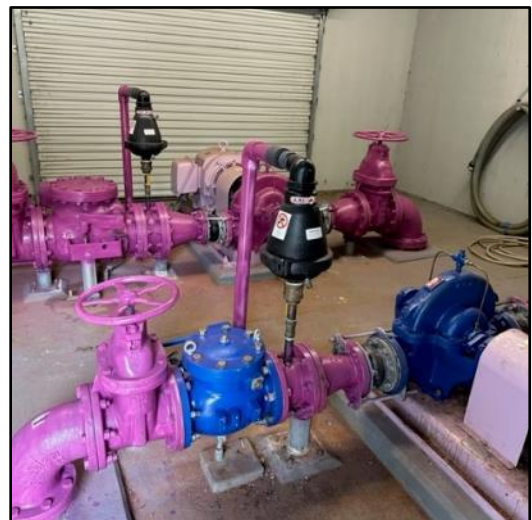
The access roads outside the facility are aging and need to be repaved but are in fair condition inside the property. Fallen trees around the site will require complete removal. The motors for both pumps were removed during the time of the visit because they were locked and not working. The roof over the chemical storage tanks is missing shingles from hurricane winds that need to be replaced. The recycle actuator is held on by a strap and needs to be properly secured. The GST level indicator is broken and needs to be replaced. A cable on the back of the GST needs to be re-secured to the side of the tank. Additionally, pressure transducer screens are damaged from sunlight exposure and need replacing. The HSPs are well maintained and functioning properly.

The electrical room equipment, pump room equipment, and storage tank are in good condition. Due to the pumps being removed, loose wires near the pumps should be put away securely. Some pipe equipment needs to be painted purple. The grounds are well maintained.

- The access roads outside the facility are washed out and need to be repaved.
- The bypass actuator is held on by a strap and needs to be properly secured.
- The GST level indicator is broken and needs to be replaced.
- GST operations need to be restored as it is not reported to be in operation.

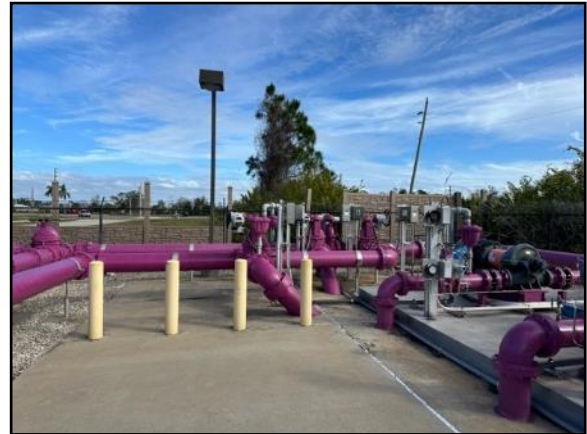
The station was in good condition overall. However, some minor issues exist that need attention.

- One of the external wall panels was missing and needs replacing.
- Pressure transducer and gauge screens have been damaged from sunlight exposure and need replacing.
- Some valves were leaking, causing rust, and should be replaced.
- Equipment should be recalibrated.
